ARMATURE FROM A CLOCK MOVEMENT MIH IV-212 - ZN AL SN CU ALLOY - MODERN TIMES

Artefact name Armature from a clock movement MIH IV-212

Authors Marianne. Senn (Empa, Dübendorf, Zurich, Switzerland) & Christian. Degrigny (HE-Arc CR, Neuchâtel, Neuchâtel, Switzerland)

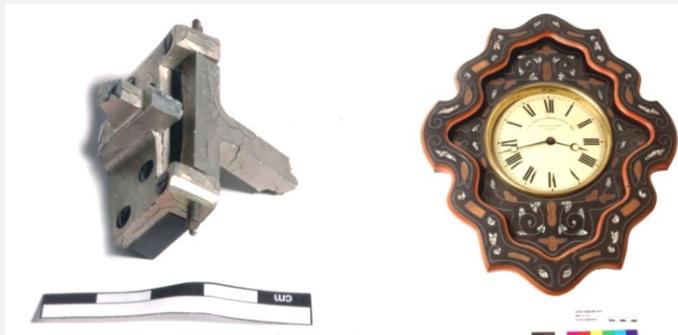
Fig. 1: Broken armature (left) from the clock movement of a wooden wall clock (right) (after Seematter 2009),

Description of the artefact Armature from the clock movement of a wooden wall clock with electric movement, broken in two elements (Fig. 1 and Fig. 2) with a heavily cracked surface.

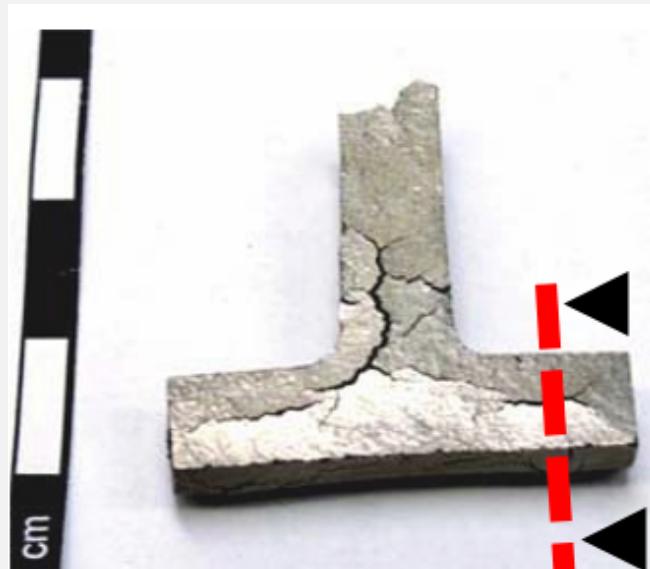
Fig. 2: Location of sampling area on one of the two broken elements of the armature,

This sample is the complete cross-section from one of the two broken elements of the armature (Fig. 2). The metal has large cracks radiating from the centre to the outside which have deformed the armature (Fig. 3).

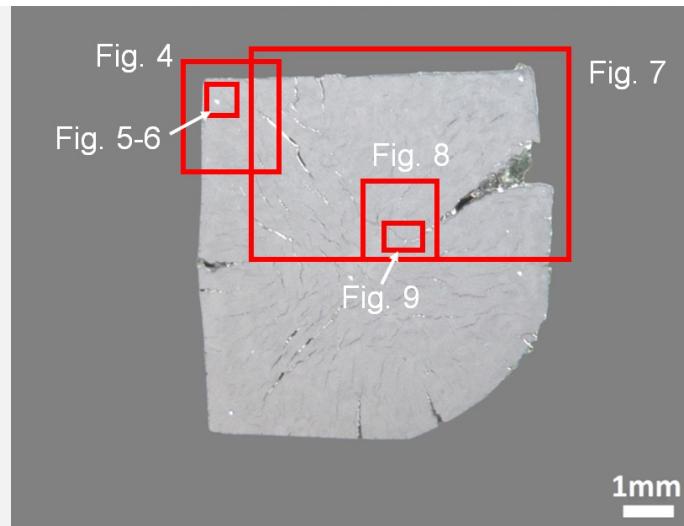
Fig. 3: Micrograph of the cross-section of the fragment sampled from the armature showing the location of Figs. 4 to 9,

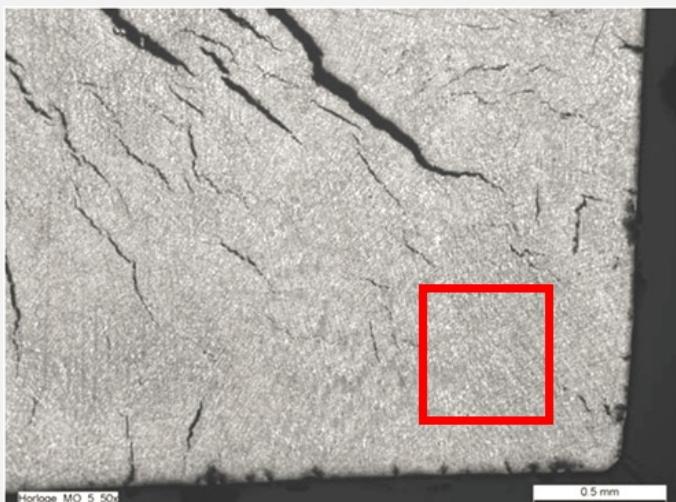
The metal is a Zn-Al-Sn-Cu alloy (Table 1) with an average hardness of HV1 105. A fine dendritic structure is observed (Fig. 4) which consists of clearly separated Zn, Al-Cu and Sn-rich phases (Figs. 5 and 6). Pb is associated with Sn but also forms tiny nodules.

Fig. 4: Micrograph of the metal sample from Fig. 3 (inverted picture, rotated by 270°, detail), unetched, bright field. A dendritic structure is visible. The micrograph of Fig. 5 is marked by a square,

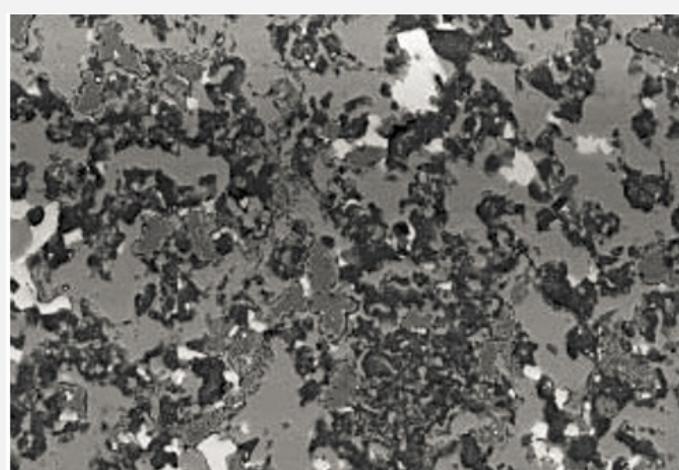
Fig. 5: SEM image, BSE-mode, detail from Fig. 4 (detail), unetched, bright field. Three phases appear: in light-grey the Zn-rich phase, in dark-grey the Al and Cu-rich phase and in white the Sn-rich phase,

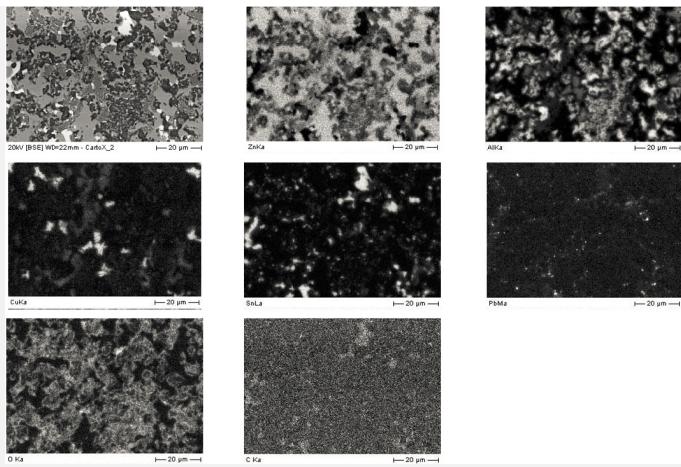
Fig. 6: SEM image, BSE-mode, and elemental chemical distribution of the selected area from Fig. 5. Method of examination: SEM/EDS, Lab of Electronic Microscopy and microanalysis, IMA (Néode), HEI Arc,

The Zn-rich phase is heavily oxidised internally (Fig. 6). The corrosion has developed throughout the entire metal body, generating cracks (Figs. 7 and 8). The cracks are Zn, O and C-rich (Fig. 9) and could be composed of zinc carbonate.

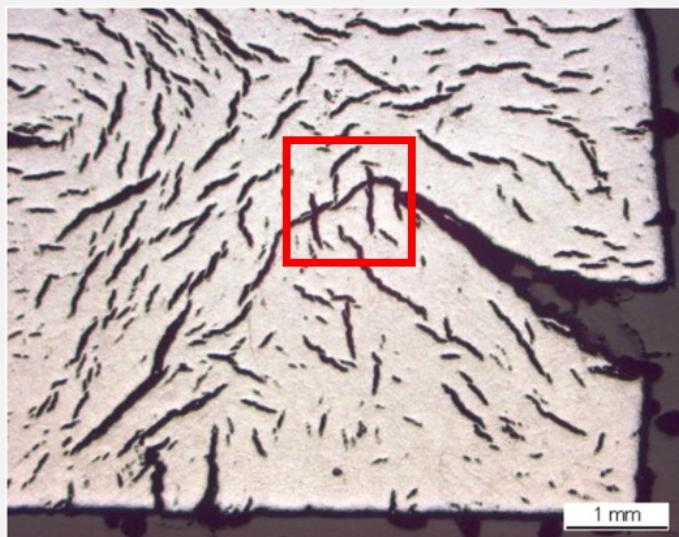
Fig. 7: Micrograph showing the metal - "corrosion products" interface from Fig. 3 (reversed picture, detail), unetched, bright field,

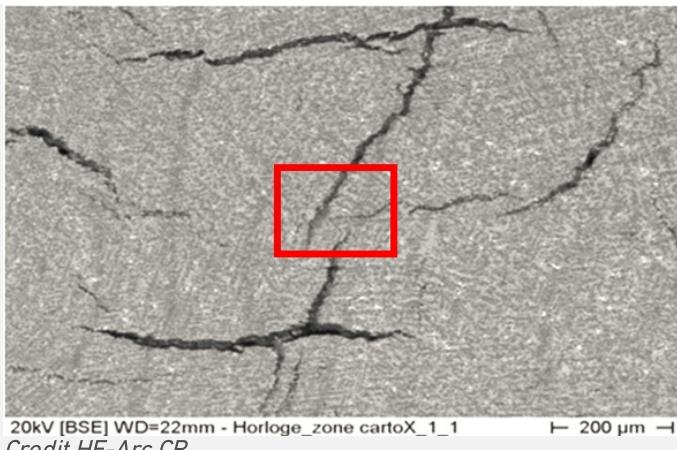
Fig. 8: Micrograph of the metal sample, detail from Fig. 7 (reversed and rotated by 90°), unetched, bright field. A dendritic structure is visible. The area selected for elementary mapping (Fig. 9) is marked by a rectangle. Can be compared to the stratigraphy representation of Fig. 10,

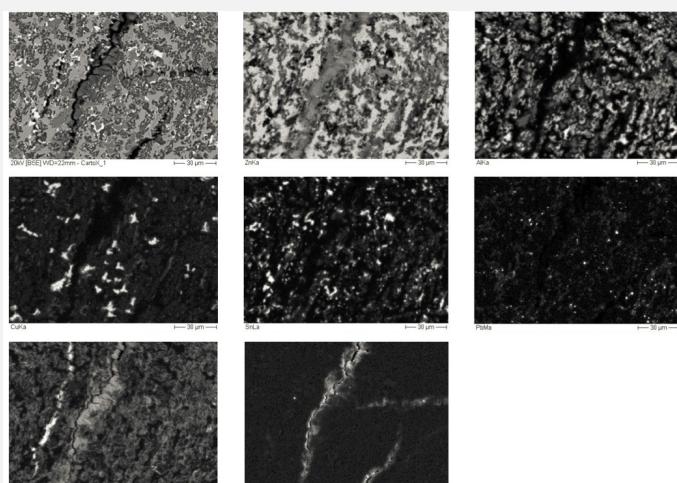
Fig. 9: SEM image, BSE-mode, and elemental chemical distribution of the selected area from Fig. 8 (detail). Method of examination: SEM/EDX, Lab of Electronic Microscopy and microanalysis, IMA (Néode), HEI Arc,
