ARMATURE FROM A CLOCK MOVEMENT MIH IV-212 - ZN AL SN CU ALLOY - MODERN TIMES

| Artefact name | Armature from a clock movement MIH IV-212 |
| Authors | Marianne. Senn (Empa, Dübendorf, Zurich, Switzerland) & Christian. Degriigny (HE-Arc CR, Neuchâtel, Neuchâtel, Switzerland) |

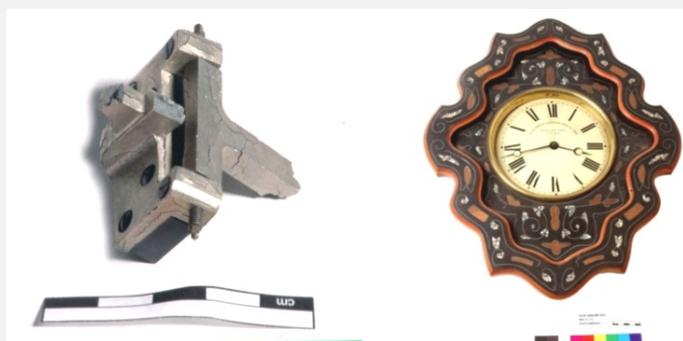
Fig. 1: Broken armature (left) from the clock movement of a wooden wall clock (right) (after Seematter 2009),

| Description of the artefact | Armature from the clock movement of a wooden wall clock with electric movement, broken in two elements (Fig. 1 and Fig. 2) with a heavily cracked surface. | |

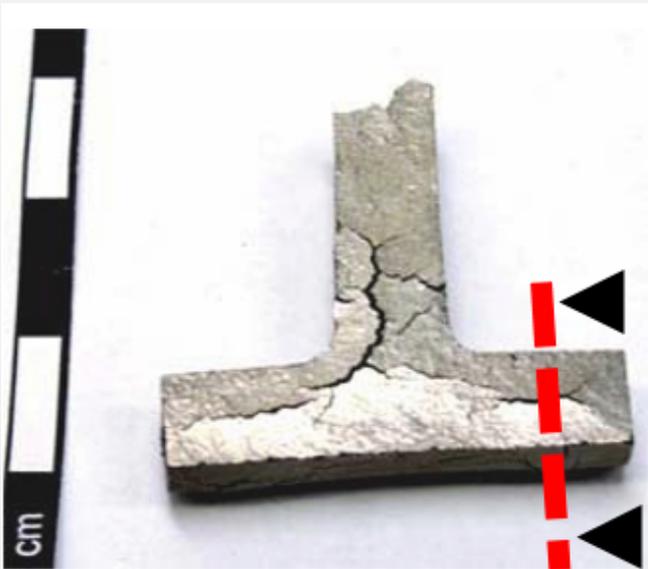
Fig. 2: Location of sampling area on one of the two broken elements of the armature,

| Description of sample | This sample is the complete cross-section from one of the two broken elements of the armature (Fig. 2). The metal has large cracks radiating from the centre to the outside which have deformed the armature (Fig. 3). |

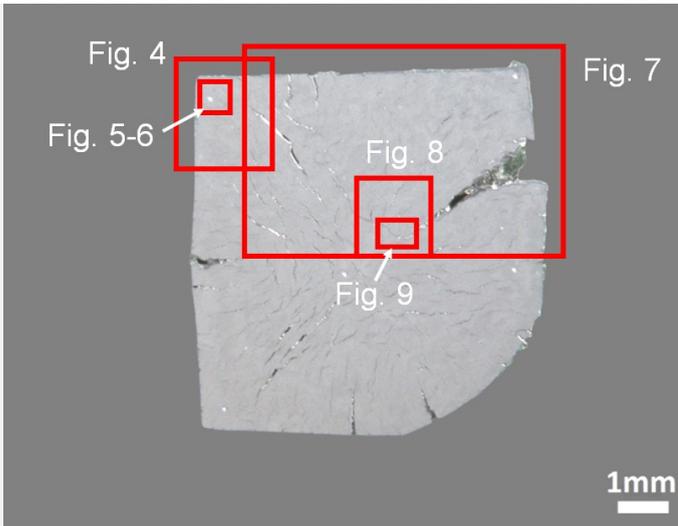
Fig. 3: Micrograph of the cross-section of the fragment sampled from the armature showing the location of Figs. 4 to 9,

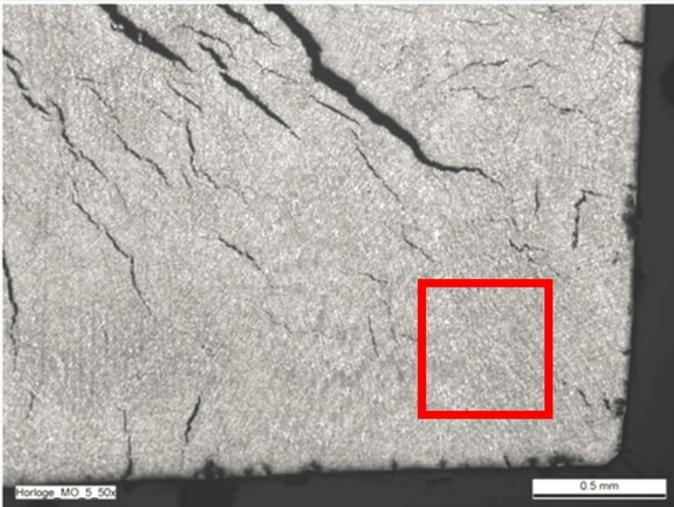
The metal is a Zn-Al-Sn-Cu alloy (Table 1) with an average hardness of HV1 105. A fine dendritic structure is observed (Fig. 4) which consists of clearly separated Zn, Al-Cu and Sn-rich phases (Figs. 5 and 6). Pb is associated with Sn but also forms tiny nodules.

Fig. 4: Micrograph of the metal sample from Fig. 3 (inverted picture, rotated by 270°, detail), unetched, bright field. A dendritic structure is visible. The micrograph of Fig. 5 is marked by a square,

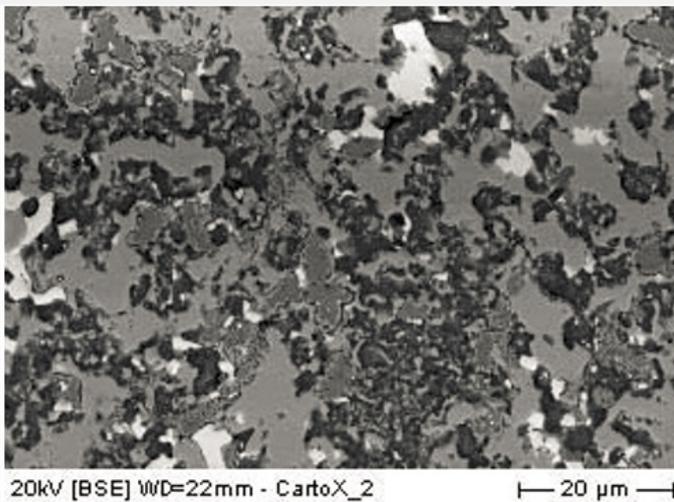
Fig. 5: SEM image, BSE-mode, detail from Fig. 4 (detail), unetched, bright field. Three phases appear: in light-grey the Zn-rich phase, in dark-grey the Al and Cu-rich phase and in white the Sn-rich phase,

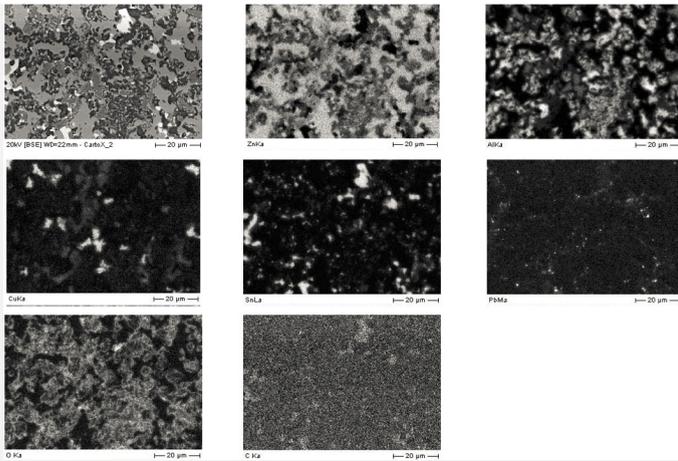
Fig. 6: SEM image, BSE-mode, and elemental chemical distribution of the selected area from Fig. 5. Method of examination: SEM/EDS, Lab of Electronic Microscopy and microanalysis, IMA (Néode), HEI Arc,

The Zn-rich phase is heavily oxidised internally (Fig. 6). The corrosion has developed throughout the entire metal body, generating cracks (Figs. 7 and 8). The cracks are Zn, O and C-rich (Fig. 9) and could be composed of zinc carbonate.

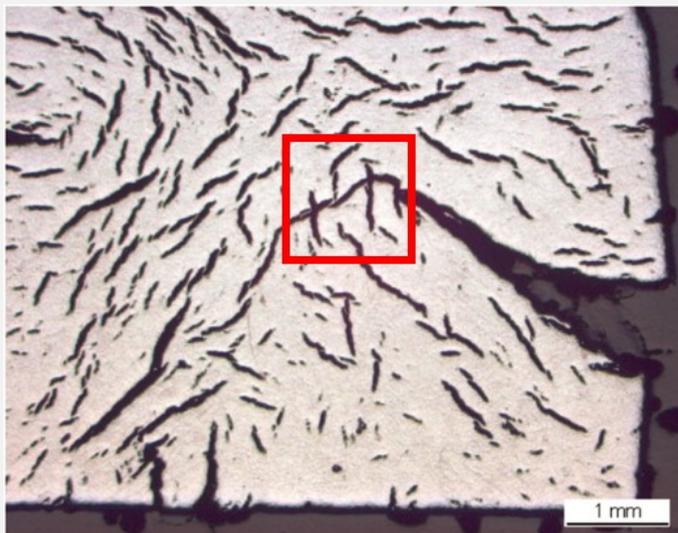
Fig. 7: Micrograph showing the metal - "corrosion products" interface from Fig. 3 (reversed picture, detail), unetched, bright field,

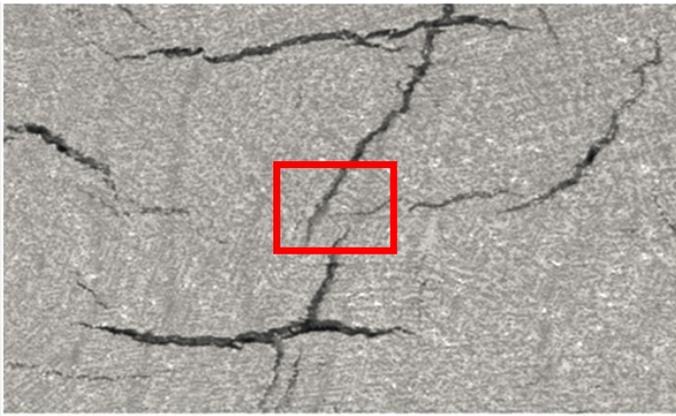
Fig. 8: Micrograph of the metal sample, detail from Fig. 7 (reversed and rotated by 90°), unetched, bright field. A dendritic structure is visible. The area selected for elementary mapping (Fig. 9) is marked by a rectangle. Can be compared to the stratigraphy representation of Fig. 10,

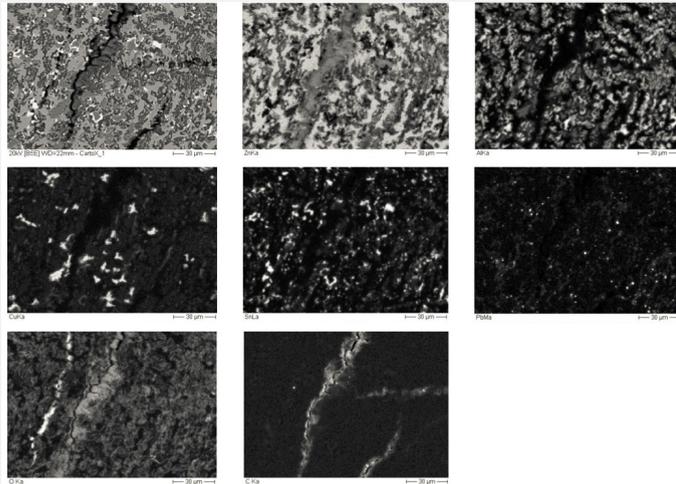
Fig. 9: SEM image, BSE-mode, and elemental chemical distribution of the selected area from Fig. 8 (detail). Method of examination: SEM/EDX, Lab of Electronic Microscopy and microanalysis, IMA (Néode), HEI Arc,

Corrosion form Internal cracking
Corrosion type zinc pest
