ARMATURE FROM A CLOCK MOVEMENT MIH IV-212 – ZN AL SN CU ALLOY – MODERN TIMES

Artefact name	Armature from a clock movement MIH IV-212
Authors	Marianne. Senn (Empa, Dübendorf, Zurich, Switzerland) & Christian. Degriigny (HE-Arc CR, Neuchâtel, Neuchâtel, Switzerland)
Url	/artefacts/971/

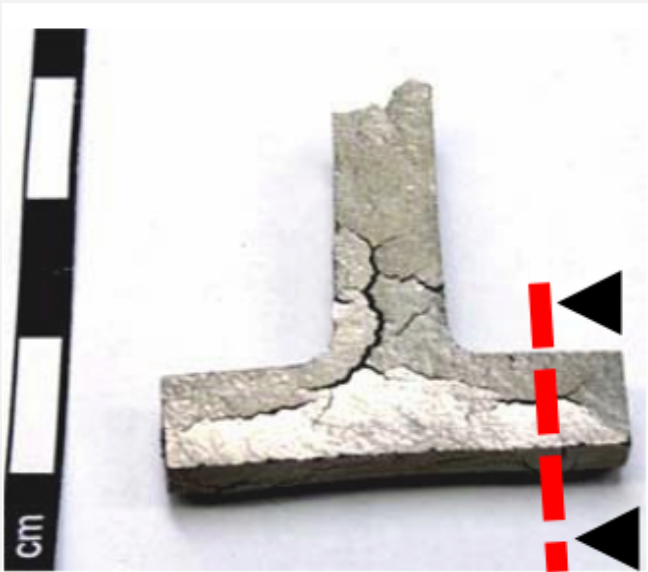
Fig. 2: Location of sampling area on one of the two broken elements of the armature,

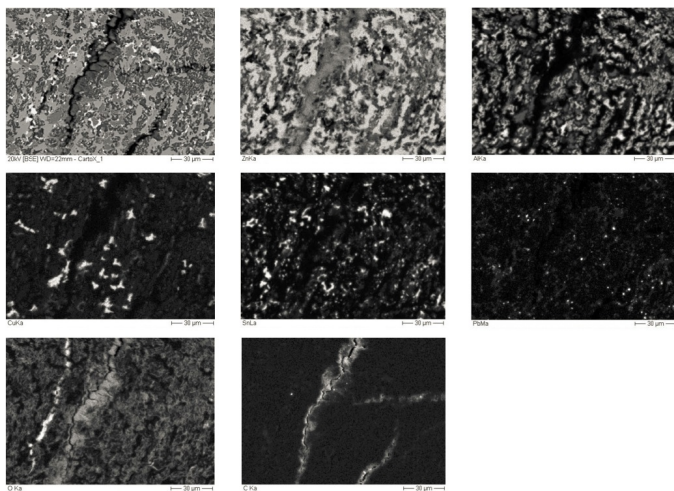
Fig. 9: SEM image, BSE-mode, and elemental chemical distribution of the selected area from Fig. 8 (detail). Method of examination: SEM/EDX, Lab of Electronic Microscopy and microanalysis, IMA (Néode), HEI Arc,
