# SHOE NAIL 2637 1370.B. - HYPOEUTECTOID STEEL - ROMAN TIMES - SWITZERLAND

**Artefact name** Shoe nail 2637 1370.B.

**Authors** Christian. Degriigny (HE-Arc CR, Neuchâtel, Neuchâtel, Switzerland) & Valentin. Boissonnas (HE-Arc CR, Neuchâtel, Neuchâtel, Switzerland) & Vincent Chappuis. (HE-Arc CR, Neuchâtel, Neuchâtel, Switzerland)

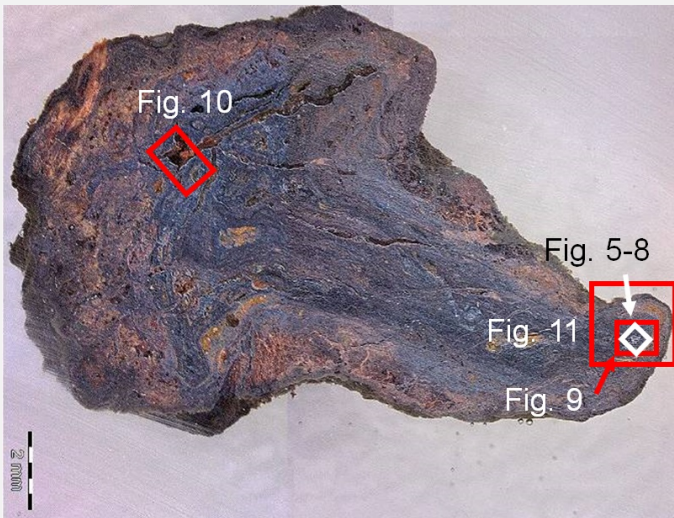
Fig. 4: Micrograph of the cross-section of the nail showing the location of figs. 5 to 11,

<b>Description of sample</b>	A longitudinal cut through the nail (Fig. 4). Dimensions: L = 16.4mm; W = about 12.0mm.
<b>Alloy</b>	Hypoeutectoid steel
<b>Technology</b>	Forged
<b>Lab number of sample</b>	HE-Arc CR 1457-S1.
<b>Sample location</b>	HE-Arc CR, Neuchâtel, Neuchâtel
<b>Responsible institution</b>	HE-Arc CR, Neuchâtel, Neuchâtel

The metal is heavily corroded and the thickness of the corrosion crust is irregular, varying from 0.8 to 3.8mm, with an average of about 2mm. The corrosion has replaced most of the metal (Fig. 4). Between corrosion layers the limit of the original structure is visible. Some leather fibers seem to be preserved as pseudomorphic structures in voids of the metal core (POM1, Figs. 9 and 10). The carbon mapping (Fig.11) shows the presence of carbon in these areas. This can also be due to the penetration of the mounting resin in the cracks.

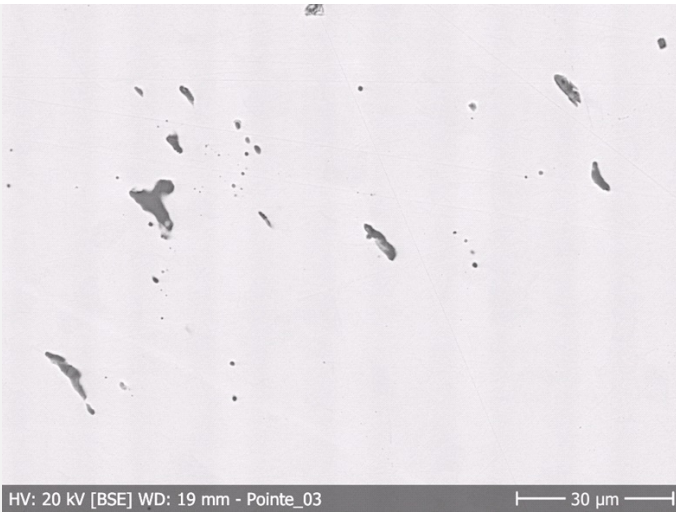
Fig. 6: SEM, BSE-mode picture of inclusions in remaining metal (detail of Fig. 5),

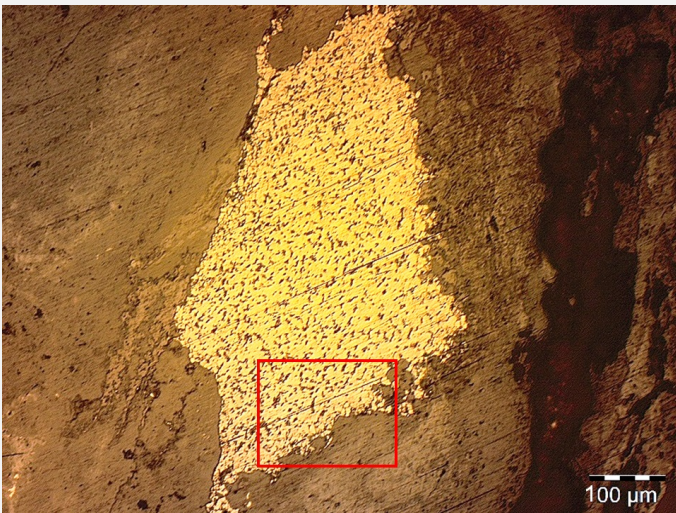
Fig. 7: Micrograph of the metal sample from Fig. 5 (detail, rotated 90°), Nital etched, bright field, with indication of Fig. 8 (red rectangle)

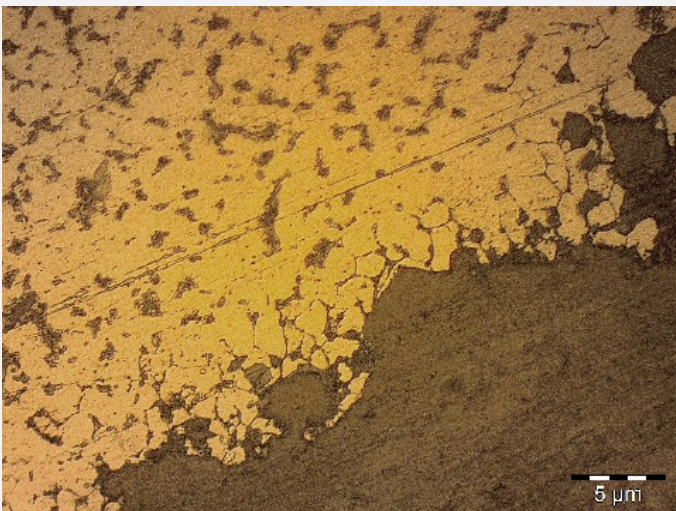
Fig. 8: Micrograph of the selected area of Fig. 7, Nital etched with no clear grain structure, bright field, Intergranular corrosion and grey phase (perlite?) are observed,

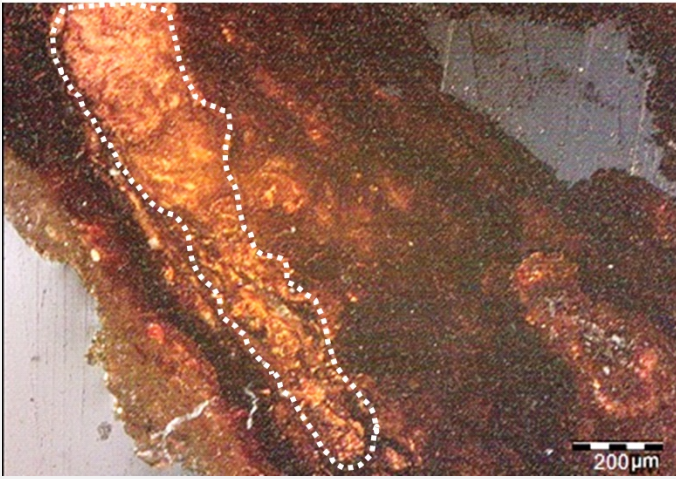
Fig. 9: Micrograph of the metal sample from Fig. 4, bright field. The delimited zone shows what could be leather pseudomorphic fibers filling a void,

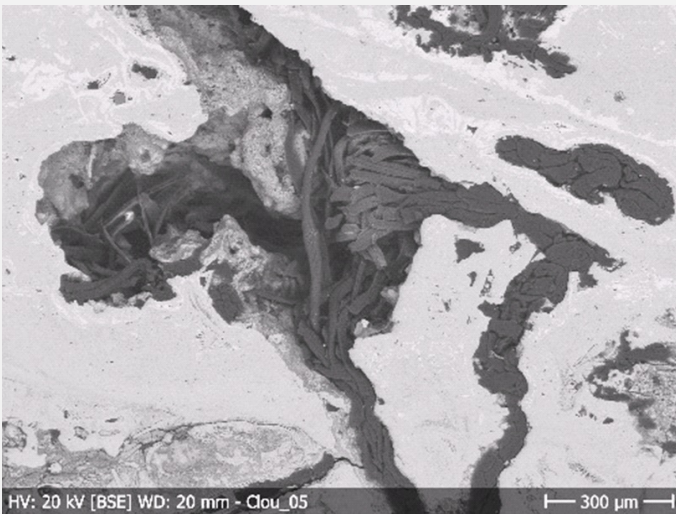
Fig. 10: SEM - BSE-mode picture of another void filled with fibers in the head of the nail (see Fig. 4),

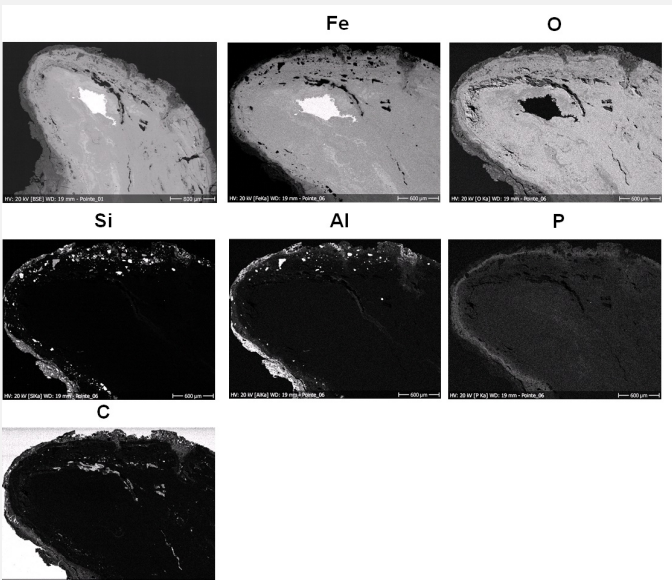
Si, Al, P and K can be considered external markers, helping to determine the limit of the original surface (Fig. 11 and Table 1). The outer layer of corrosion products (CP1-3) ranges from dark grey to orange in bright field and contains less O and Fe on its borders than the inner layer (CP4-5, Figs. 4 and 11, Table 1). The SEM pictures show a marbling appearance of the inner corrosion layer (CP5). Cl and S do not seem to be present in the sampled nail.

Fig. 11: Elemental chemical distribution of the selected area from Fig. 4 (90° counter-clockwise rotated). SEM-EDS,

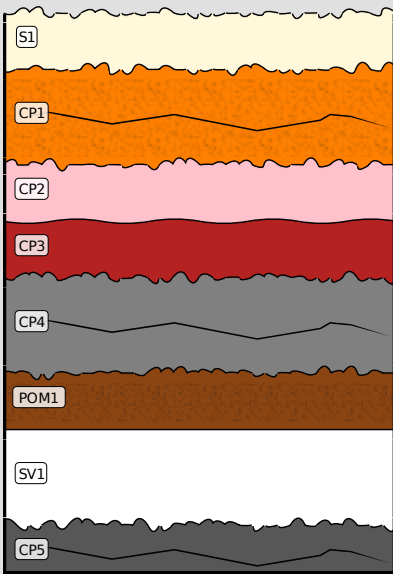
Fig. 12: Stratigraphic representation of the nail in cross-section (dark field) using the MiCorr application. The characteristics of the strata are only accessible by clicking on the drawing that redirects you to the search tool by stratigraphy representation. This representation can be compared to Fig. 14, Credit HE-Arc CR, V.Chappuis.

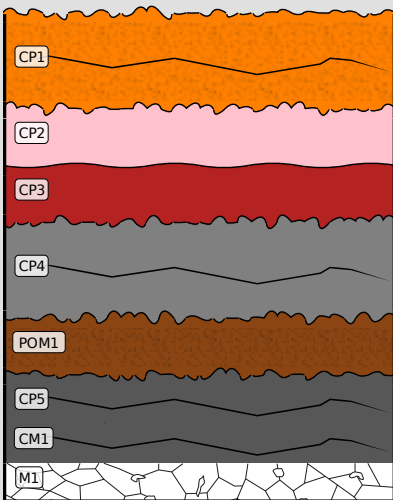
Fig. 13: Stratigraphic representation of the nail in cross-section (dark field) using the MiCorr application. The characteristics of the strata are only accessible by clicking on the drawing that redirects you to the search tool by stratigraphy representation. This representation can be compared to Fig. 14, Credit HE-Arc CR, V.Chappuis.
