# SHOE NAIL 2637 1370.B. – HYPOEUTECTOID STEEL – ROMAN TIMES – SWITZERLAND

Artefact name	Shoe nail 2637 1370.B.
Authors	Christian. Degriigny (HE-Arc CR, Neuchâtel, Neuchâtel, Switzerland) & Valentin. Boissonnas (HE-Arc CR, Neuchâtel, Neuchâtel, Switzerland) & Vincent Chappuis. (HE-Arc CR, Neuchâtel, Neuchâtel, Switzerland)
Url	/artefacts/973/

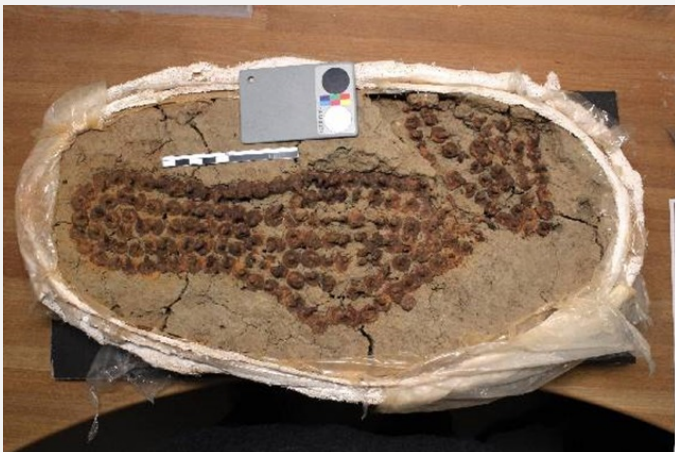
Fig. 1: A Roman shoe nail from a block taken from an excavation site before conservation,

Description of the artefact	A Roman shoe nail from a block taken from an excavation site (Fig. 1) covered with a thick corrosion crust. The forged nails were hammered into the leather soles on a bucking tool. Average dimensions of the shoe nails: L = about 14mm; diamter = 11mm; W = up to 0.8g.		
Type of artefact	Shoe nail		
Origin	Hofstetterfeld, near Roman Necropolis, Sursee, Lucerne, Switzerland		
Recovering date	Unknown		
Chronology category	Roman Times		
chronology tpq	50	A.D. ▼	
chronology taq	100	A.D. ▼

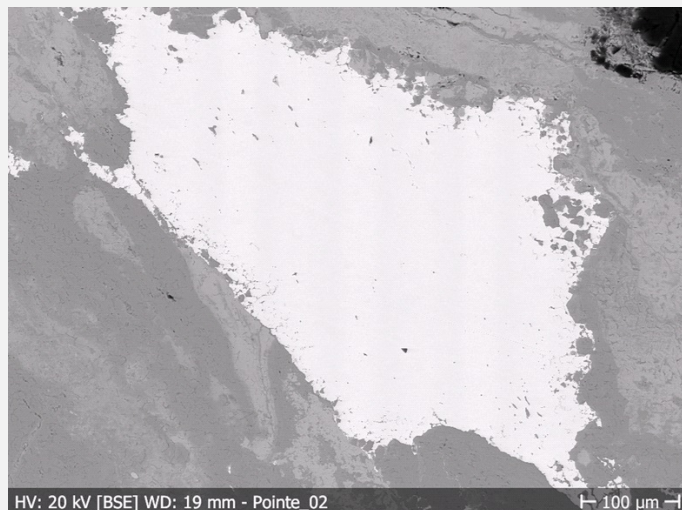
The remaining metal is an hypoeutectoid steel (Fig. 5 and 6), containing Fe, Si and O slags inclusions (possibly fayalite  $\text{FeO, SiO}_2$ ), and consisting of less than 1% of the total volume of the highly mineralized nail. After Nital etching, it shows intergranular corrosion on one of its sides (Figs. 7 and 8).

Fig. 5: SEM, BSE-mode picture of remaining metal from cross-section of Fig. 4,

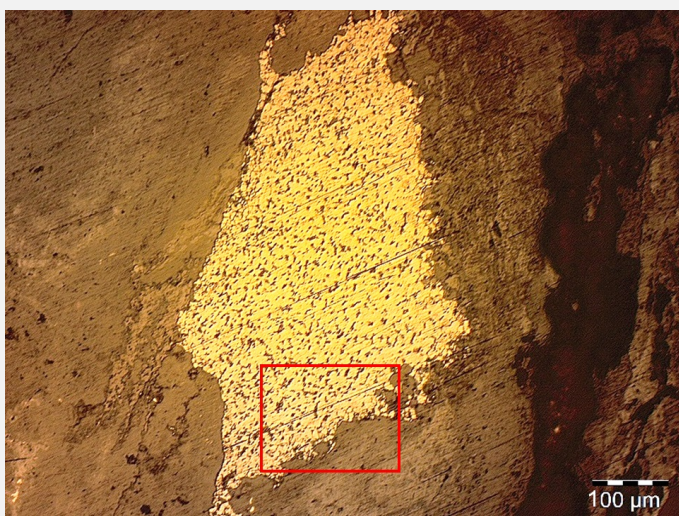
Fig. 7: Micrograph of the metal sample from Fig. 5 (detail, rotated 90°), Nital etched, bright field, with indication of Fig. 8 (red rectangle)

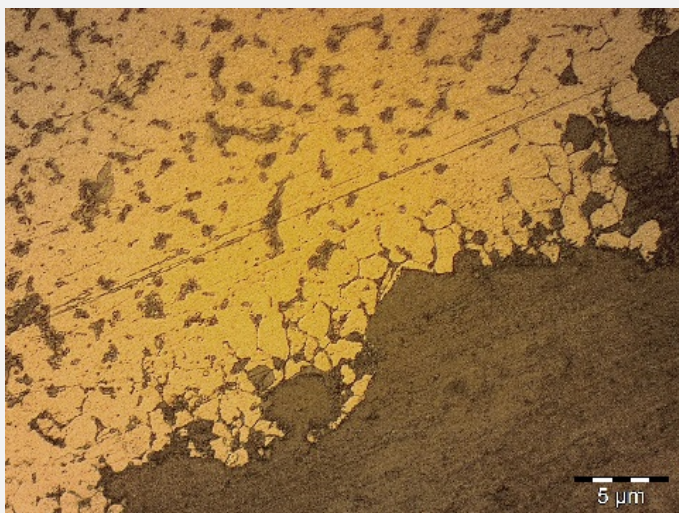
Fig. 8: Micrograph of the selected area of Fig. 7, Nital etched with no clear grain structure, bright field, Intergranular corrosion and grey phase (perlite?) are observed,

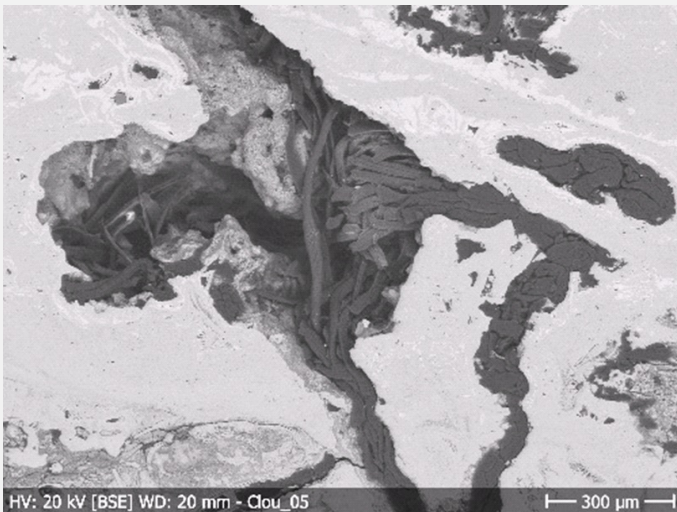
Fig. 10: SEM - BSE-mode picture of another void filled with fibers in the head of the nail (see Fig. 4),

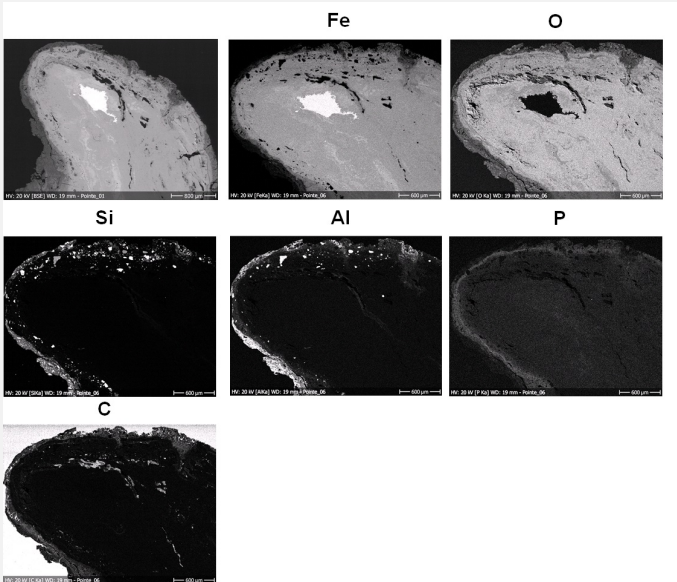
Si, Al, P and K can be considered external markers, helping to determine the limit of the original surface (Fig. 11 and Table 1). The outer layer of corrosion products (CP1-3) ranges from dark grey to orange in bright field and contains less O and Fe on its borders than the inner layer (CP4-5, Figs. 4 and 11, Table 1). The SEM pictures show a marbling appearance of the inner corrosion layer (CP5). Cl and S do not seem to be present in the sampled nail.

Fig. 11: Elemental chemical distribution of the selected area from Fig. 4 (90° counter-clockwise rotated). SEM-EDS,
