# SHOE NAIL 2637 1370.B. – HYPOEUTECTOID STEEL – ROMAN TIMES – SWITZERLAND

Artefact name	Shoe nail 2637 1370.B.
Authors	Christian. Degriigny (HE-Arc CR, Neuchâtel, Neuchâtel, Switzerland) & Valentin. Boissonnas (HE-Arc CR, Neuchâtel, Neuchâtel, Switzerland) & Vincent Chappuis. (HE-Arc CR, Neuchâtel, Neuchâtel, Switzerland)
Url	/artefacts/973/

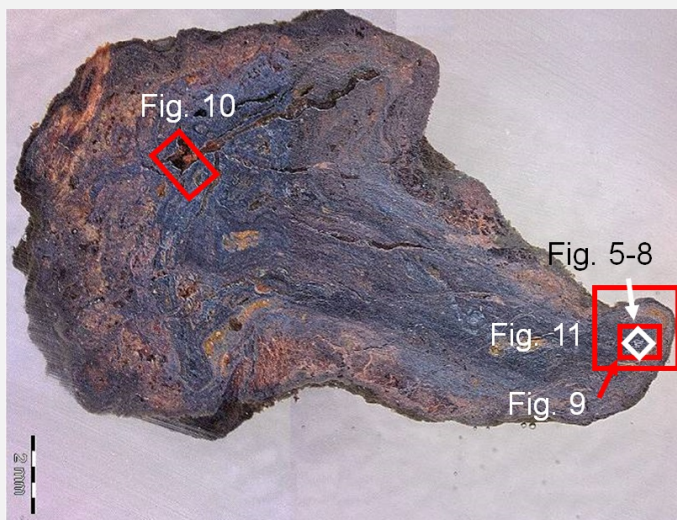
Fig. 4: Micrograph of the cross-section of the nail showing the location of figs. 5 to 11,

<b>Description of sample</b>	A longitudinal cut through the nail (Fig. 4). Dimensions: L = 16.4mm; W = about 12.0mm.
<b>Alloy</b>	Hypoeutectoid steel
<b>Technology</b>	Forged
<b>Lab number of sample</b>	HE-Arc CR 1457-S1.
<b>Sample location</b>	HE-Arc CR, Neuchâtel, Neuchâtel
<b>Responsible institution</b>	HE-Arc CR, Neuchâtel, Neuchâtel

The metal is heavily corroded and the thickness of the corrosion crust is irregular, varying from 0.8 to 3.8mm, with an average of about 2mm. The corrosion has replaced most of the metal (Fig. 4). Between corrosion layers the limit of the original structure is visible. Some leather fibers seem to be preserved as pseudomorphic structures in voids of the metal core (POM1, Figs. 9 and 10). The carbon mapping (Fig.11) shows the presence of carbon in these areas. This can also be due to the penetration of the mounting resin in the cracks.

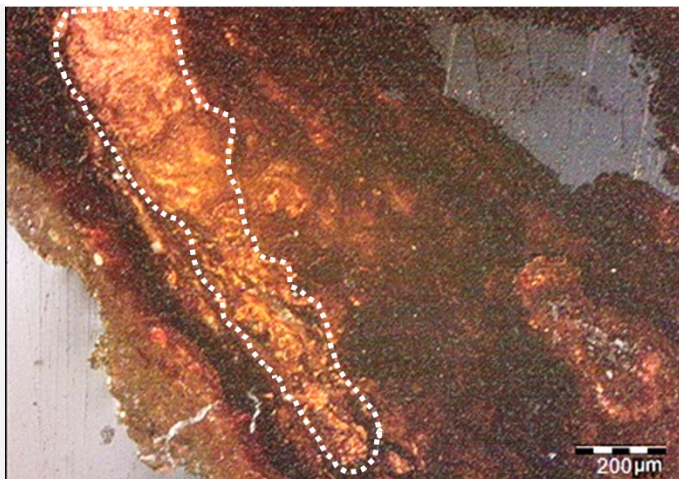
Fig. 9: Micrograph of the metal sample from Fig. 4, bright field. The delimited zone shows what could be leather pseudomorphic fibers filling a void,

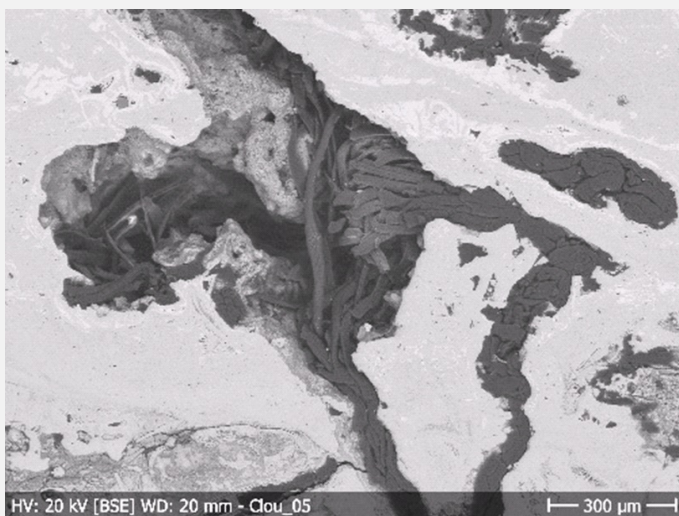
Fig. 10: SEM - BSE-mode picture of another void filled with fibers in the head of the nail (see Fig. 4),

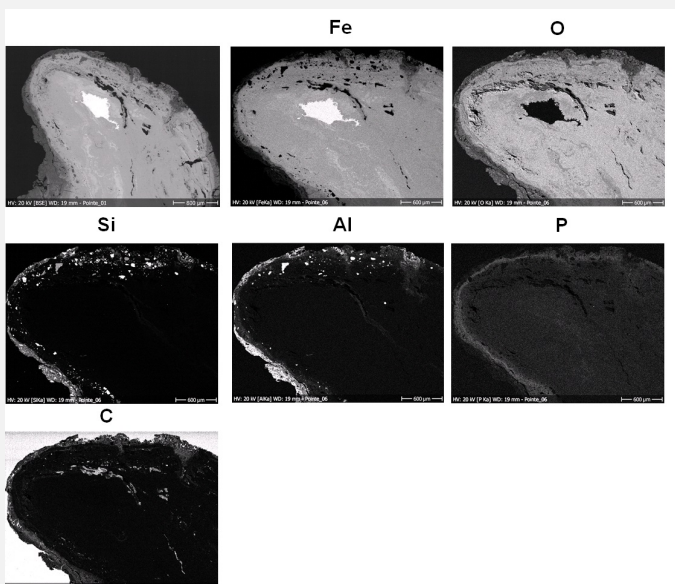
Si, Al, P and K can be considered external markers, helping to determine the limit of the original surface (Fig. 11 and Table 1). The outer layer of corrosion products (CP1-3) ranges from dark grey to orange in bright field and contains less O and Fe on its borders than the inner layer (CP4-5, Figs. 4 and 11, Table 1). The SEM pictures show a marbling appearance of the inner corrosion layer (CP5). Cl and S do not seem to be present in the sampled nail.

Fig. 11: Elemental chemical distribution of the selected area from Fig. 4 (90° counter-clockwise rotated). SEM-EDS,
