SHOE NAIL 2637 1370.B. - HYPOEUTECTOID STEEL - ROMAN TIMES - SWITZERLAND

Artefact name Shoe nail 2637 1370.B.

Authors Christian. Degrigny (HE-Arc CR, Neuchâtel, Neuchâtel, Switzerland) & Valentin. Boissonnas (HE-Arc CR, Neuchâtel, Neuchâtel, Switzerland) & Vincent Chappuis. (HE-Arc CR, Neuchâtel, Neuchâtel, Switzerland)

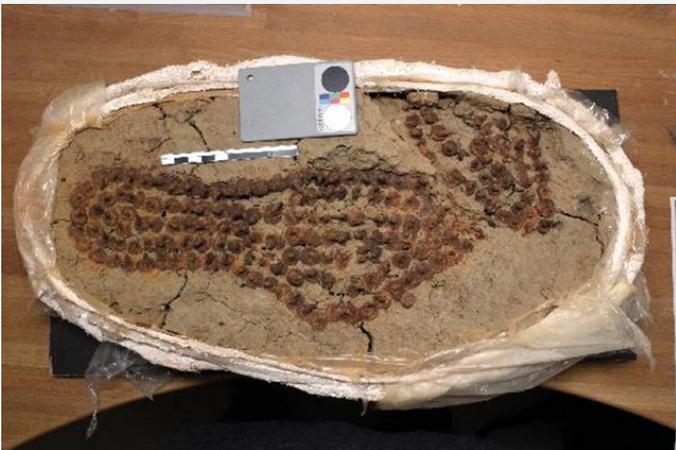
Fig. 1: A Roman shoe nail from a block taken from an excavation site before conservation,

Description of the artefact	A Roman shoe nail from a block taken from an excavation site (Fig. 1) covered with a thick corrosion crust. The forged nails were hammered into the leather soles on a bucking tool. Average dimensions of the shoe nails: L = about 14mm; diamter = 11mm; W = up to 0.8g.
Type of artefact	Shoe nail
Origin	Hofstetterfeld, near Roman Necropolis, Sursee, Lucerne, Switzerland
Recovering date	Unknown
Chronology category	Roman Times
chronology tpq	<input type="text" value="50"/> A.D. ▼
chronology taq	<input type="text" value="100"/> A.D. ▼

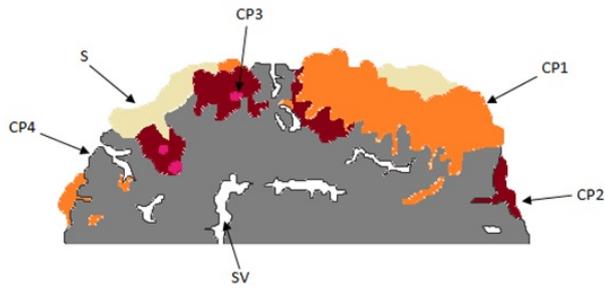
Fig. 3: Preliminary stratigraphy of the corrosion layers based on the observation of a broken nail,

S = compact sand-clay soil.
 CP1 = powdery soil, orange-coloured by corrosion products.
 CP2 = dark-red corrosion crust, breaks into bits.
 CP3 = vivid pink-red and globular corrosion products.
 CP4 = dark grey to black and very hard corrosion products, results in a dark-orange powder when scratched.
 SV = structural void near the center of the cross section, seems to draw a square shape.

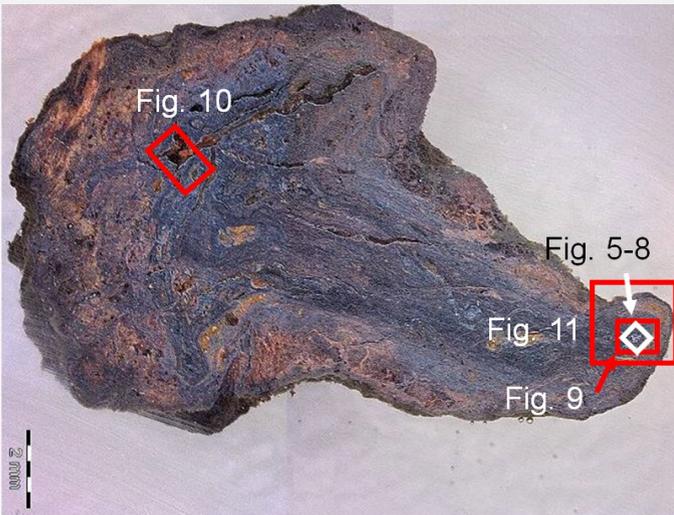
Fig. 4: Micrograph of the cross-section of the nail showing the location of figs. 5 to 11,

The metal is heavily corroded and the thickness of the corrosion crust is irregular, varying from 0.8 to 3.8mm, with an average of about 2mm. The corrosion has replaced most of the metal (Fig. 4). Between corrosion layers the limit of the original structure is visible. Some leather fibers seem to be preserved as pseudomorphic structures in voids of the metal core (POM1, Figs. 9 and 10). The carbon mapping (Fig.11) shows the presence of carbon in these areas. This can also be due to the penetration of the mounting resin in the cracks.

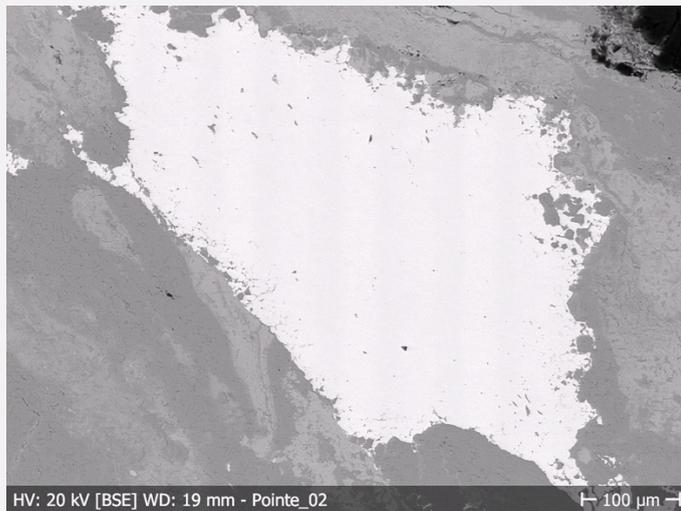
The remaining metal is an hypoeutectoid steel (Fig. 5 and 6), containing Fe, Si and O slags inclusions (possibly fayalite FeO, SiO_2), and consisting of less than 1% of the total volume of the highly mineralized nail. After Nital etching, it shows intergranular corrosion on one of its sides (Figs. 7 and 8).

Fig. 5: SEM, BSE-mode picture of remaining metal from cross-section of Fig. 4,

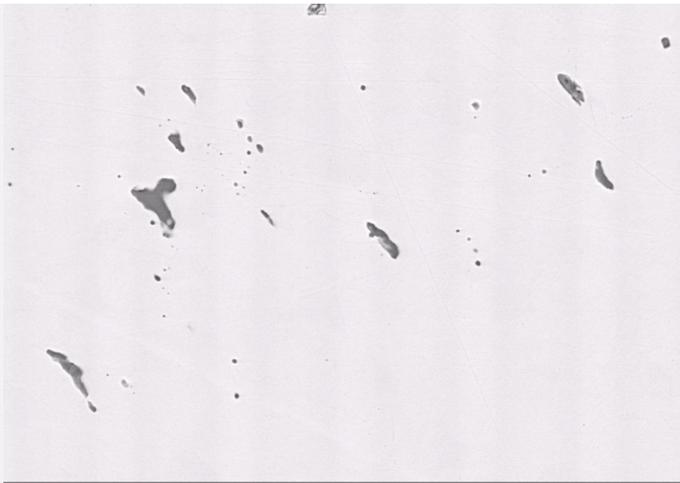
Fig. 6: SEM, BSE-mode picture of inclusions in remaining metal (detail of Fig. 5),

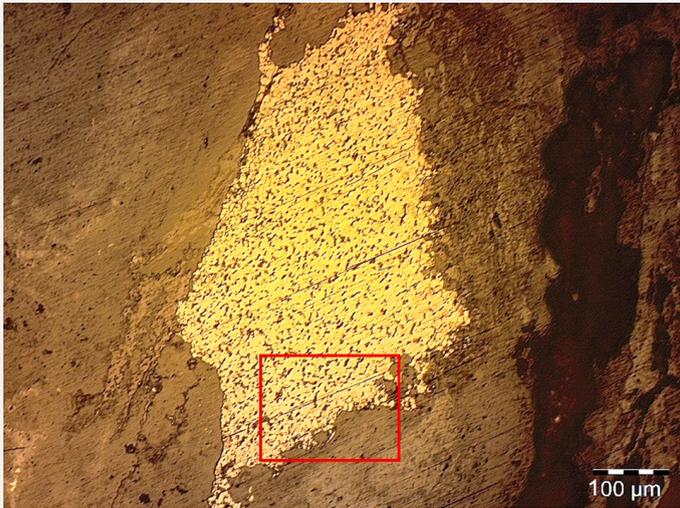
Fig. 7: Micrograph of the metal sample from Fig. 5 (detail, rotated 90°), Nital etched, bright field, with indication of Fig. 8 (red rectangle)

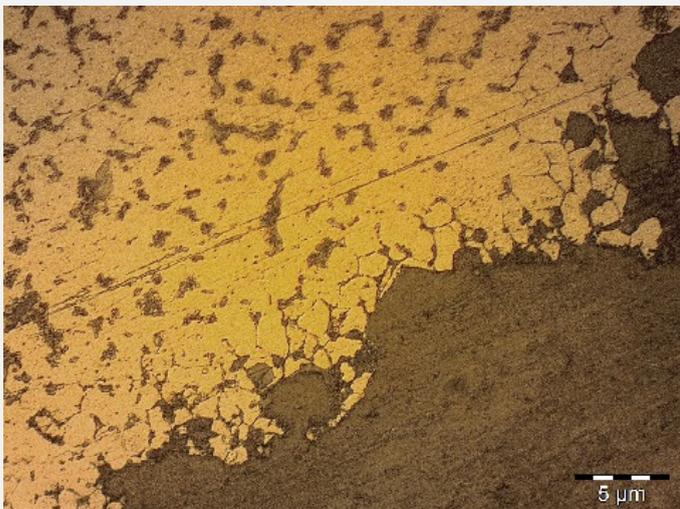
Fig. 8: Micrograph of the selected area of Fig. 7, Nital etched with no clear grain structure, bright field, Intergranular corrosion and grey phase (perlite?) are observed,

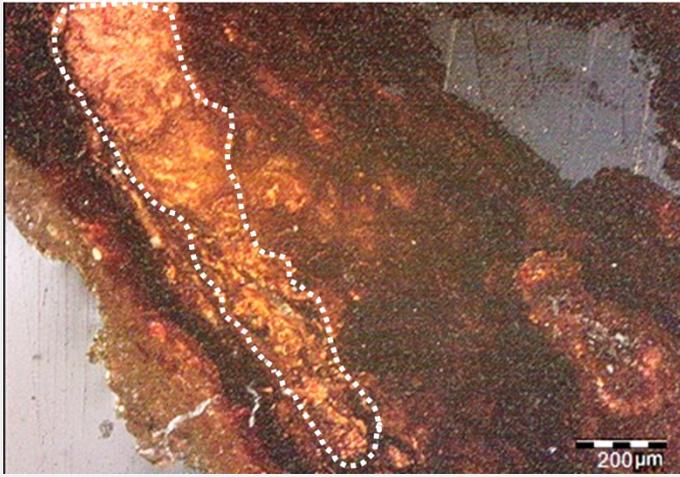
Fig. 9: Micrograph of the metal sample from Fig. 4, bright field. The delimited zone shows what could be leather pseudomorphic fibers filling a void,

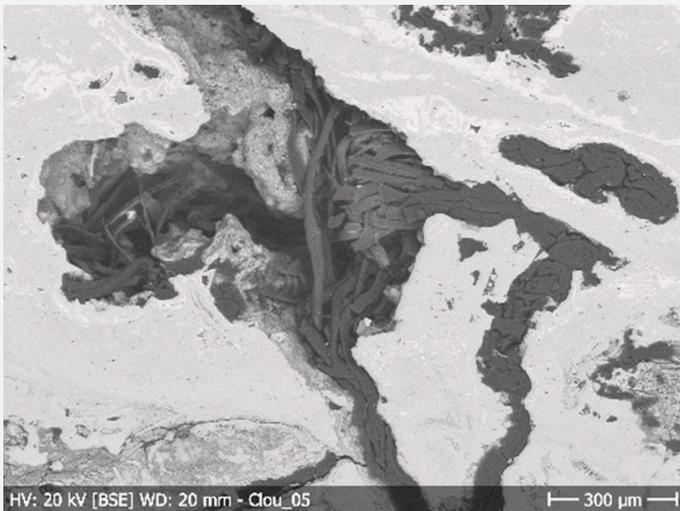
Fig. 10: SEM - BSE-mode picture of another void filled with fibers in the head of the nail (see Fig. 4),

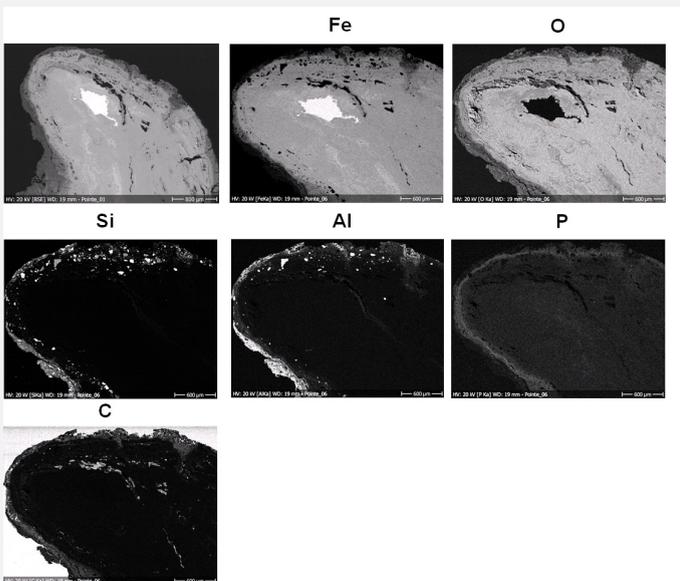
Si, Al, P and K can be considered external markers, helping to determine the limit of the original surface (Fig. 11 and Table 1). The outer layer of corrosion products (CP1-3) ranges from dark grey to orange in bright field and contains less O and Fe on its borders than the inner layer (CP4-5, Figs. 4 and 11, Table 1). The SEM pictures show a marbling appearance of the inner corrosion layer (CP5). Cl and S do not seem to be present in the sampled nail.

Fig. 11: Elemental chemical distribution of the selected area from Fig. 4 (90° counter-clockwise rotated). SEM-EDS,

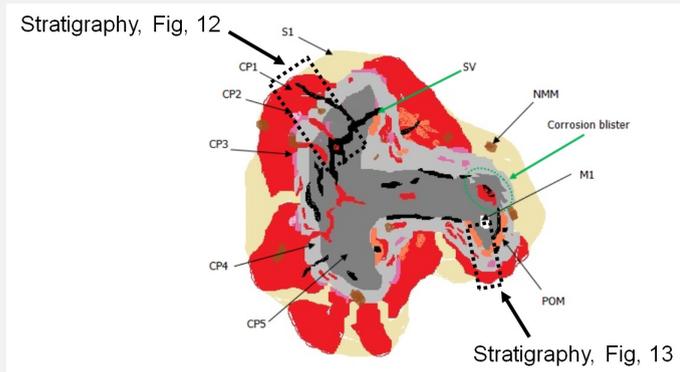
The schematic representation of corrosion layers of Fig. 3 integrating additional information based on the analyses carried out is given in Fig. 14. The following strata were identified:

Fig. 14: Improved stratigraphic representation of the nail from visual observations and analyses and visualization of the two stratigraphies of Figs, 12 and 13,
