SHOE NAIL 2637 1370.B. - HYPOEUTECTOID STEEL - ROMAN TIMES - SWITZERLAND

Artefact name Shoe nail 2637 1370.B.

Authors Christian. Degrigny (HE-Arc CR, Neuchâtel, Neuchâtel, Switzerland) & Valentin. Boissonnas (HE-Arc CR, Neuchâtel, Neuchâtel, Switzerland) & Vincent Chappuis. (HE-Arc CR, Neuchâtel, Neuchâtel, Switzerland)

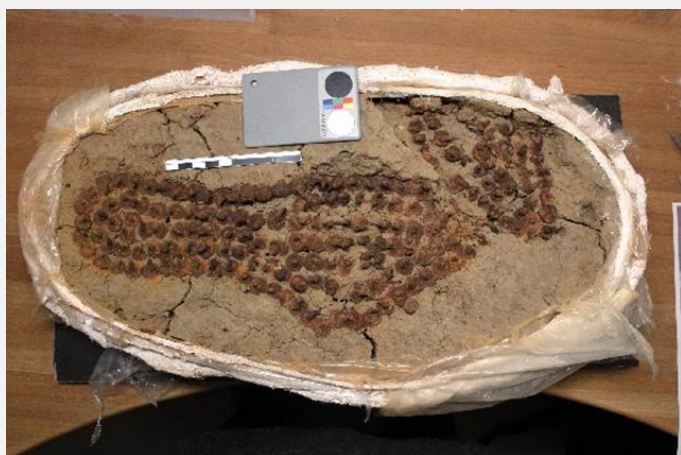
Fig. 1: A Roman shoe nail from a block taken from an excavation site before conservation,

Description of the artefact A Roman shoe nail from a block taken from an excavation site (Fig. 1) covered with a thick corrosion crust. The forged nails were hammered into the leather soles on a bucking tool. Average dimensions of the shoe nails: L = about 14mm; diamter = 11mm; W = up to 0.8g.

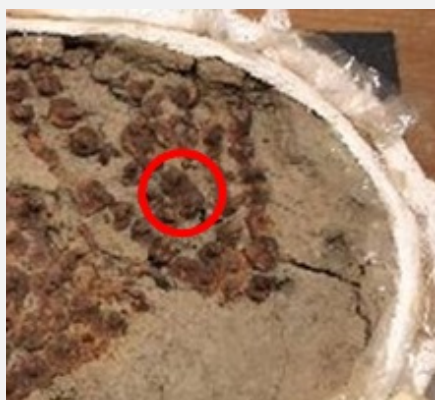
Fig. 2: Incomplete shoe from which the nail was sampled (in red circle),

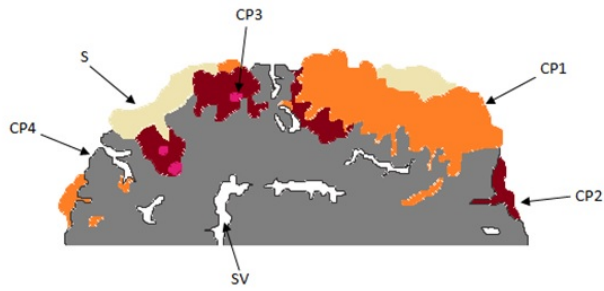
Fig. 3: Preliminary stratigraphy of the corrosion layers based on the observation of a broken nail,

S = compact sand-clay soil.
 CP1 = powdery soil, orange-coloured by corrosion products.
 CP2 = dark-red corrosion crust, breaks into bits.
 CP3 = vivid pink-red and globular corrosion products.
 CP4 = dark grey to black and very hard corrosion products, results in a dark-orange powder when scratched.
 SV = structural void near the center of the cross section, seems to draw a square shape.

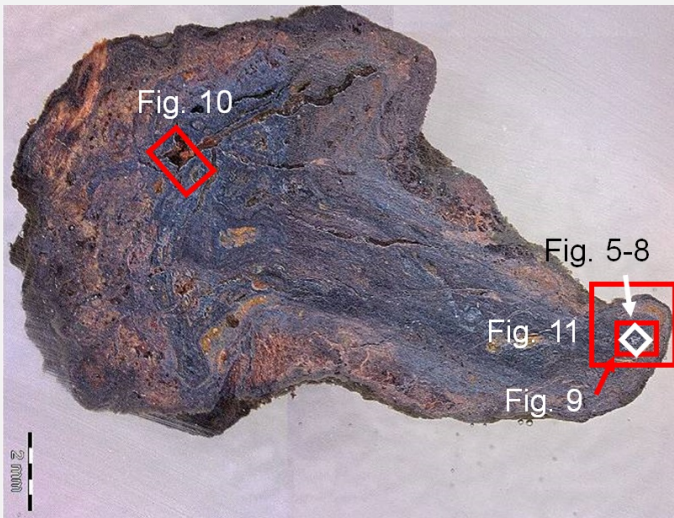
Fig. 4: Micrograph of the cross-section of the nail showing the location of figs. 5 to 11,

Description of sample	A longitudinal cut through the nail (Fig. 4). Dimensions: L = 16.4mm; W = about 12.0mm.
Alloy	Hypoeutectoid steel
Technology	Forged
Lab number of sample	HE-Arc CR 1457-S1.
Sample location	HE-Arc CR, Neuchâtel, Neuchâtel
Responsible institution	HE-Arc CR, Neuchâtel, Neuchâtel

The metal is heavily corroded and the thickness of the corrosion crust is irregular, varying from 0.8 to 3.8mm, with an average of about 2mm. The corrosion has replaced most of the metal (Fig. 4). Between corrosion layers the limit of the original structure is visible. Some leather fibers seem to be preserved as pseudomorphic structures in voids of the metal core (POM1, Figs. 9 and 10). The carbon mapping (Fig.11) shows the presence of carbon in these areas. This can also be due to the penetration of the mounting resin in the cracks.

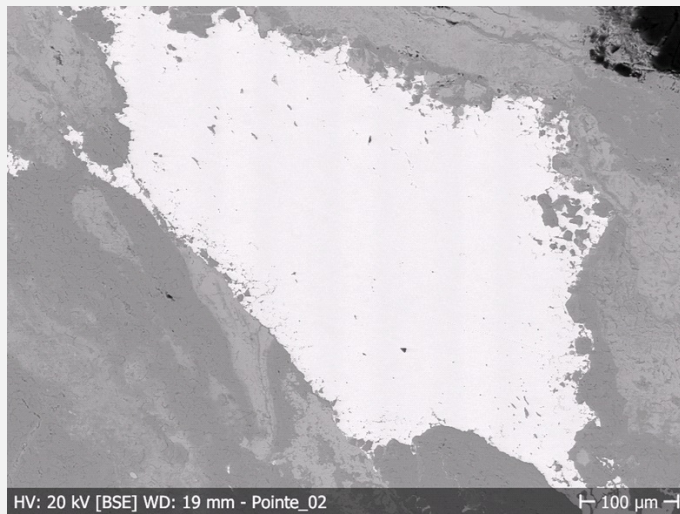
The remaining metal is an hypoeutectoid steel (Fig. 5 and 6), containing Fe, Si and O slags inclusions (possibly fayalite FeO, SiO_2), and consisting of less than 1% of the total volume of the highly mineralized nail. After Nital etching, it shows intergranular corrosion on one of its sides (Figs. 7 and 8).

Fig. 5: SEM, BSE-mode picture of remaining metal from cross-section of Fig. 4,

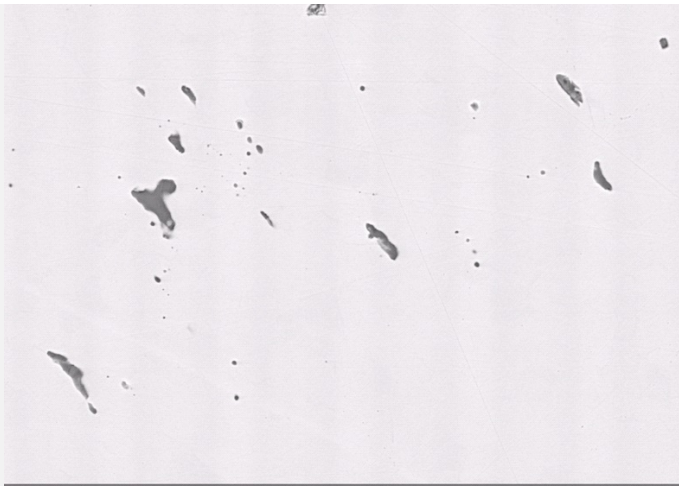
Fig. 6: SEM, BSE-mode picture of inclusions in remaining metal (detail of Fig. 5),

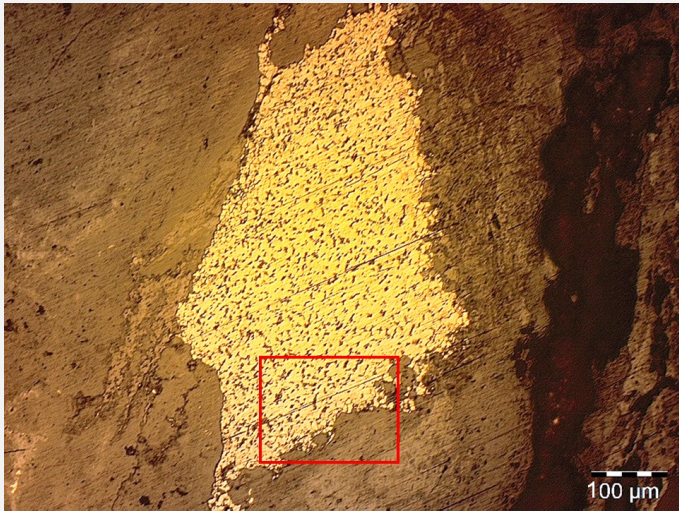
Fig. 7: Micrograph of the metal sample from Fig. 5 (detail, rotated 90°), Nital etched, bright field, with indication of Fig. 8 (red rectangle)

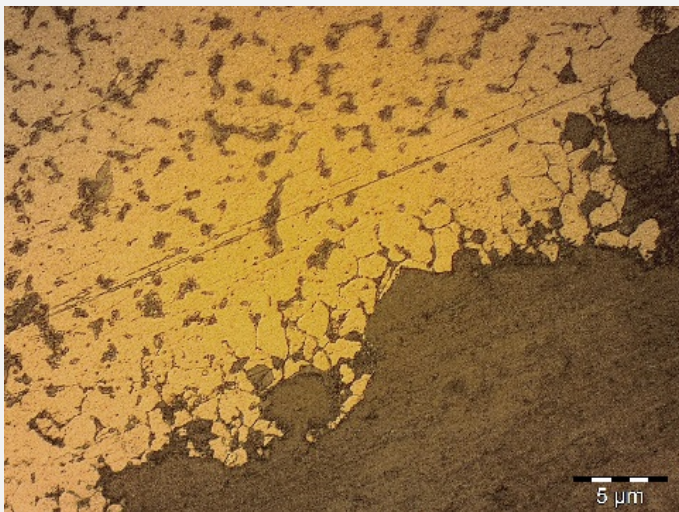
Fig. 8: Micrograph of the selected area of Fig. 7, Nital etched with no clear grain structure, bright field, Intergranular corrosion and grey phase (perlite?) are observed,

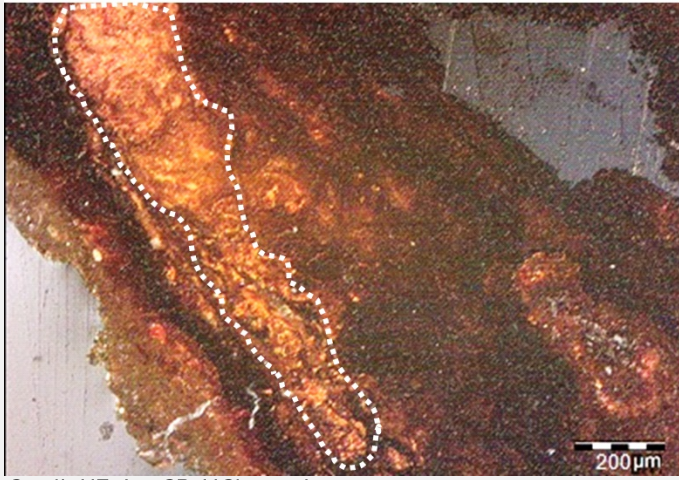
Fig. 9: Micrograph of the metal sample from Fig. 4, bright field. The delimited zone shows what could be leather pseudomorphic fibers filling a void,

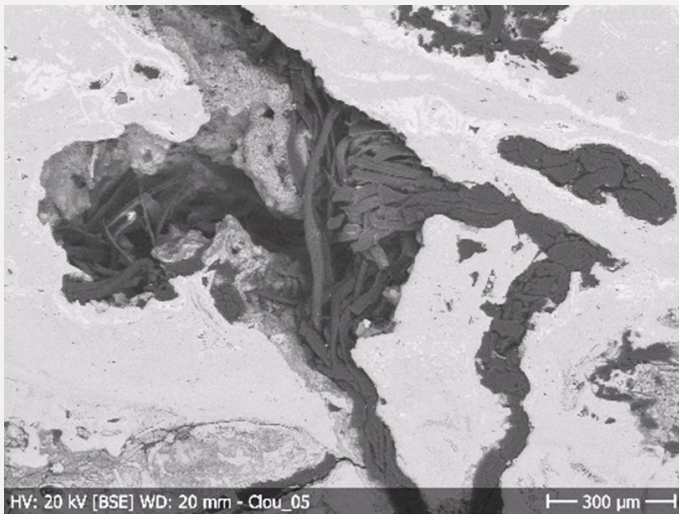
Fig. 10: SEM - BSE-mode picture of another void filled with fibers in the head of the nail (see Fig. 4),

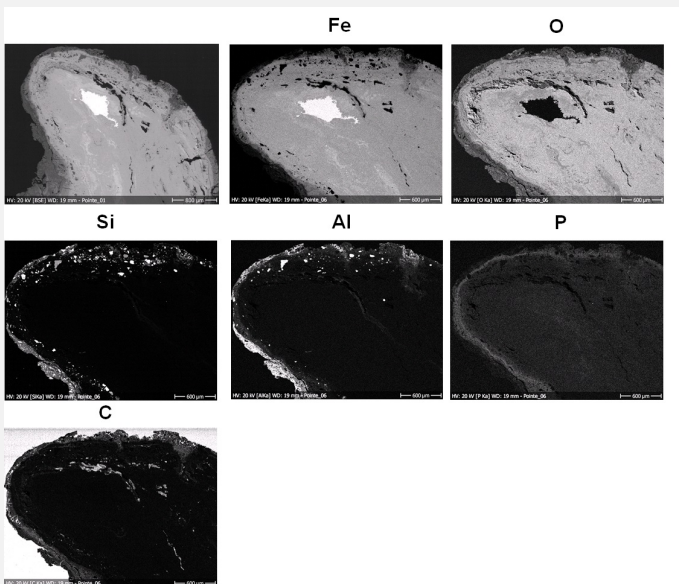
Si, Al, P and K can be considered external markers, helping to determine the limit of the original surface (Fig. 11 and Table 1). The outer layer of corrosion products (CP1-3) ranges from dark grey to orange in bright field and contains less O and Fe on its borders than the inner layer (CP4-5, Figs. 4 and 11, Table 1). The SEM pictures show a marbling appearance of the inner corrosion layer (CP5). Cl and S do not seem to be present in the sampled nail.

Fig. 11: Elemental chemical distribution of the selected area from Fig. 4 (90° counter-clockwise rotated). SEM-EDS,

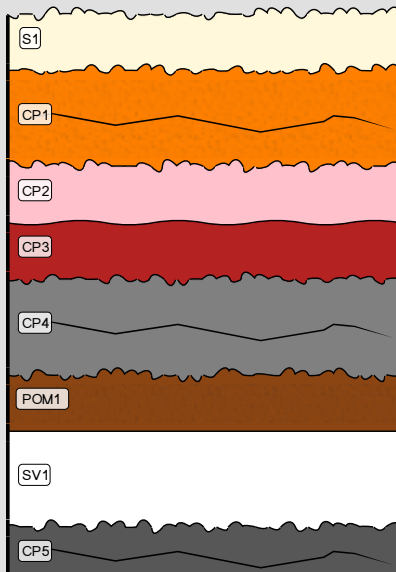
Fig. 12: Stratigraphic representation of the nail in cross-section (dark field) using the MiCorr application. The characteristics of the strata are only accessible by clicking on the drawing that redirects you to the search tool by stratigraphy representation. This representation can be compared to Fig. 14, Credit HE-Arc CR, V.Chappuis.

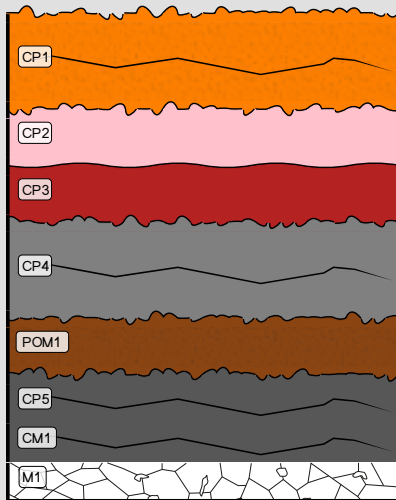
Fig. 13: Stratigraphic representation of the nail in cross-section (dark field) using the MiCorr application. The characteristics of the strata are only accessible by clicking on the drawing that redirects you to the search tool by stratigraphy representation. This representation can be compared to Fig. 14, Credit HE-Arc CR, V.Chappuis.

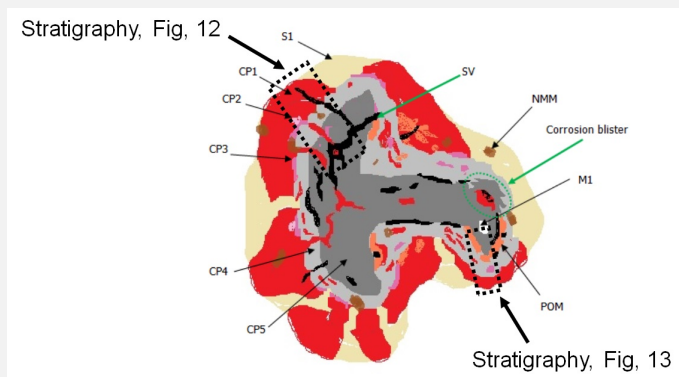
The schematic representation of corrosion layers of Fig. 3 integrating additional information based on the analyses carried out is given in Fig. 14. The following strata were identified:

Fig. 14: Improved stratigraphic representation of the nail from visual observations and analyses and visualization of the two stratigraphies of Figs, 12 and 13,
