# SHOE NAIL 2637 1370.B. - HYPOEUTECTOID STEEL - ROMAN TIMES - SWITZERLAND

**Artefact name** Shoe nail 2637 1370.B.

**Authors** Christian. Degriigny (HE-Arc CR, Neuchâtel, Neuchâtel, Switzerland) & Valentin. Boissonnas (HE-Arc CR, Neuchâtel, Neuchâtel, Switzerland) & Vincent Chappuis. (HE-Arc CR, Neuchâtel, Neuchâtel, Switzerland)

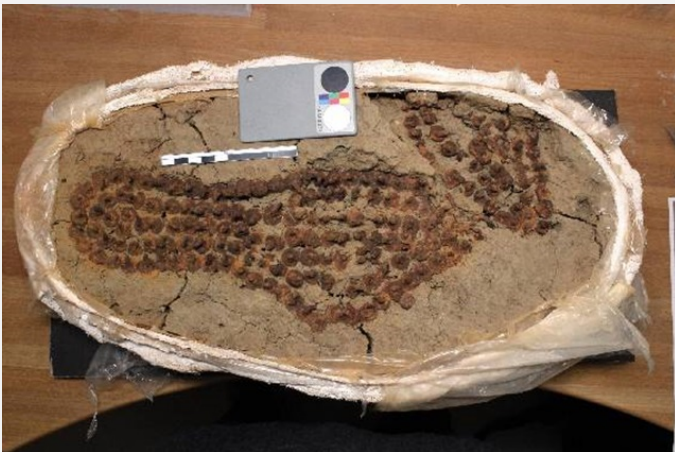
Fig. 1: A Roman shoe nail from a block taken from an excavation site before conservation,

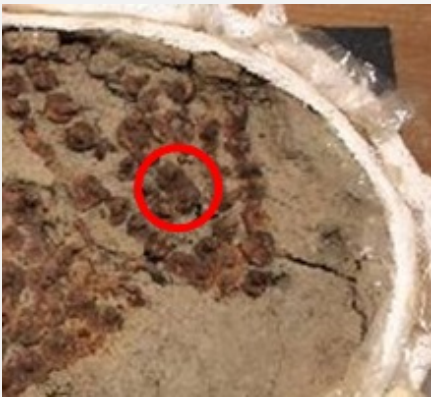
Fig. 2: Incomplete shoe from which the nail was sampled (in red circle),

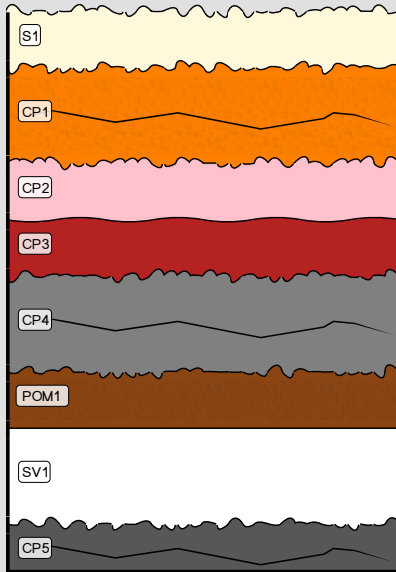
Fig. 12: Stratigraphic representation of the nail in cross-section (dark field) using the MiCorr application. The characteristics of the strata are only accessible by clicking on the drawing that redirects you to the search tool by stratigraphy representation. This representation can be compared to Fig. 14, Credit HE-Arc CR, V.Chappuis.

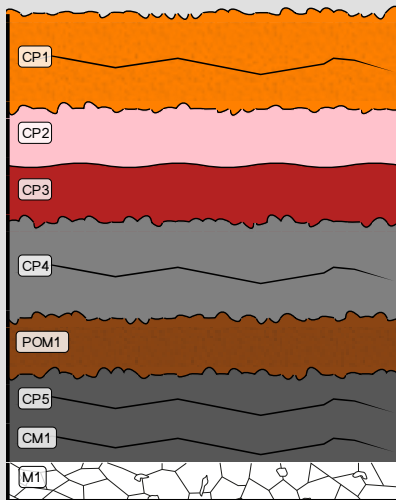
Fig. 13: Stratigraphic representation of the nail in cross-section (dark field) using the MiCorr application. The characteristics of the strata are only accessible by clicking on the drawing that redirects you to the search tool by stratigraphy representation. This representation can be compared to Fig. 14, Credit HE-Arc CR, V.Chappuis.

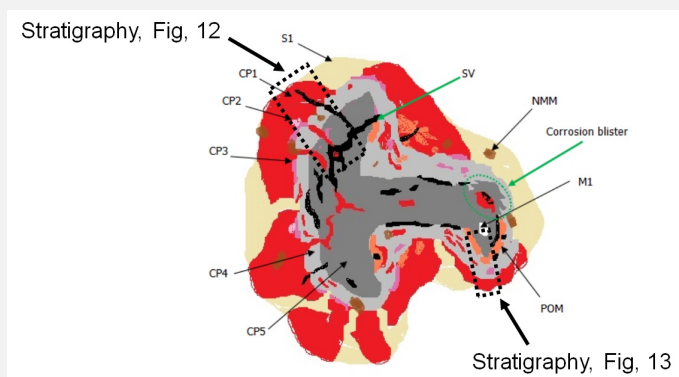
The schematic representation of corrosion layers of Fig. 3 integrating additional information based on the analyses carried out is given in Fig. 14. The following strata were identified:

S1 = sand-clay soil, compact, cemented when dry, powdery when abraded, very thin particle size (usually about and less than 0.1mm). Undefined thickness (soil).

CP1 = powdery orange (loosely coherent) and matte corrosion crust, sometimes forming humps. Partially mixed with S1 and POM layers (diffused interfaces). 1 to 5 millimeters thick.

CP2 = vivid red or pink dots, more brittle than powdery (loose cohesion) and mostly matte, only two or three observed, always above CP3 interfaces. Usually 1 mm spheric diameter.

CP3 = dark reddish corrosion product, forming smooth, matte and brittle layers that are parallel to CP4, with a clean and regular interface. The corrosion products are generally hard, but sometimes break up into grains, resulting in a more irregular interface. The layer is approximately 0.5mm thick.

CP4 = dark grey to black corrosion product, smooth with pseudo-metallic reflection (a bit glossy), very hard, when scratched results in orange powder, with somewhat irregular shape and thickness (ranging from 0.3 to 2mm).

CP5 = dark grey to black corrosion product, generally a bit darker than CP4. Smooth with pseudo-metallic reflection, even harder than CP4 and when scratched it turns into an orange coloured powder. Irregular interface regarding CP4. Clear transition and somewhat parallel from CP4 to CP5. As regards its thickness, it fills the remaining volume.

NMM = silica and calcareous inclusions.

POM = mostly powdery and grain-like material, ranging from orange to dark brown in colour, somewhat glossy and similar to crystals when illuminated. A few fiber-like zones are present, which are more satin than glossy. They are dark brown to charcoal black, very brittle and break into a powdery and grain-like material. POM is located above or close to CP3 and CP4 layers, sometimes mixed into S1 or CP1 layers with a diffused interface. Overall, the stratum is approximately 0.2-0.3mm thick.

SV = structural void, present as fissures that either pass through the different layers, or are present at corrosion interfaces, especially at the CP4/CP5 interface. The void is 0.1 to 0.3mm thick and partially filled with POM in the outer layers.

M1 = glossy with metallic reflection.

Fig. 14: Improved stratigraphic representation of the nail from visual observations and analyses and visualization of the two stratigraphies of Figs, 12 and 13,
