TANG FRAGMENT OF A KNIFE HR-6246 – TIN BRONZE – LATE BRONZE AGE – SWITZERLAND

Authors Marianne. Senn (Empa, Dübendorf, Zurich, Switzerland) & Christian. Degriigny (HE-Arc CR, Neuchâtel, Neuchâtel, Switzerland)

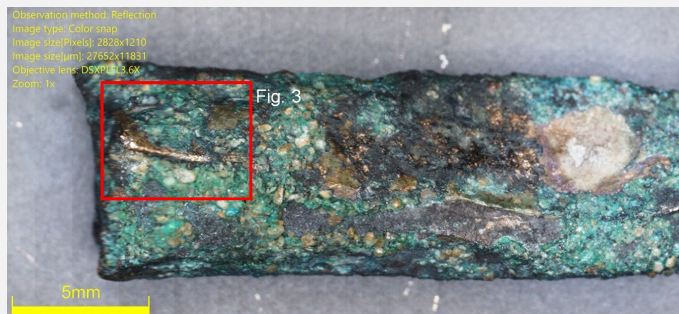
Fig. 1: Tang fragment of a knife (after Rychner-Faraggi 1983, plate 35.35),

Fig. 2: Lake (shiny brown) and terrestrial (granulated green-blue) crust covering the tang with lacuna on the right showing the underlying metal and detail of Fig. 3,

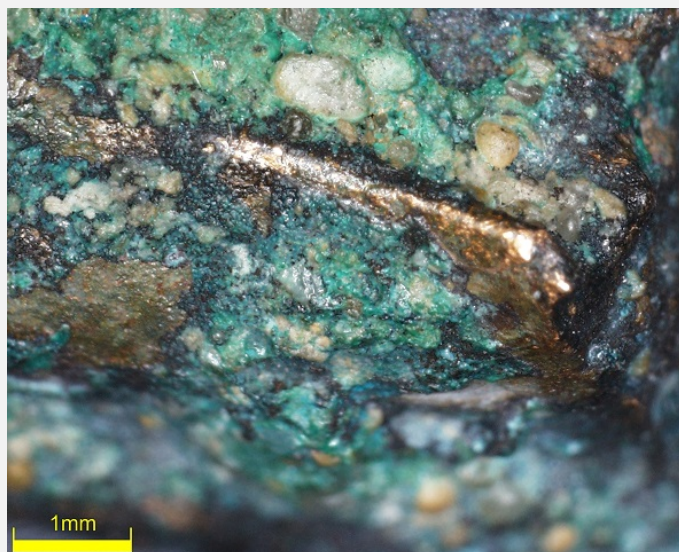
Fig. 3: Detail of Fig. 2 (rotated by 180°),

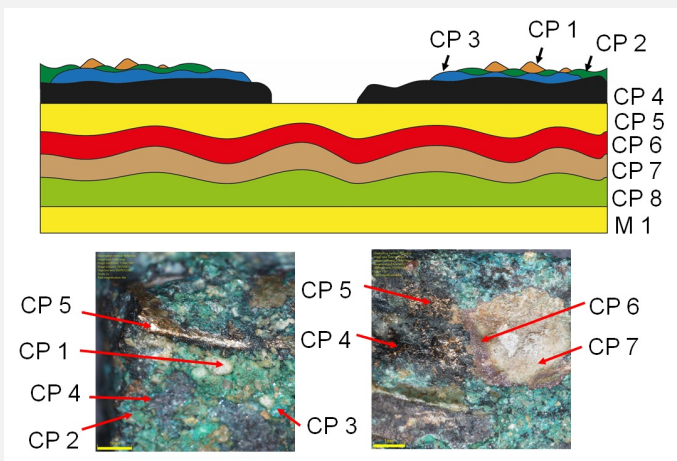
The schematic representation below gives an overview of the corrosion layers encountered on the tang from a first visual macroscopic observation.

Fig. 6: Stratigraphic representation of the tang fragment and location of the strata,

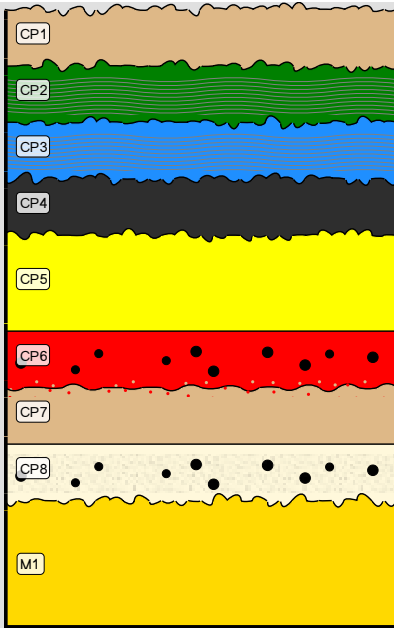
Fig. 7: Stratigraphic representation of the corrosion structure of the tang fragment observed macroscopically under binocular microscope using the MiCorr application. The characteristics of the strata are only accessible by clicking on the drawing that redirects you to the search tool by stratigraphy representation, Credit HE-Arc CR.

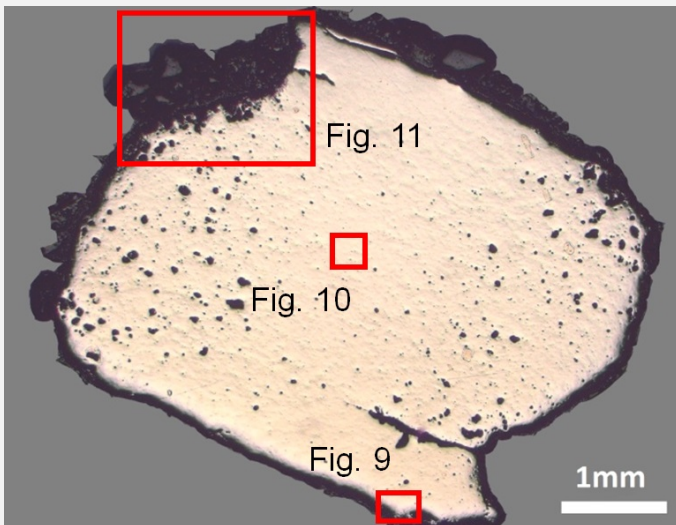
Fig. 8: Micrograph of the cross-section of the sample taken from the tang fragment showing the location of Figs. 9 to 11,

Description of sample	The cross-section corresponds to a lateral cut (Fig. 4). The surface is covered with a thick corrosion crust but part of it has gone (Fig. 8).
Alloy	Tin Bronze
Technology	Cold worked after annealing
Lab number of sample	MAH 87-197
Sample location	Musées d'art et d'histoire, Genève, Geneva
Responsible institution	Musées d'art et d'histoire, Genève, Geneva
Date and aim of sampling	1987, metallography and corrosion characterisation

The remaining metal is a tin bronze (Table 1) with high porosity (Fig. 8) and large cracks both on the left and right edges of the sample (Fig. 8). The metal contains small, elongated copper sulphide (Table 2) and Pb inclusions that are oriented parallel to the cracks. Near the metal surface, slip lines are outlined by the development of intergranular corrosion (Fig. 9). The etched metal shows small, elongated grains. Slip lines are also visible (Fig. 10). Annealing is visible in areas near the surface. The average hardness of the metal is HV1 145, but significant variations are observed, depending on where the measurements are taken.

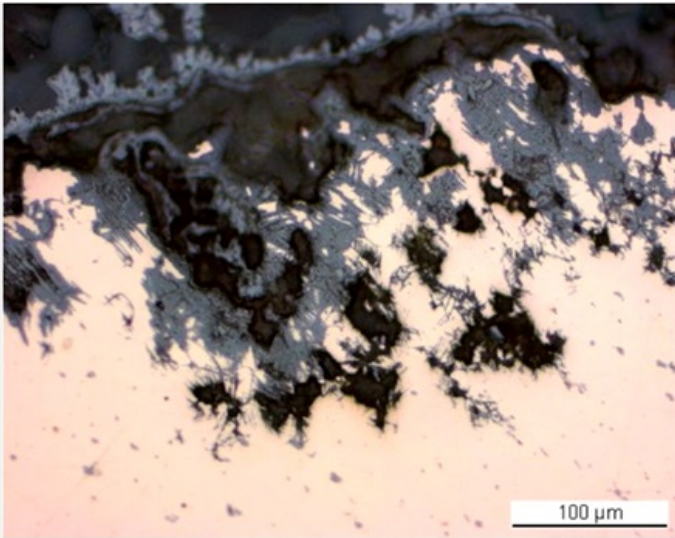
Fig. 9: Micrograph of the metal sample from Fig. 8 (inverted and reversed picture, detail), unetched, bright field. Corrosion products are in dark-grey whereas the metal is in pink. Slip lines are outlined by the development of intergranular corrosion,

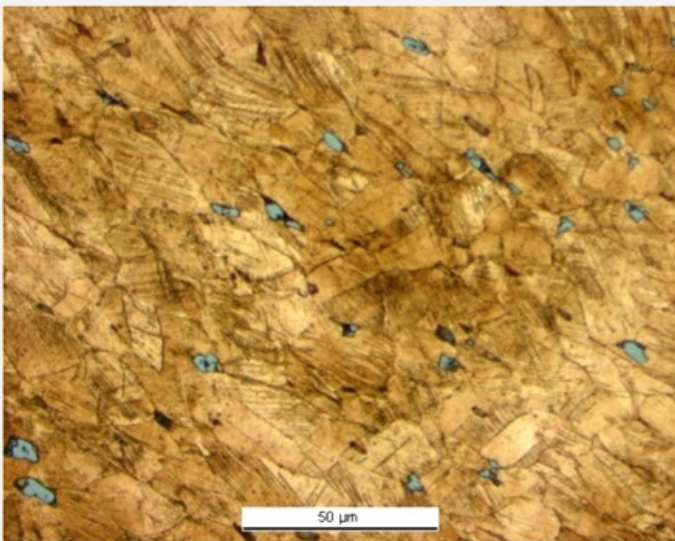
Fig. 10: Micrograph of the metal sample from Fig. 8 (detail), etched, bright field. We observe elongated grains with slip lines as well as grey copper sulphide inclusions,

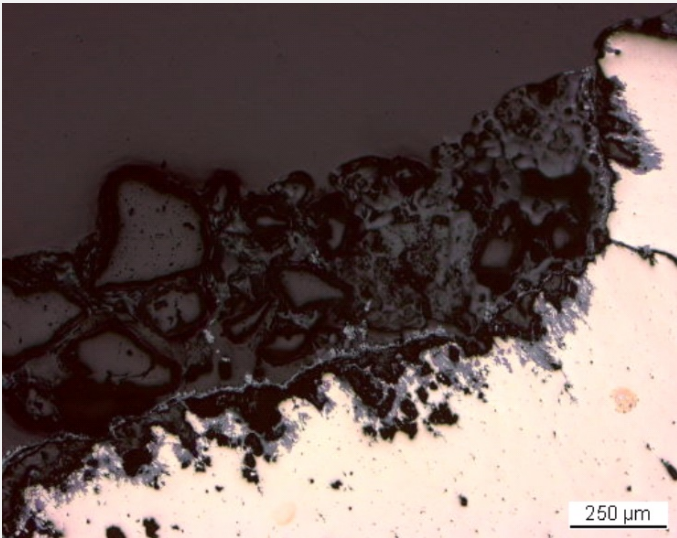
The corrosion crust has a thickness between 0.1mm and 0.7mm (Fig. 8). In bright field (Fig. 11), one can observe that the metal has been replaced by light-grey corrosion products. Adjacent to the metal is a thick, heterogeneous, dark-grey layer with a band of light-grey corrosion products. In polarised light (Fig. 12), all corrosion products which were previously light-grey appear brown-green-yellow, the dark-grey layer being turquoise. The elemental chemical distribution of the SEM images (Figs. 13 and 14) reveals that the inner corrosion products are Sn-rich whereas the adjacent band is Cu and S-rich (Fig. 15). The outer layer contains large inclusions (quartz and others, Si, Al and Na,

Fig. 11: Micrograph of the metal sample from Fig. 8 (detail), unetched, bright field. The inner light-grey corrosion products extend into the metal surface (in pink) and appear as a line within the dark-grey corrosion layer,

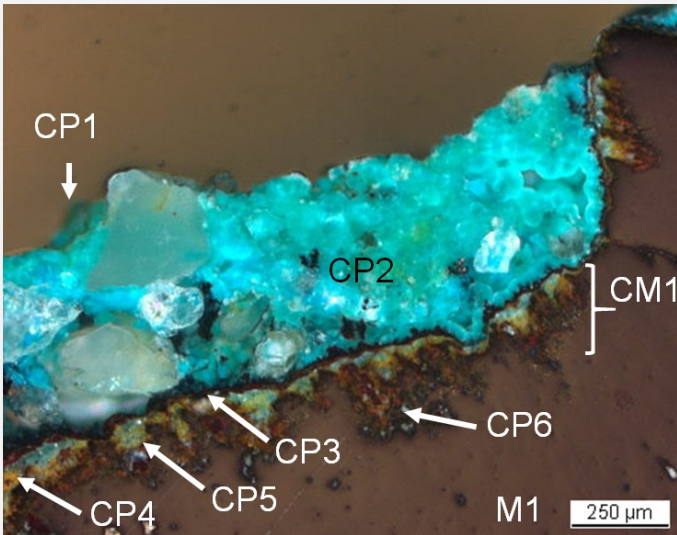
Fig. 12: Micrograph similar to Fig. 11 and corresponding to the stratigraphy of Fig. 16, polarized light. One can see that large mineral features are incorporated only in the corrosion layers above the brown-orange corrosion band,

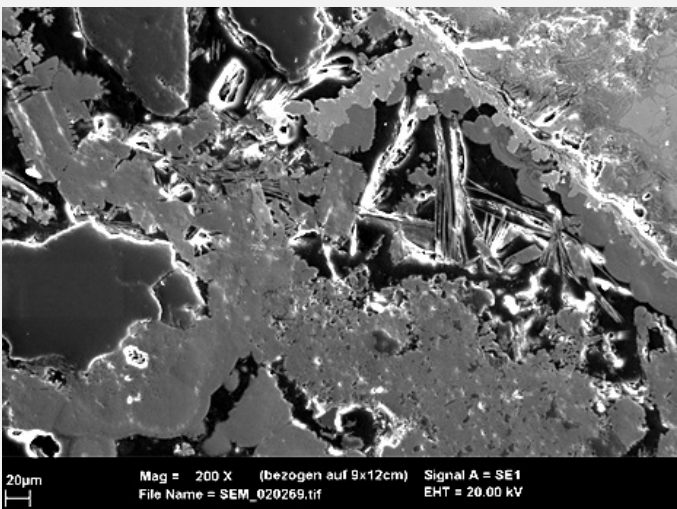
Fig. 13: SEM image (detail of Fig. 11), SE-mode. From bottom to top right: the thick, porous outer corrosion layer, the light-grey band and the remaining metal,

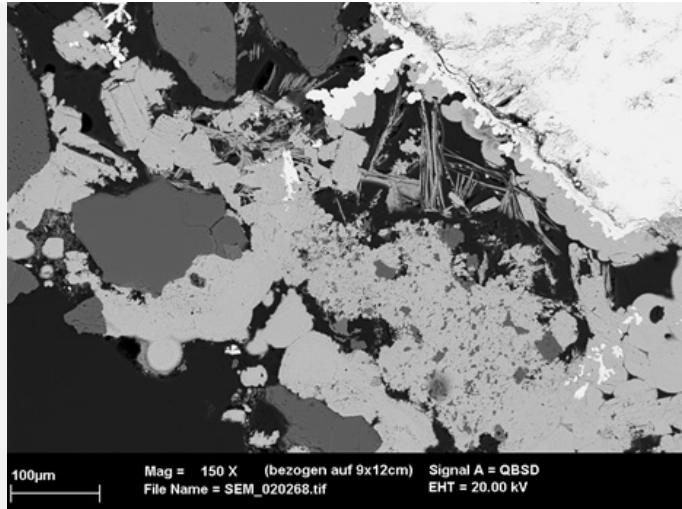
Fig. 14: SEM image, similar to Fig. 13, BSE-mode,

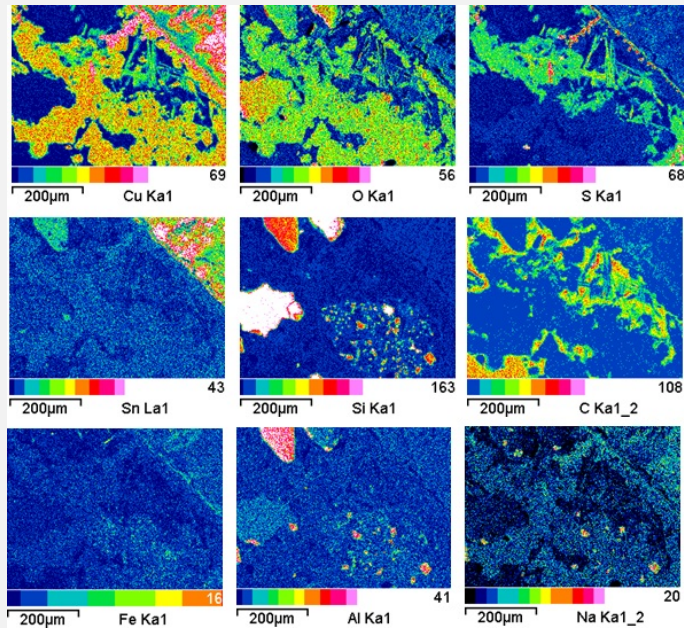
see Figs. 14-15) and is most probably composed of malachite/ $\text{Cu}_2(\text{CO}_3)(\text{OH})_2$ (only Cu and O are detected – Fig. 15). S is distributed throughout this layer. XRD analyses indicated the presence of posnjakite/ $\text{Cu}_4\text{SO}_4(\text{OH})_6\text{H}_2\text{O}$, chalcocite/ Cu_2S and djurleite/ $\text{Cu}_{1.93}\text{S}$ (Schweizer 1994).

Fig. 15: EDS elemental chemical distribution of the SEM image of Fig. 13. Method of examination: SEM/EDS, Laboratory of Analytical Chemistry, Empa,

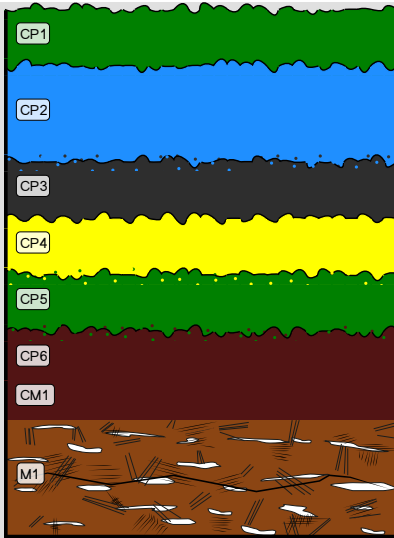
Fig. 16: Stratigraphic representation of the sample taken from the tang fragment in cross-section (dark field) using the MiCorr application. The characteristics of the strata are only accessible by clicking on the drawing that redirects you to the search tool by stratigraphy representation. This representation can be compared to Fig. 12, Credit HE-Arc CR.

Corrosion products CP2 to CP5 observed under binocular corresponds to CP1 to CP4 under cross-section. The other CPs are more difficult to compare, certainly due to the disruption of the corrosion structure during the cutting process.
