TANG FRAGMENT OF A KNIFE HR-6246 – TIN BRONZE – LATE BRONZE AGE – SWITZERLAND

Artefact name Tang fragment of a knife HR-6246

Authors Marianne. Senn (Empa, Dübendorf, Zurich, Switzerland) & Christian. Degriigny (HE-Arc CR, Neuchâtel, Neuchâtel, Switzerland)

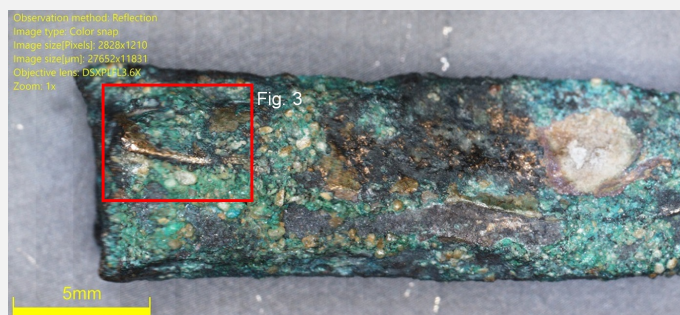
Fig. 1: Tang fragment of a knife (after Rychner-Faraggi 1983, plate 35.35),

Fig. 2: Lake (shiny brown) and terrestrial (granulated green-blue) crust covering the tang with lacuna on the right showing the underlying metal and detail of Fig. 3,

Description of the artefact	Tang fragment of a knife with lake (shiny brown) and terrestrial (granulated green-blue) crust (Fig. 1). Dimensions: L = 2.7cm; Ø = around 5mm; WT = 5.8g.
Type of artefact	Knife
Origin	Hauterive - Champréveyres, Neuchâtel, Neuchâtel, Switzerland
Recovering date	Excavation 1983-1985, object from layer 1 (layer with material from Bronze Age till 20th cent.)
Chronology category	Late Bronze Age
chronology tpq	1050 B.C. ▾
chronology taq	800 B.C. ▾
Chronology comment	Hallstatt A/B
Burial conditions / environment	Lake
Artefact location	Laténium, Neuchâtel, Neuchâtel
Owner	Laténium, Neuchâtel, Neuchâtel
Inv. number	Hr 6246
Recorded conservation data	N/A

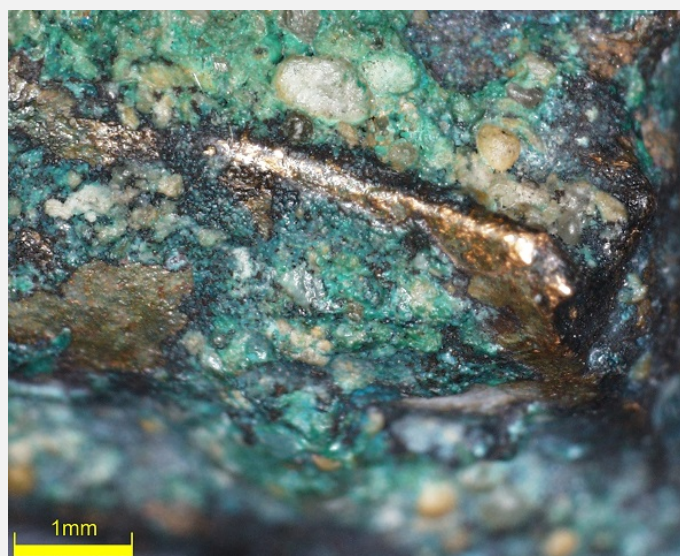
Fig. 3: Detail of Fig. 2 (rotated by 180°),

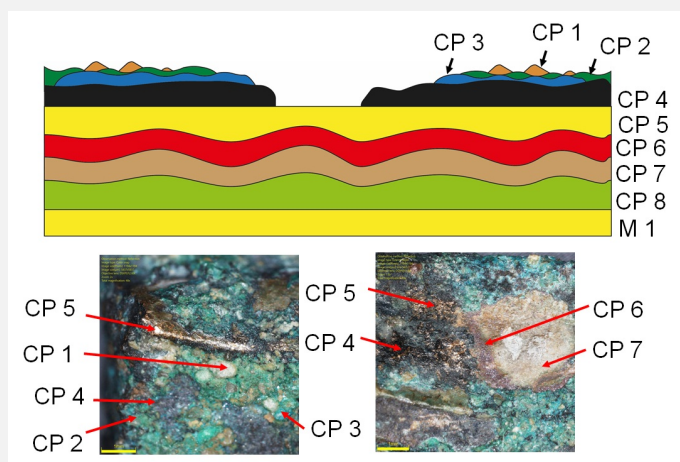
Fig. 6: Stratigraphic representation of the tang fragment and location of the strata,

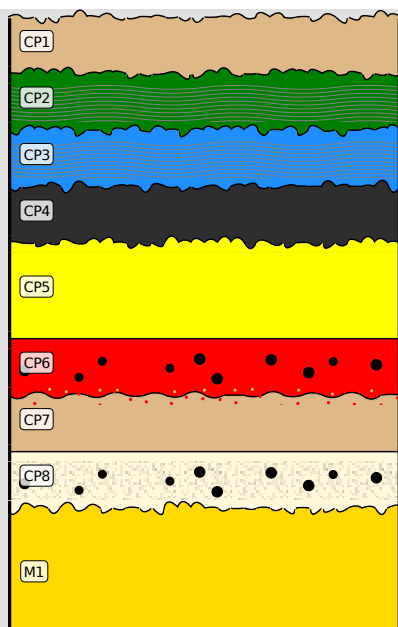
Fig. 7: Stratigraphic representation of the corrosion structure of the tang fragment observed macroscopically under binocular microscope using the MiCorr application. The characteristics of the strata are only accessible by clicking on the drawing that redirects you to the search tool by stratigraphy representation, Credit HE-Arc CR.

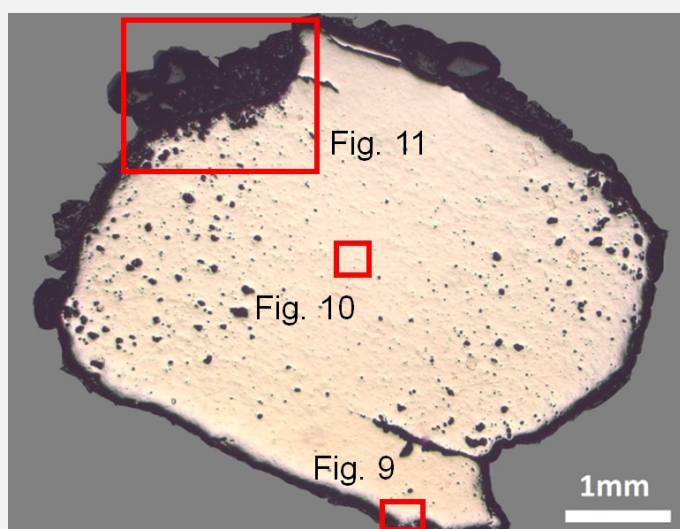
Fig. 8: Micrograph of the cross-section of the sample taken from the tang fragment showing the location of Figs. 9 to 11,

The cross-section corresponds to a lateral cut (Fig. 4). The surface is covered with a thick corrosion crust but part of it has gone (Fig. 8).

The remaining metal is a tin bronze (Table 1) with high porosity (Fig. 8) and large cracks both on the left and right edges of the sample (Fig. 8). The metal contains small, elongated copper sulphide (Table 2) and Pb inclusions that are oriented parallel to the cracks. Near the metal surface, slip lines are outlined by the development of intergranular corrosion (Fig. 9). The etched metal shows small, elongated grains. Slip lines are also visible (Fig. 10). Annealing is visible in areas near the surface. The average hardness of the metal is HV1 145, but significant variations are observed, depending on where the measurements are taken.

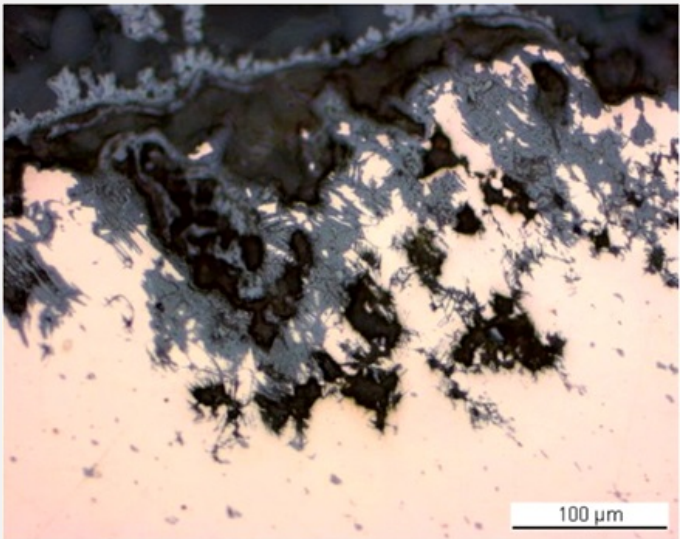
Fig. 9: Micrograph of the metal sample from Fig. 8 (inverted and reversed picture, detail), unetched, bright field. Corrosion products are in dark-grey whereas the metal is in pink. Slip lines are outlined by the development of intergranular corrosion,

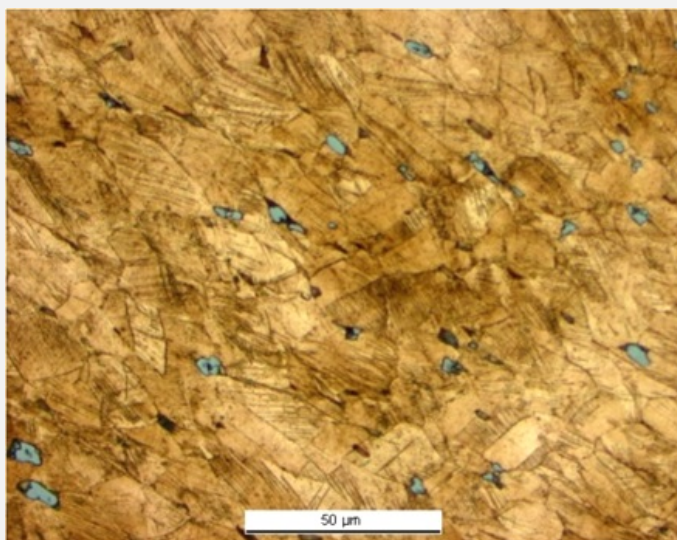
Fig. 10: Micrograph of the metal sample from Fig. 8 (detail), etched, bright field. We observe elongated grains with slip lines as well as grey copper sulphide inclusions,

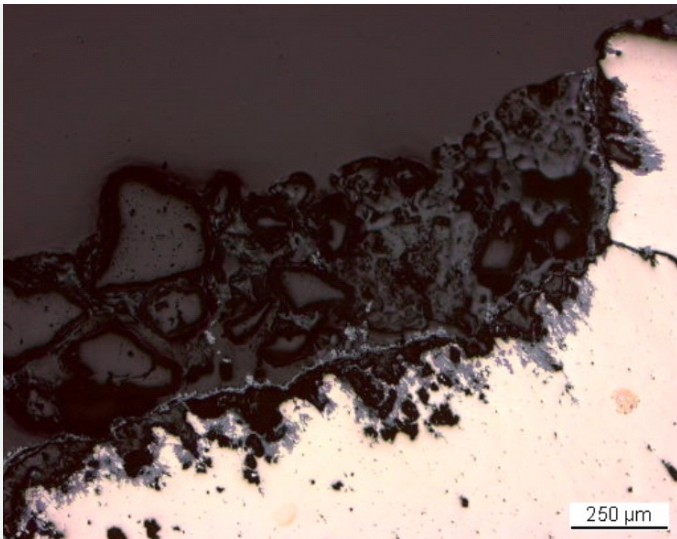
The corrosion crust has a thickness between 0.1mm and 0.7mm (Fig. 8). In bright field (Fig. 11), one can observe that the metal has been replaced by light-grey corrosion products. Adjacent to the metal is a thick, heterogeneous, dark-grey layer with a band of light-grey corrosion products. In polarised light (Fig. 12), all corrosion products which were previously light-grey appear brown-green-yellow, the dark-grey layer being turquoise. The elemental chemical distribution of the SEM images (Figs. 13 and 14) reveals that the inner corrosion products are Sn-rich whereas the adjacent band is Cu and S-rich (Fig. 15). The outer layer contains large inclusions (quartz and others, Si, Al and Na, see Figs. 14-15) and is most probably composed of malachite/ $\text{Cu}_2(\text{CO}_3)(\text{OH})_2$ (only Cu and O are detected – Fig. 15). S is distributed throughout this layer. XRD analyses indicated the presence of posnjakite/ $\text{Cu}_4\text{SO}_4(\text{OH})_6\text{H}_2\text{O}$, chalcocite/ Cu_2S and djurleite/ $\text{Cu}_{1.93}\text{S}$ (Schweizer 1994).

Fig. 11: Micrograph of the metal sample from Fig. 8 (detail), unetched, bright field. The inner light-grey corrosion products extend into the metal surface (in pink) and appear as a line within the dark-grey corrosion layer,

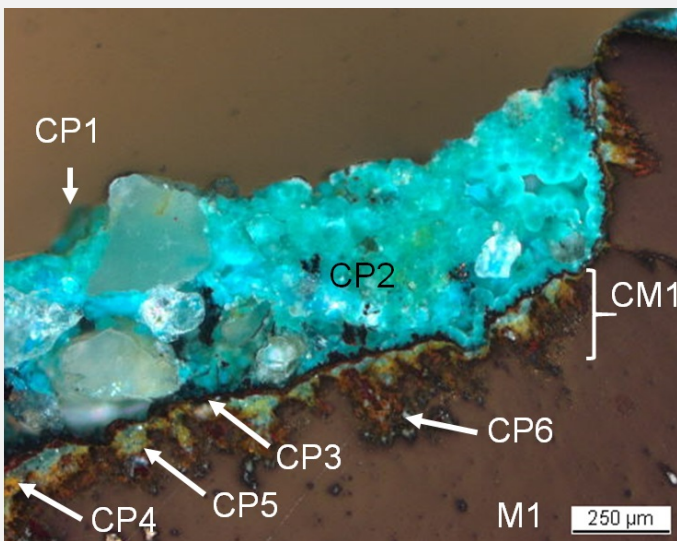
Fig. 12: Micrograph similar to Fig. 11 and corresponding to the stratigraphy of Fig. 16, polarized light. One can see that large mineral features are incorporated only in the corrosion layers above the brown-orange corrosion band,

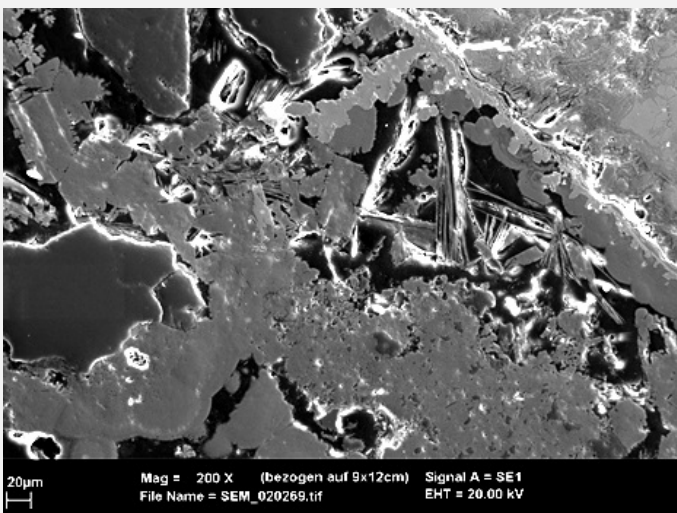
Fig. 13: SEM image (detail of Fig. 11), SE-mode. From bottom to top right: the thick, porous outer corrosion layer, the light-grey band and the remaining metal,

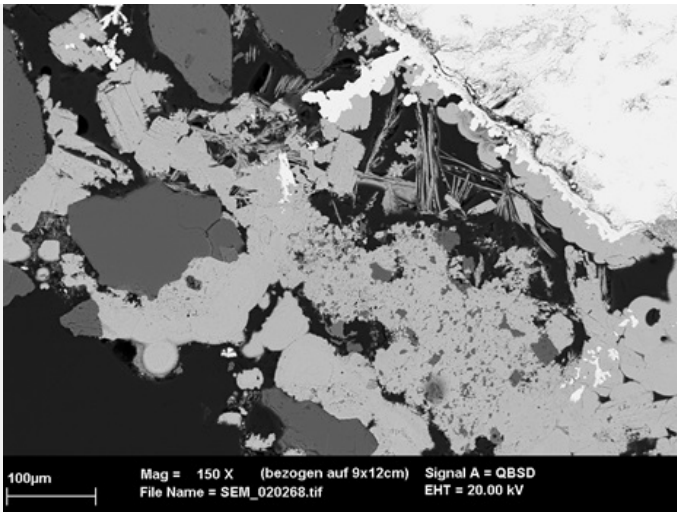
Fig. 14: SEM image, similar to Fig. 13, BSE-mode,

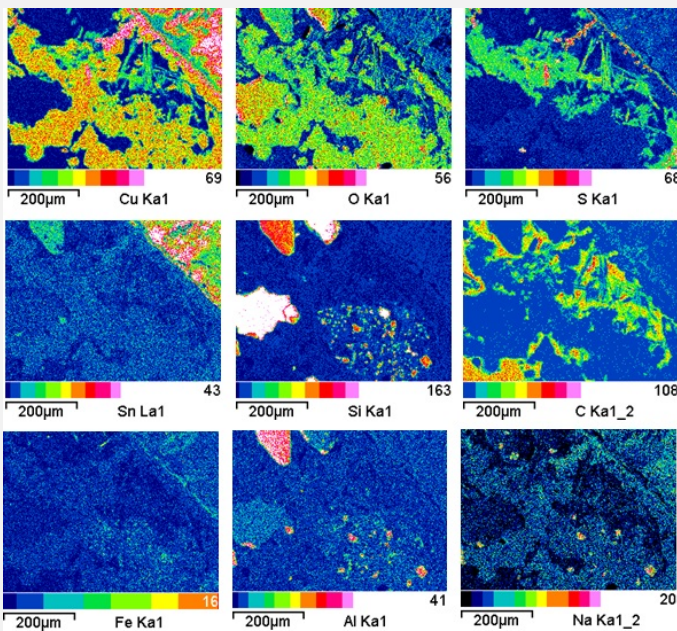
Fig. 15: EDS elemental chemical distribution of the SEM image of Fig. 13. Method of examination: SEM/EDS, Laboratory of Analytical Chemistry, Empa,

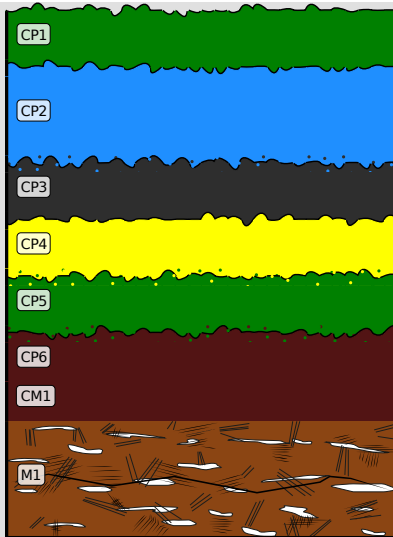
Fig. 16: Stratigraphic representation of the sample taken from the tang fragment in cross-section (dark field) using the MiCorr application. The characteristics of the strata are only accessible by clicking on the drawing that redirects you to the search tool by stratigraphy representation. This representation can be compared to Fig. 12, Credit HE-Arc CR.
