TANG FRAGMENT OF A KNIFE HR-6246 – TIN BRONZE – LATE BRONZE AGE – SWITZERLAND

Artefact name Tang fragment of a knife HR-6246

Authors Marianne. Senn (Empa, Dübendorf, Zurich, Switzerland) & Christian. Degriigny (HE-Arc CR, Neuchâtel, Neuchâtel, Switzerland)

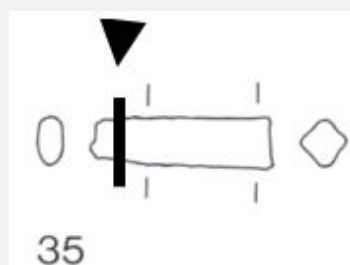
Fig. 4: Location of sampling area,

Fig. 5: Cross-section of the tang and remaining material,

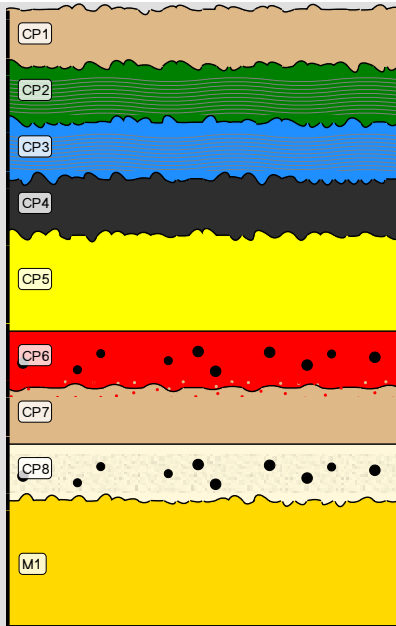
Fig. 7: Stratigraphic representation of the corrosion structure of the tang fragment observed macroscopically under binocular microscope using the MiCorr application. The characteristics of the strata are only accessible by clicking on the drawing that redirects you to the search tool by stratigraphy representation, Credit HE-Arc CR.

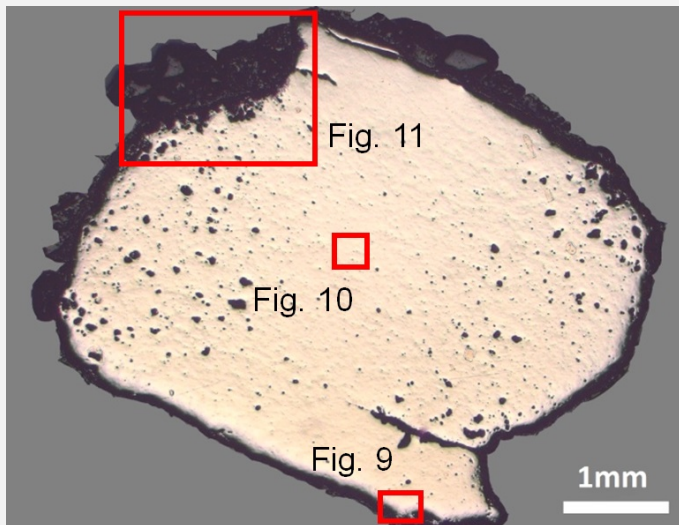
Fig. 8: Micrograph of the cross-section of the sample taken from the tang fragment showing the location of Figs. 9 to 11,

Description of sample	The cross-section corresponds to a lateral cut (Fig. 4). The surface is covered with a thick corrosion crust but part of it has gone (Fig. 8).
Alloy	Tin Bronze
Technology	Cold worked after annealing
Lab number of sample	MAH 87-197
Sample location	Musées d'art et d'histoire, Genève, Geneva
Responsible institution	Musées d'art et d'histoire, Genève, Geneva
Date and aim of sampling	1987, metallography and corrosion characterisation

The remaining metal is a tin bronze (Table 1) with high porosity (Fig. 8) and large cracks both on the left and right edges of the sample (Fig. 8). The metal contains small, elongated copper sulphide (Table 2) and Pb inclusions that are oriented parallel to the cracks. Near the metal surface, slip lines are outlined by the development of intergranular corrosion (Fig. 9). The etched metal shows small, elongated grains. Slip lines are also visible (Fig. 10). Annealing is visible in areas near the surface. The average hardness of the metal is HV1 145, but significant variations are observed, depending on where the measurements are taken.

The corrosion crust has a thickness between 0.1mm and 0.7mm (Fig. 8). In bright field (Fig. 11), one can observe that the metal has been replaced by light-grey corrosion products. Adjacent to the metal is a thick, heterogeneous, dark-grey layer with a band of light-grey corrosion products. In polarised light (Fig. 12), all corrosion products which were previously light-grey appear brown-green-yellow, the dark-grey layer being turquoise. The elemental chemical distribution of the SEM images (Figs. 13 and 14) reveals that the inner corrosion products are Sn-rich whereas the adjacent band is Cu and S-rich (Fig. 15). The outer layer contains large inclusions (quartz and others, Si, Al and Na,

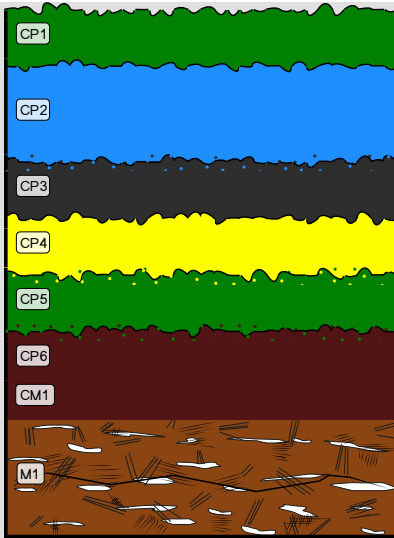
Fig. 16: Stratigraphic representation of the sample taken from the tang fragment in cross-section (dark field) using the MiCorr application. The characteristics of the strata are only accessible by clicking on the drawing that redirects you to the search tool by stratigraphy representation. This representation can be compared to Fig. 12, Credit HE-Arc CR.

Corrosion products CP2 to CP5 observed under binocular corresponds to CP1 to CP4 under cross-section. The other CPs are more difficult to compare, certainly due to the disruption of the corrosion structure during the cutting process.
