TANG FRAGMENT OF A KNIFE HR-6246 – TIN BRONZE – LATE BRONZE AGE – SWITZERLAND

Authors Marianne. Senn (Empa, Dübendorf, Zurich, Switzerland) & Christian. Degriigny (HE-Arc CR, Neuchâtel, Neuchâtel, Switzerland)

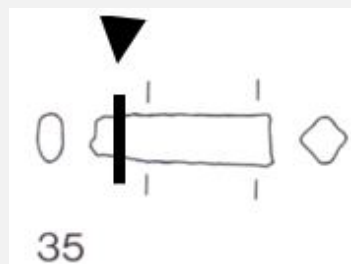
Fig. 4: Location of sampling area,

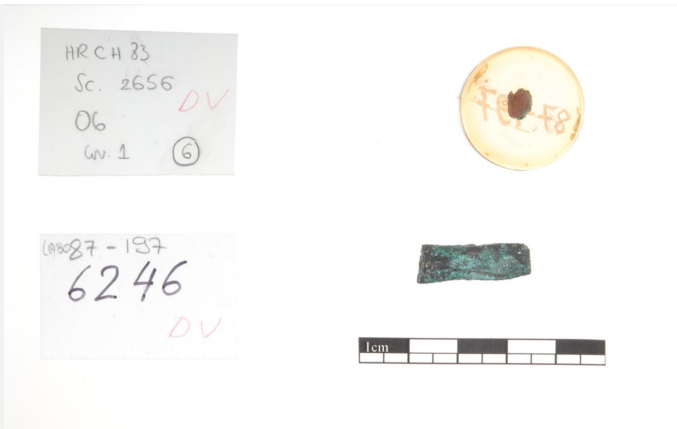
Fig. 5: Cross-section of the tang and remaining material,

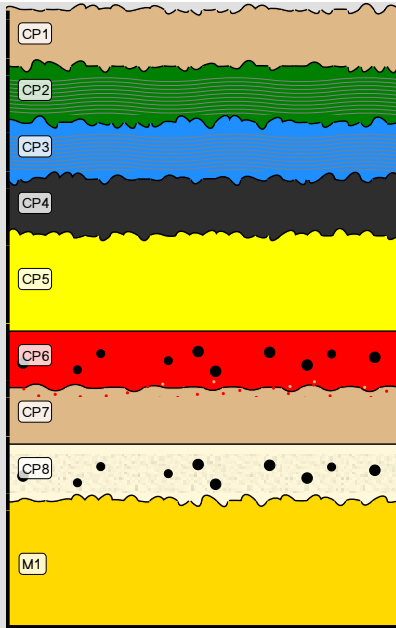
Fig. 7: Stratigraphic representation of the corrosion structure of the tang fragment observed macroscopically under binocular microscope using the MiCorr application. The characteristics of the strata are only accessible by clicking on the drawing that redirects you to the search tool by stratigraphy representation, Credit HE-Arc CR.

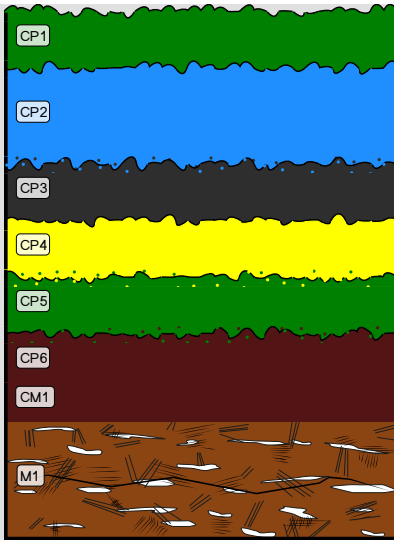
Fig. 16: Stratigraphic representation of the sample taken from the tang fragment in cross-section (dark field) using the MiCorr application. The characteristics of the strata are only accessible by clicking on the drawing that redirects you to the search tool by stratigraphy representation. This representation can be compared to Fig. 12, Credit HE-Arc CR.

Corrosion products CP2 to CP5 observed under binocular corresponds to CP1 to CP4 under cross-section. The other CPs are more difficult to compare, certainly due to the disruption of the corrosion structure during the cutting process.
