AIRCRAFT REAR FASTENING PLATE VHS-497 – AL ALLOY – MODERN TIMES

Artefact name	Aircraft rear fastening plate VHS-497
Authors	Marianne. Senn (Empa, Dübendorf, Zurich, Switzerland) & Christian. Degrigny (HE-Arc CR, Neuchâtel, Neuchâtel, Switzerland)
Url	/artefacts/979/

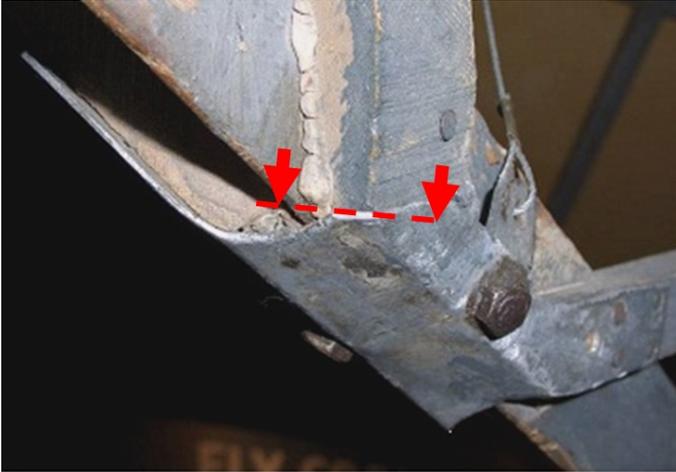
Fig. 2: Location of sampling area,

Description of sample	Sample cut from the corner of the fastening plate (Fig. 2). Dimensions: L = 4mm ; W = 1.2mm.
Alloy	Al Alloy
Technology	Hot rolled and annealed
Lab number of sample	DUF-12
Sample location	HE-Arc CR, Neuchâtel, Neuchâtel
Responsible institution	Swiss Museum of Transport, Luzern, Lucerne
Date and aim of sampling	September 2007, metallography and alloy composition

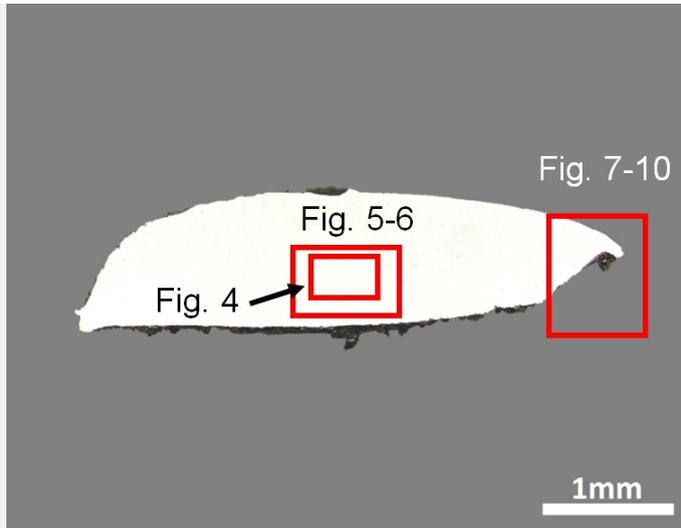
Fig. 3: Micrograph of the cross-section of the sample taken from the back fastening plate showing the location of Figs. 4 to 10,

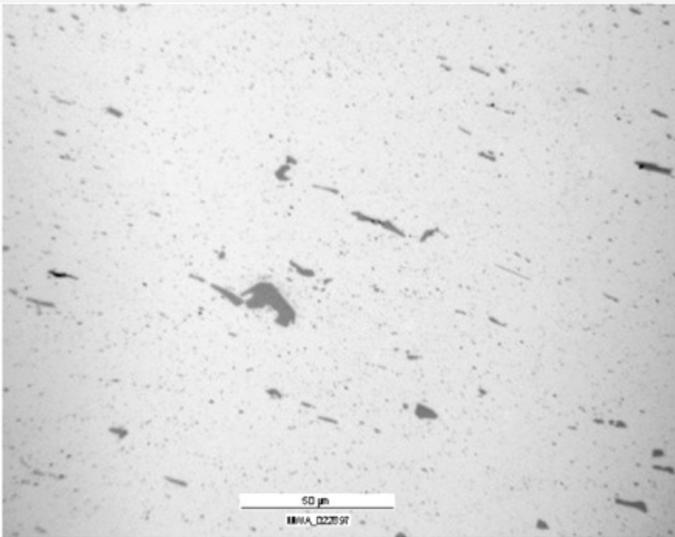
The metal is a relatively pure aluminium alloy with numerous inclusions (Table 1). From the chemical composition of the inclusions they can be interpreted as alpha-AlFeSi intermetallic compounds. In bright field we observe elongated inclusions indicating that the metal was rolled (Fig. 4). The alloy composition is similar to an unalloyed primary aluminium (Al content between 99 and 99.8 mass%). The O content reflects the immediate oxidation of the metal and is not part of the alloy. After etching the organisation of inclusions in rows is more easily seen (Fig. 5). The SEM image shows large grains formed after annealing (Fig. 6). The average hardness of the metal is HV1 40.

Table 1: Chemical composition (mass %) of the metal and inclusions (from Fig. 4). Method of analysis: SEM/EDS, Laboratory of Analytical Chemistry, Empa.

Fig. 4: Micrograph of the metal sample from Fig. 3 (detail), unetched, bright field. The metal matrix is in white, the elongated inclusions in grey,

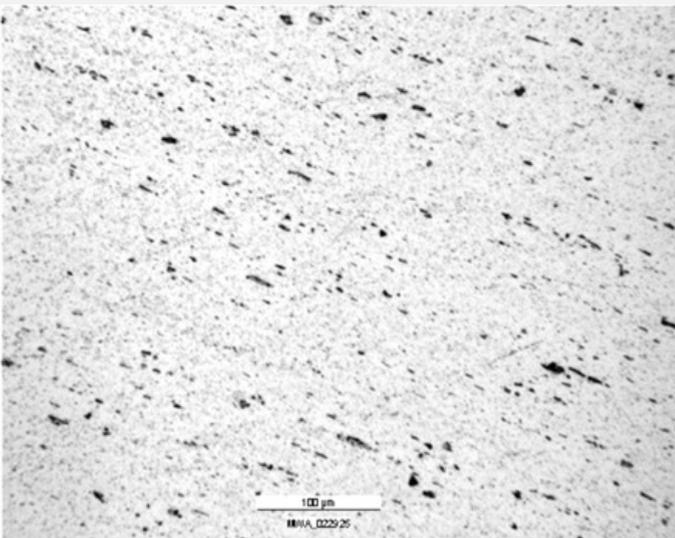
Fig. 5: Micrograph of the metal sample from Fig. 3 (detail), etched, bright field. The metal matrix is in white, the elongated inclusions in dark-grey and black,

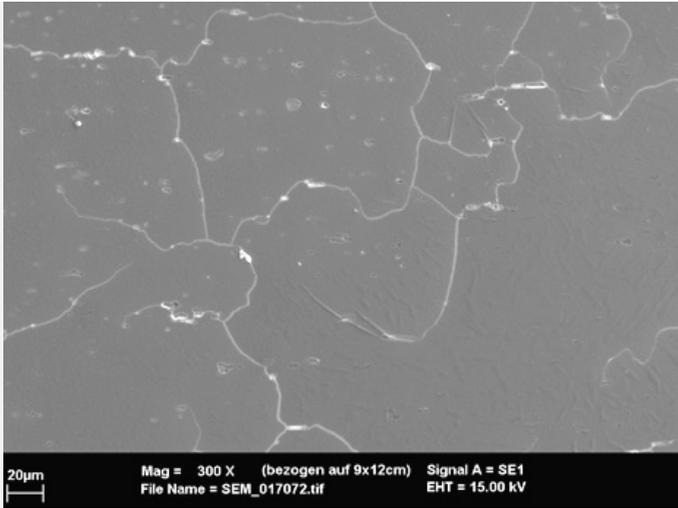
Fig. 6: SEM image of the metal sample from Fig. 3 (detail), SE-mode, etched. We observe the presence of large grains and numerous elongated inclusions,

Microstructure	Recrystallized structure with large grains
First metal element	Al
Other metal elements	Si

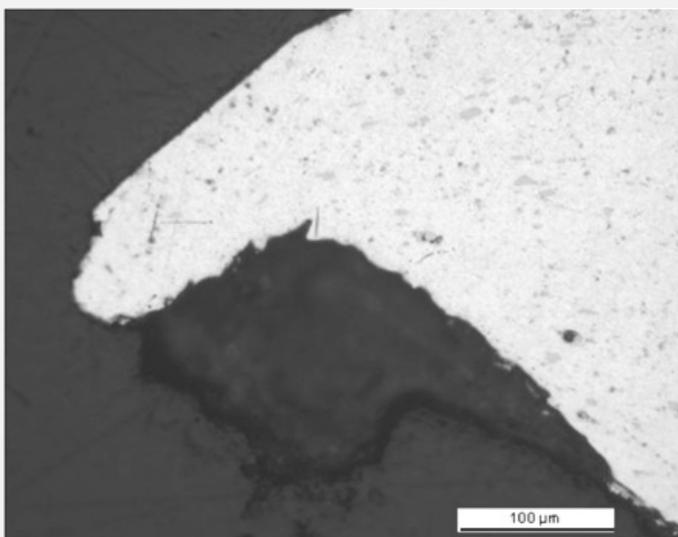
The metal is covered by a very thin corrosion layer (CP1). In addition to this, locally thicker adhering materials can be observed (NMM1, appearing as dark-grey area in Fig. 7). Under polarized light, they appear blue-brown (Fig. 8). Analysis by SEM-EDS indicates that the metal is, as expected, covered by a very thin Al and O-rich layer whereas the particles in the adherent material contain C, O, Si, Ca, Fe, Zn, S and even Ti (Figs. 9 and 10). The location of the adherent material and the presence of both Zn and Ti suggest that it is a residue of a paint coating.

Fig. 7: Micrograph showing the metal - adhering material interface from Fig. 3 (reversed picture, detail), unetched, bright field. We observe in white the metal matrix and dark-grey the adhering material,

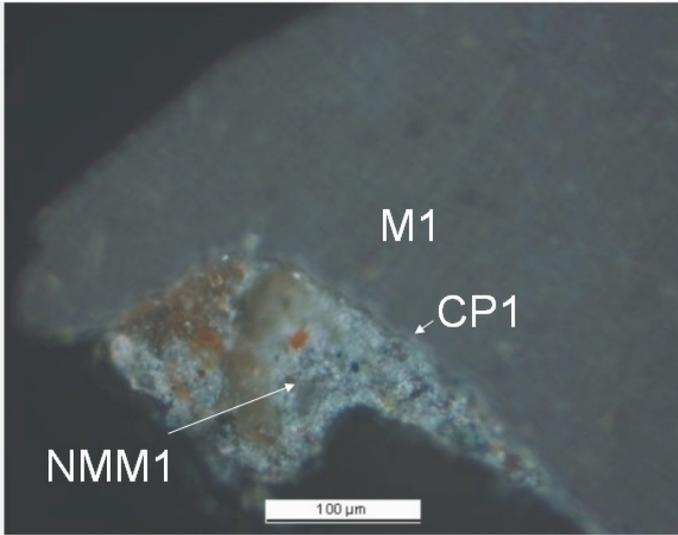
Fig. 8: Micrograph (same as Fig. 7) and corresponding to the stratigraphy of Fig. 11, unetched, polarised light. We observe in grey the metal matrix and blue-brown the adhering material,

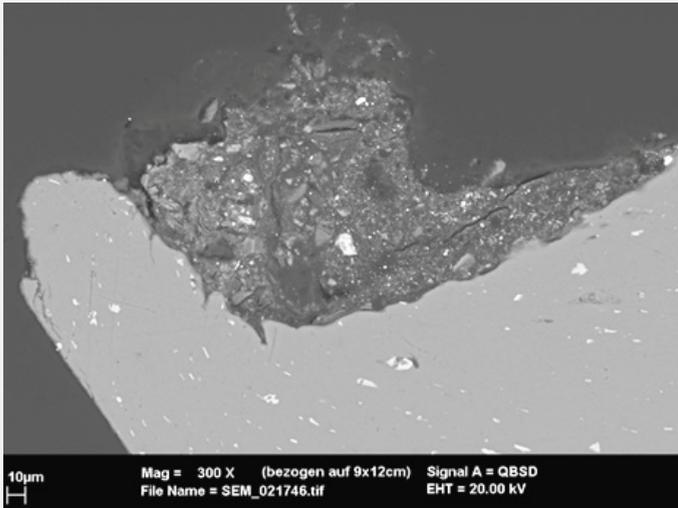
Fig. 9: SEM image (same as Fig. 7, inverted picture, detail), BSE-mode, unetched,

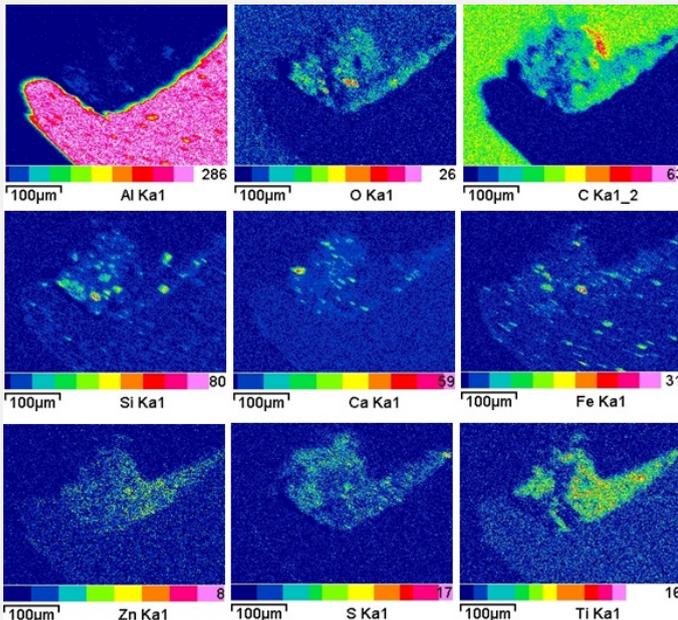
Fig. 10: Elemental chemical distribution of the selected area from Fig. 9. Method of examination: SEM/EDS, Laboratory of Analytical Chemistry, Empa,

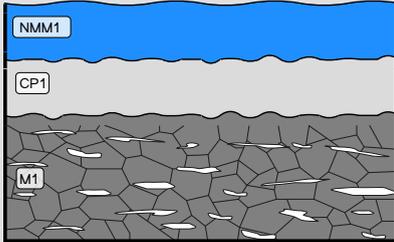
Fig. 11: Stratigraphic representation of the sample taken from the back fastening plate in cross-section (dark field) using the MiCorr application. The characteristics of the strata are only accessible by clicking on the drawing that redirects you to the search tool by stratigraphy representation. This representation can be compared to Fig. 8, Credit HE-Arc CR.
