# AIRCRAFT REAR FASTENING PLATE VHS-497 – AL ALLOY – MODERN TIMES

Artefact name	Aircraft rear fastening plate VHS-497
Authors	Marianne. Senn (Empa, Dübendorf, Zurich, Switzerland) & Christian. Degrigny (HE-Arc CR, Neuchâtel, Neuchâtel, Switzerland)
Url	/artefacts/979/

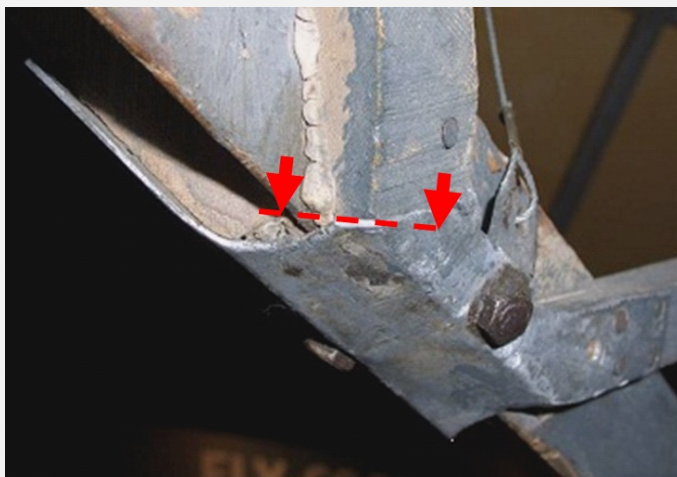
Fig. 2: Location of sampling area,

<b>Description of sample</b>	Sample cut from the corner of the fastening plate (Fig. 2). Dimensions: L = 4mm ; W = 1.2mm.
<b>Alloy</b>	Al Alloy
<b>Technology</b>	Hot rolled and annealed
<b>Lab number of sample</b>	DUF-12
<b>Sample location</b>	HE-Arc CR, Neuchâtel, Neuchâtel
<b>Responsible institution</b>	Swiss Museum of Transport, Luzern, Lucerne
<b>Date and aim of sampling</b>	September 2007, metallography and alloy composition

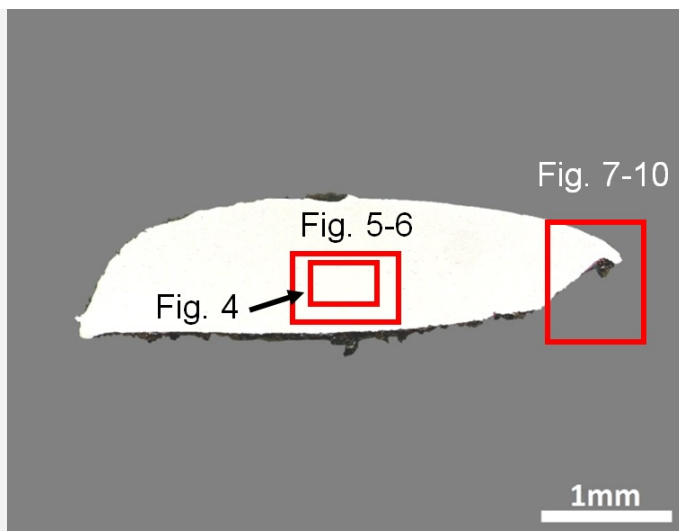
Fig. 3: Micrograph of the cross-section of the sample taken from the back fastening plate showing the location of Figs. 4 to 10,

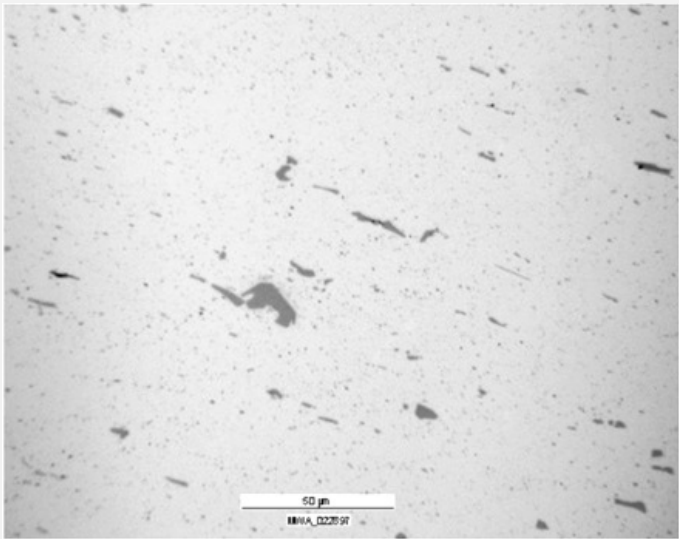
The metal is a relatively pure aluminium alloy with numerous inclusions (Table 1). From the chemical composition of the inclusions they can be interpreted as alpha-AlFeSi intermetallic compounds. In bright field we observe elongated inclusions indicating that the metal was rolled (Fig. 4). The alloy composition is similar to an unalloyed primary aluminium (Al content between 99 and 99.8 mass%). The O content reflects the immediate oxidation of the metal and is not part of the alloy. After etching the organisation of inclusions in rows is more easily seen (Fig. 5). The SEM image shows large grains formed after annealing (Fig. 6). The average hardness of the metal is HV1 40.

Table 1: Chemical composition (mass %) of the metal and inclusions (from Fig. 4). Method of analysis: SEM/EDS, Laboratory of Analytical Chemistry, Empa.

Fig. 4: Micrograph of the metal sample from Fig. 3 (detail), unetched, bright field. The metal matrix is in white, the elongated inclusions in grey,

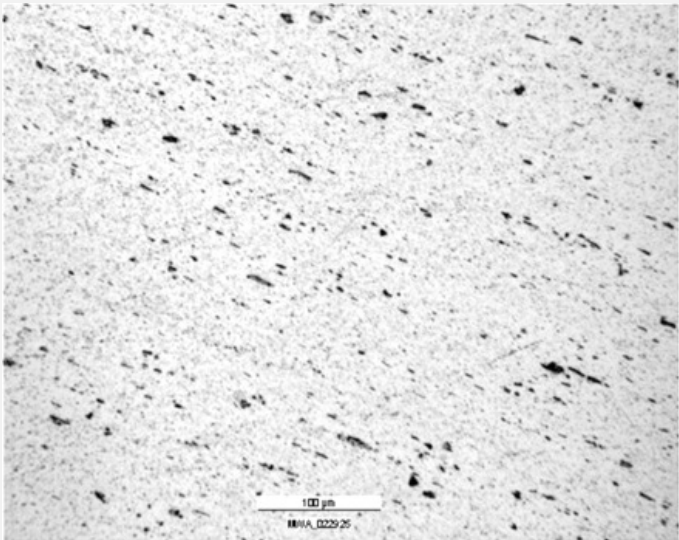
Fig. 5: Micrograph of the metal sample from Fig. 3 (detail), etched, bright field. The metal matrix is in white, the elongated inclusions in dark-grey and black,

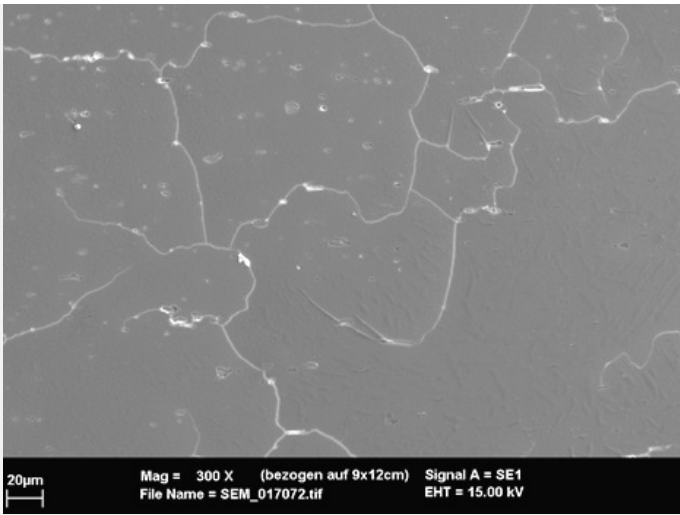
Fig. 6: SEM image of the metal sample from Fig. 3 (detail), SE-mode, etched. We observe the presence of large grains and numerous elongated inclusions,

Microstructure	Recrystallized structure with large grains
First metal element	Al
Other metal elements	Si

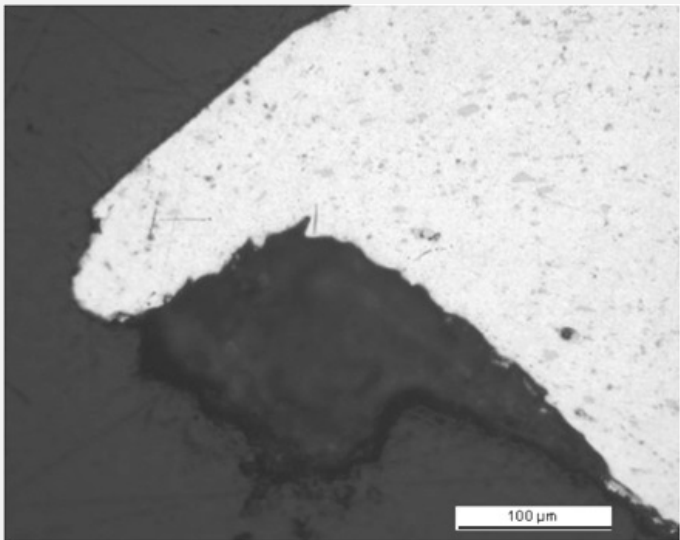
The metal is covered by a very thin corrosion layer (CP1). In addition to this, locally thicker adhering materials can be observed (NMM1, appearing as dark-grey area in Fig. 7). Under polarized light, they appear blue-brown (Fig. 8). Analysis by SEM-EDS indicates that the metal is, as expected, covered by a very thin Al and O-rich layer whereas the particles in the adherent material contain C, O, Si, Ca, Fe, Zn, S and even Ti (Figs. 9 and 10). The location of the adherent material and the presence of both Zn and Ti suggest that it is a residue of a paint coating.

Fig. 7: Micrograph showing the metal - adhering material interface from Fig. 3 (reversed picture, detail), unetched, bright field. We observe in white the metal matrix and dark-grey the adhering material,

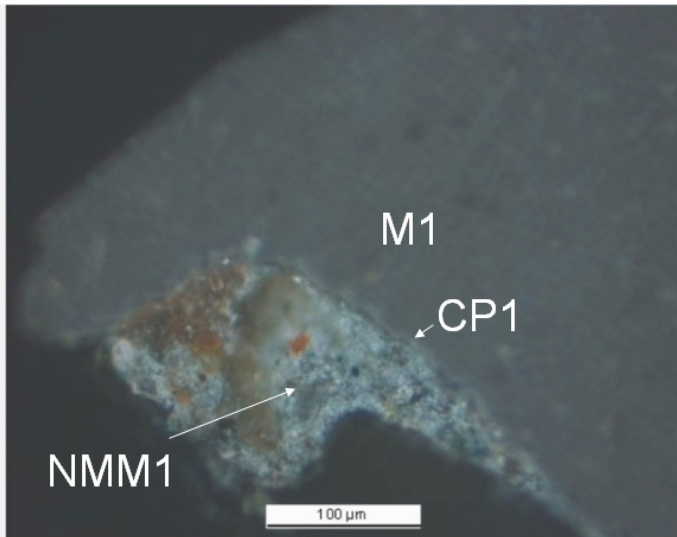
Fig. 8: Micrograph (same as Fig. 7) and corresponding to the stratigraphy of Fig. 11, unetched, polarised light. We observe

in grey the metal matrix and blue-brown the adhering material,

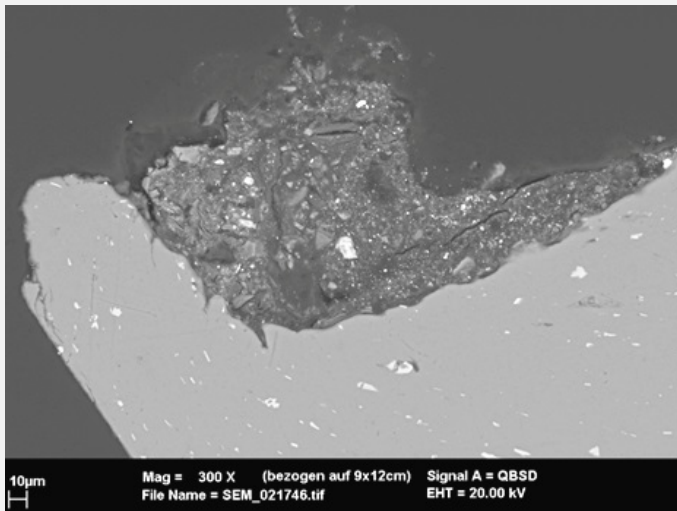
Fig. 9: SEM image (same as Fig. 7, inverted picture, detail), BSE-mode, unetched,

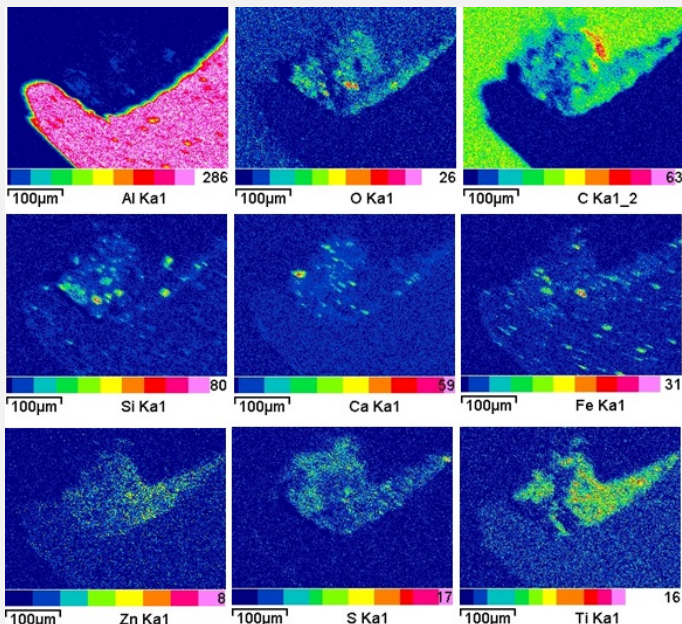
Fig. 10: Elemental chemical distribution of the selected area from Fig. 9. Method of examination: SEM/EDS, Laboratory of Analytical Chemistry, Empa,

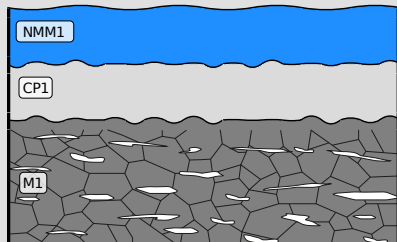
Fig. 11: Stratigraphic representation of the sample taken from the back fastening plate in cross-section (dark field) using the MiCorr application. The characteristics of the strata are only accessible by clicking on the drawing that redirects you to the search tool by stratigraphy representation. This representation can be compared to Fig. 8, Credit HE-Arc CR.
