# AIRCRAFT FRONT FASTENING PLATE VHS-497 (2) - AL CU SN ZN SI ALLOY - MODERN TIMES

**Artefact name** Aircraft front fastening plate VHS-497 (2)

**Authors** Marianne. Senn (Empa, Dübendorf, Zurich, Switzerland) & Christian. Degrigny (HE-Arc CR, Neuchâtel, Neuchâtel, Switzerland)

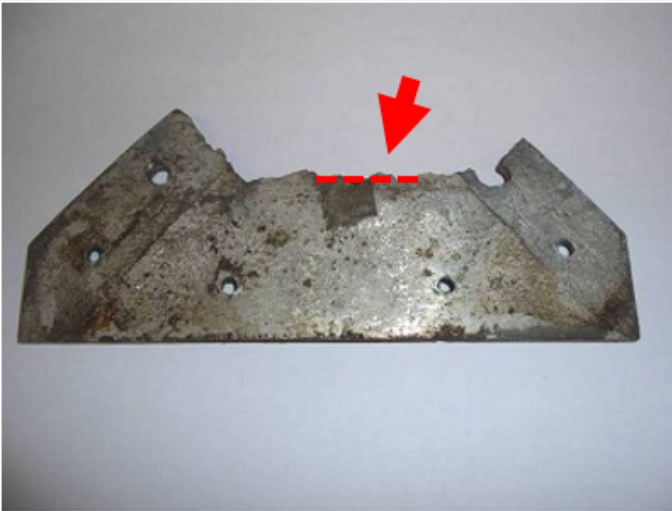
Fig. 2: Location of sampling area,

<b>Description of sample</b>	The top part has been cut during sampling (Fig. 2). The more regular right side is the plate surface and the irregular side is the broken edge (Fig. 3). Dimensions: L = 4mm ; W = 4mm.
<b>Alloy</b>	Al Cu Sn Zn Si Alloy
<b>Technology</b>	As-cast
<b>Lab number of sample</b>	DUF-4
<b>Sample location</b>	HE-Arc CR, Neuchâtel, Neuchâtel
<b>Responsible institution</b>	Swiss Museum of Transport, Luzern, Lucerne
<b>Date and aim of sampling</b>	September 2007, metallography and alloy composition

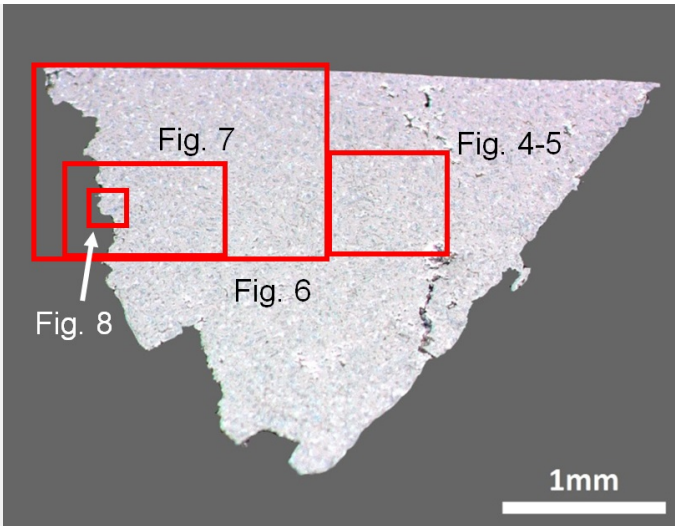
Fig. 3: Micrograph of the cross-section of the sample taken from the front fastening plate showing the location of Figs. 4 to 8,

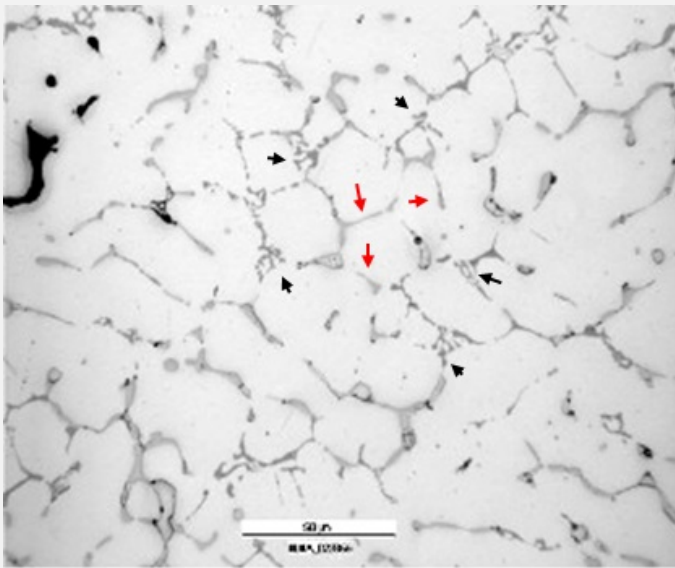
The metal is an aluminium alloy containing Cu, Sn, Zn and Si (Table 1). The unetched metal shows an as-cast structure consisting of the aluminium matrix with Sn (not soluble in Al) inclusions (Figs. 4 and 5), intermetallic compounds such as Al<sub>2</sub>Cu (Fig. 4, red arrows) and clusters of Al,Fe,Cu & Si phases (Fig. 4, black arrows). There are porosities in the metal (Figs. 3 and 5). The average hardness of the metal is HV1 80.

Fig. 4: Micrograph of the metal sample from Fig. 3 (detail), unetched, bright field. The cast structure is revealed by light grey intermetallic compounds (Al<sub>2</sub>Cu, red arrows), dark-grey Al,Fe,Si & Cu phase clusters (black arrows) and Sn inclusions (nodules). On the top left some pores can be seen,

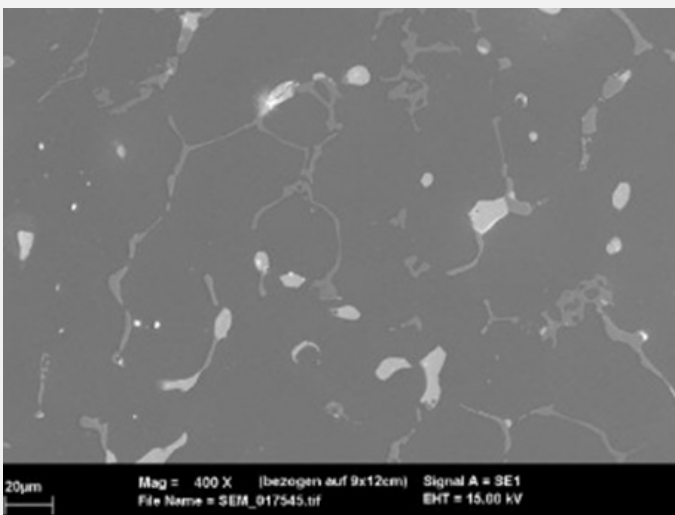
Table 1: Chemical composition (mass %) of the metal and inclusions (from Fig. 5). Method of analysis: SEM/EDS, Laboratory of Analytical Chemistry, Empa.

Fig. 5: SEM image of the metal sample from Fig. 3 (detail), SE-mode, unetched. We observe in dark-grey the metal matrix, in medium-grey the intermetallic compound Al<sub>2</sub>Cu as well as Al,Fe,Si & Cu phase clusters and in light-grey the Sn inclusions,

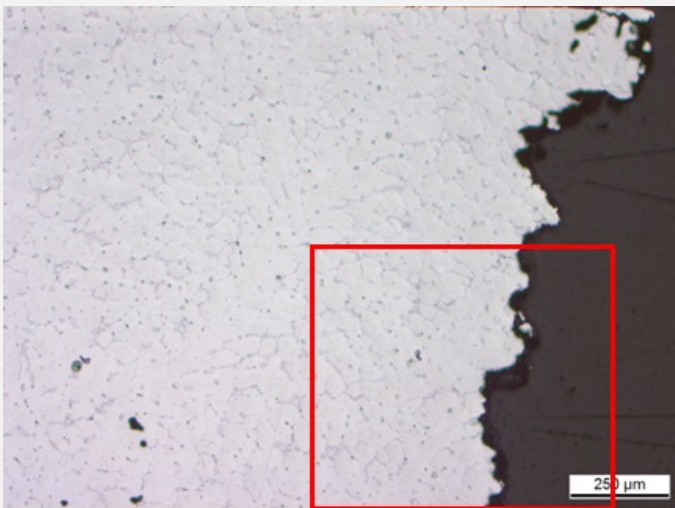
No corrosion layer can be seen on the metal surface (Figs. 3 and 6). Under polarized light small white and brown particles are visible on the broken edge (D1, Fig. 7). Their analysis reveals the presence of silica particles surrounded by dirt (Table 2 and Fig. 8). The metal surface is covered by a thin oxygen bearing skin (CP1, Fig. 8).

Fig. 6: Micrograph showing the metal - "corrosion products" interface from Fig. 3 (reversed picture, detail), unetched, bright field. We observe in white the metal matrix, in dark-grey Al,Fe, Si & Cu phase and light-grey Al<sub>2</sub>Cu intermetallic compounds. The micrograph of Fig. 7 is marked by a rectangle,

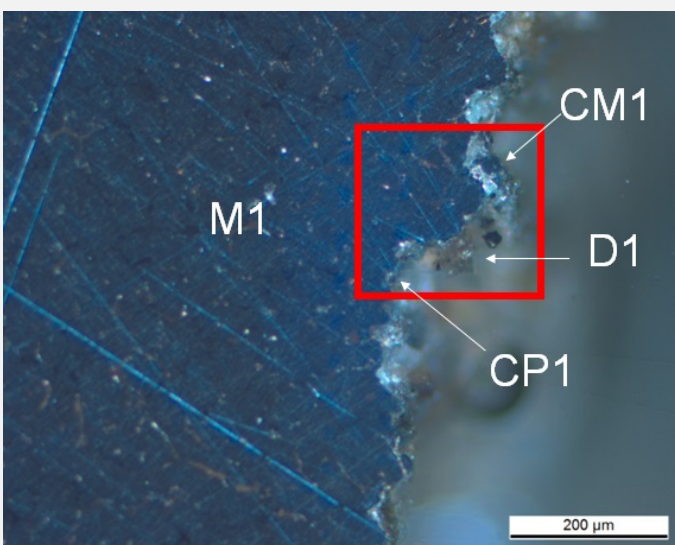
Fig. 7: Micrograph from Fig. 6 (detail) and corresponding to the stratigraphy of Fig. 9, unetched, polarised light. We observe in dark blue the metal matrix and blue-brown the adherent material. The area selected for elemental chemical distribution (Fig. 8) is marked by a rectangle,

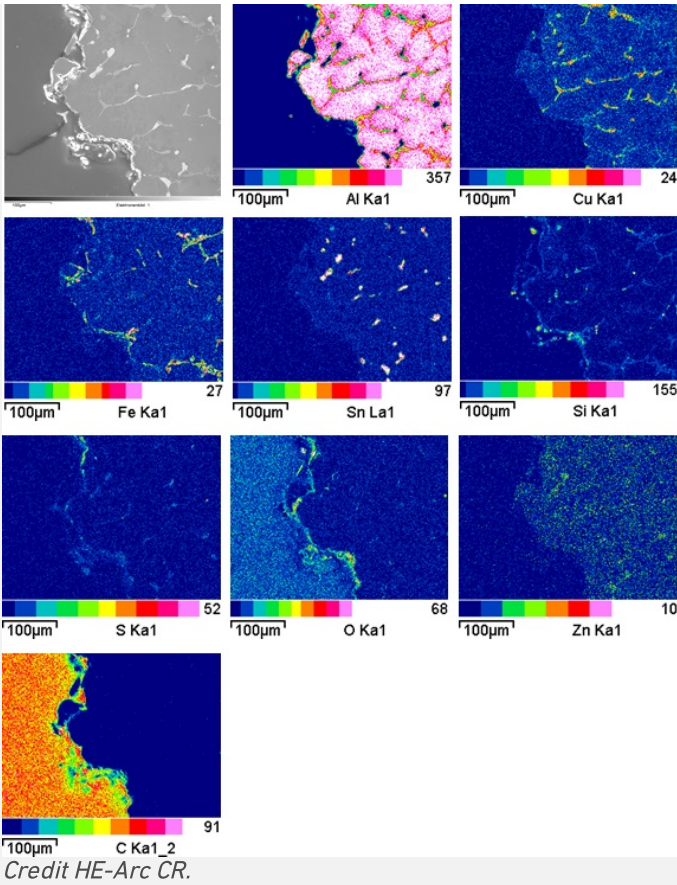
Table 2: Chemical composition (mass %) of the adhering particles to the metal surface (from Fig. 8). Method of analysis: SEM/EDS, Laboratory of Analytical Chemistry, Empa.

Fig. 8: SEM image, BSE-mode, and elemental chemical distribution of the selected area from Fig. 7 (reversed picture, detail). Method of examination: SEM/EDS, Laboratory of Analytical Chemistry, Empa,

This front fastening plate of Dufaux IV plane is made in cast Al-Cu-Sn-Zn-Si, an alloy rather common at the beginning of the 20th century. No corrosion layer has been found on the metal surface except adherent silica-rich particles and the thin oxidised skin typical of Al alloys. The presence of these materials can be explained by the regular maintenance of the metal, probably using silicon carbide abrasive paper.

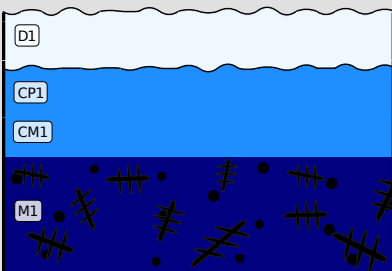
Fig. 9: Stratigraphic representation of the sample taken from the front fastening plate in cross-section (dark field) using the MiCorr application. The characteristics of the strata are only accessible by clicking on the drawing that redirects you to the search tool by stratigraphy representation. This representation can be compared to Fig. 7, Credit HE-Arc CR.
