# AIRCRAFT FRONT FASTENING PLATE VHS-497 (2) – AL CU SN ZN SI ALLOY – MODERN TIMES

Artefact name	Aircraft front fastening plate VHS-497 (2)
Authors	Marianne. Senn (Empa, Dübendorf, Zurich, Switzerland) & Christian. Degryny (HE-Arc CR, Neuchâtel, Neuchâtel, Switzerland)
Url	/artefacts/980/

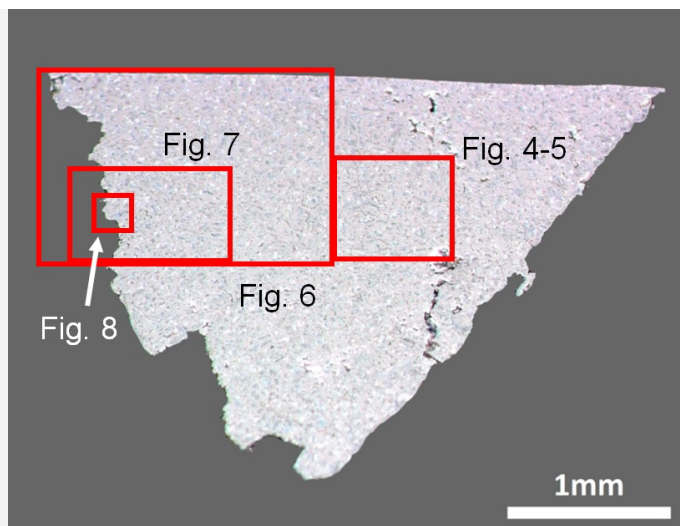
Fig. 3: Micrograph of the cross-section of the sample taken from the front fastening plate showing the location of Figs. 4 to 8,

<b>Description of sample</b>	The top part has been cut during sampling (Fig. 2). The more regular right side is the plate surface and the irregular side is the broken edge (Fig. 3). Dimensions: L = 4mm ; W = 4mm.
<b>Alloy</b>	Al Cu Sn Zn Si Alloy
<b>Technology</b>	As-cast
<b>Lab number of sample</b>	DUF-4
<b>Sample location</b>	HE-Arc CR, Neuchâtel, Neuchâtel
<b>Responsible institution</b>	Swiss Museum of Transport, Luzern, Lucerne
<b>Date and aim of sampling</b>	September 2007, metallography and alloy composition

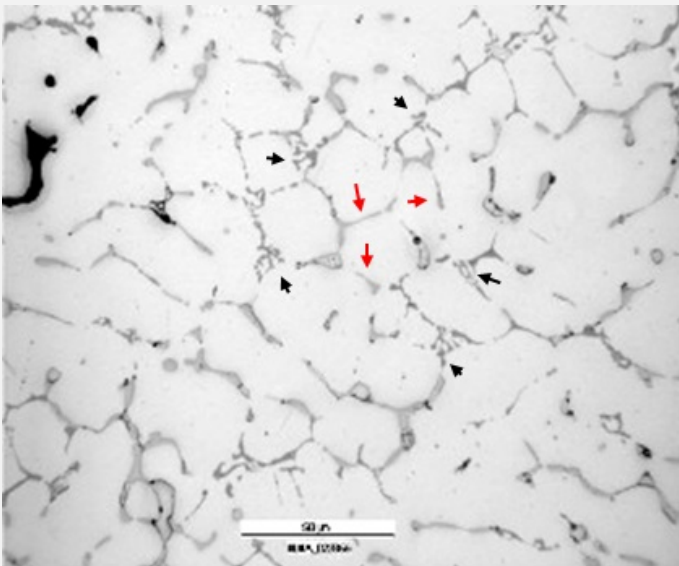
The metal is an aluminium alloy containing Cu, Sn, Zn and Si (Table 1). The unetched metal shows an as-cast structure consisting of the aluminium matrix with Sn (not soluble in Al) inclusions (Figs. 4 and 5), intermetallic compounds such as Al<sub>2</sub>Cu (Fig. 4, red arrows) and clusters of Al,Fe,Cu & Si phases (Fig. 4, black arrows). There are porosities in the metal (Figs. 3 and 5). The average hardness of the metal is HV1 80.

Fig. 4: Micrograph of the metal sample from Fig. 3 (detail), unetched, bright field. The cast structure is revealed by light grey intermetallic compounds (Al<sub>2</sub>Cu, red arrows), dark-grey Al,Fe,Si & Cu phase clusters (black arrows) and Sn inclusions (nodules). On the top left some pores can be seen,

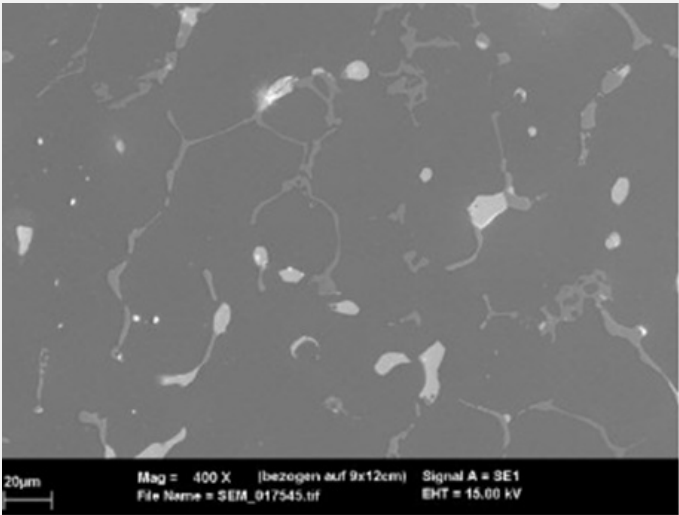
Table 1: Chemical composition (mass %) of the metal and inclusions (from Fig. 5). Method of analysis: SEM/EDS, Laboratory of Analytical Chemistry, Empa.

Fig. 5: SEM image of the metal sample from Fig. 3 (detail), SE-mode, unetched. We observe in dark-grey the metal matrix, in medium-grey the intermetallic compound Al<sub>2</sub>Cu as well as Al,Fe,Si & Cu phase clusters and in light-grey the Sn inclusions,

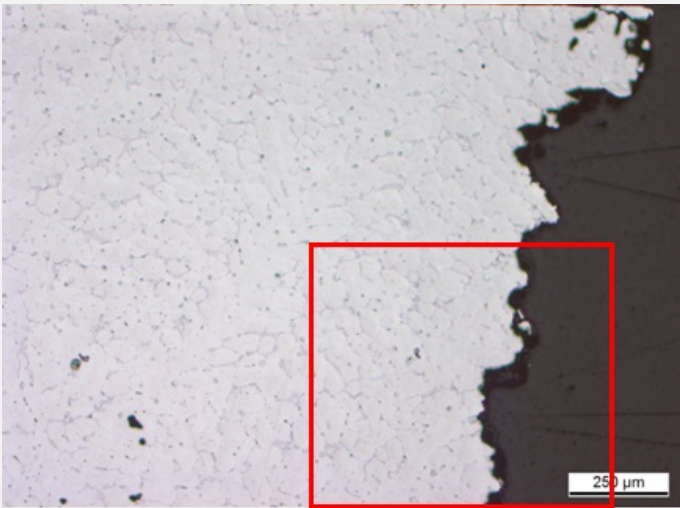
No corrosion layer can be seen on the metal surface (Figs. 3 and 6). Under polarized light small white and brown particles are visible on the broken edge (D1, Fig. 7). Their analysis reveals the presence of silica particles surrounded by dirt (Table 2 and Fig. 8). The metal surface is covered by a thin oxygen bearing skin (CP1, Fig. 8).

Fig. 6: Micrograph showing the metal - "corrosion products" interface from Fig. 3 (reversed picture, detail), unetched, bright field. We observe in white the metal matrix, in dark-grey Al,Fe, Si & Cu phase and light-grey Al<sub>2</sub>Cu intermetallic compounds. The micrograph of Fig. 7 is marked by a rectangle,

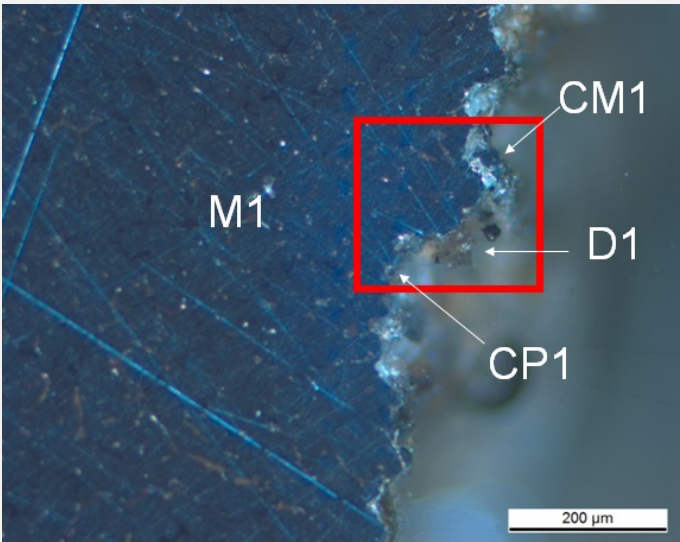
Fig. 7: Micrograph from Fig. 6 (detail) and corresponding to the stratigraphy of Fig. 9, unetched, polarised light. We observe in dark blue the metal matrix and blue-brown the adherent material. The area selected for elemental chemical distribution (Fig. 8) is marked by a rectangle,

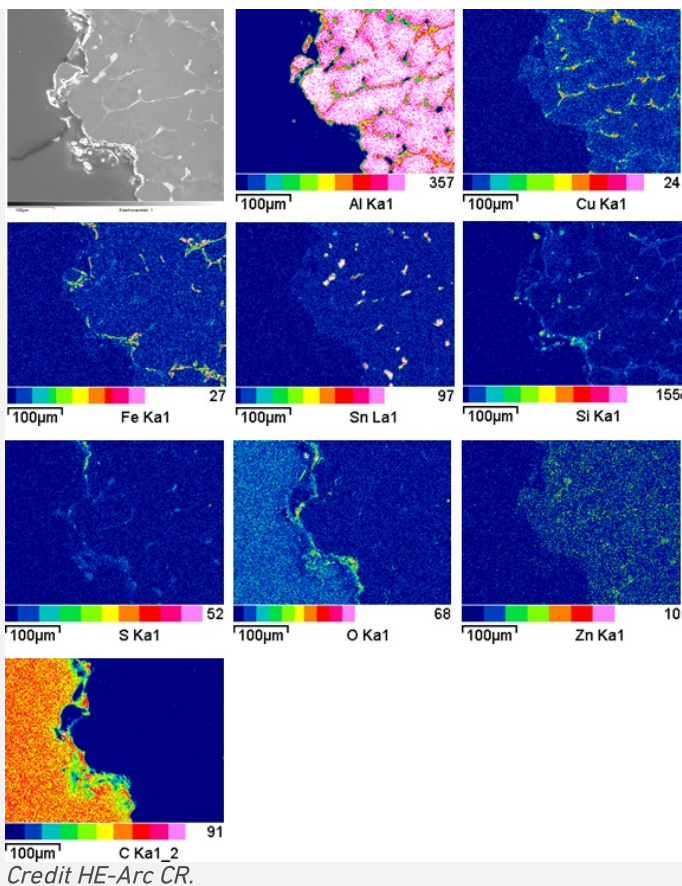
Table 2: Chemical composition (mass %) of the adhering particles to the metal surface (from Fig. 8). Method of analysis: SEM/EDS, Laboratory of Analytical Chemistry, Empa.

Fig. 8: SEM image, BSE-mode, and elemental chemical distribution of the selected area from Fig. 7 (reversed picture, detail). Method of examination: SEM/EDS, Laboratory of Analytical Chemistry, Empa,

This front fastening plate of Dufaux IV plane is made in cast Al-Cu-Sn-Zn-Si, an alloy rather common at the beginning of the 20th century. No corrosion layer has been found on the metal surface except adherent silica-rich particles and the thin oxidised skin typical of Al alloys. The presence of these materials can be explained by the regular maintenance of the metal, probably using silicon carbide abrasive paper.

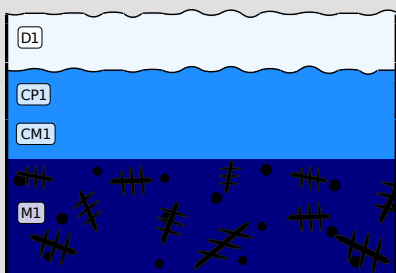
Fig. 9: Stratigraphic representation of the sample taken from the front fastening plate in cross-section (dark field) using the MiCorr application. The characteristics of the strata are only accessible by clicking on the drawing that redirects you to the search tool by stratigraphy representation. This representation can be compared to Fig. 7, Credit HE-Arc CR.
