# PIN OR NEEDLE FRAGMENT HR-3031 – TIN BRONZE – LATE BRONZE AGE – SWITZERLAND

<b>Artefact name</b>	Pin or needle fragment HR-3031
<b>Authors</b>	Marianne. Senn (EMPA, Dübendorf, Zurich, Switzerland) & Christian. Degrigny (HE-Arc CR, Neuchâtel, Neuchâtel, Switzerland)
<b>Url</b>	/artefacts/986/

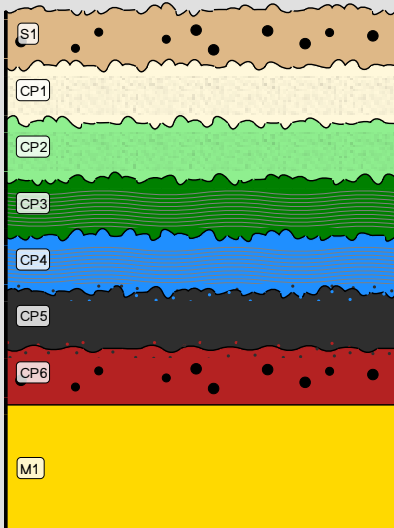
Fig. 3: Stratigraphic representation of the pin or needle fragment with green-blue patina under binocular using the MiCorr application. The characteristics of the strata are only accessible by clicking on the drawing that redirects you to the search tool by stratigraphy representation, Credit HE-Arc CR.

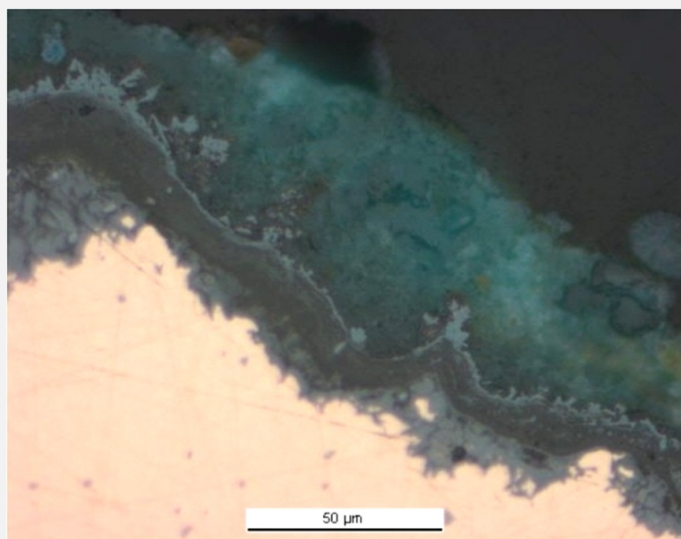
The corrosion crust has an average thickness of about 50µm (Fig. 7). In polarised light (Fig. 8), the corrosion stratigraphy is more clearly visible: it is composed of an inner dark red-green-yellow corrosion layer (CP6 to CP8, an agglomerate of nanoscale stannic oxides with cuprite) directly on the metal core (Table 3 and Fig. 9, already studied by Piccardo et al. 2007), an intermediate multi-layered black-grey bands (CP3 to CP5) and an outer turquoise-green layer (CP1-CP2) analysed with XRD by Schweizer and identified as malachite/CuCO<sub>3</sub>Cu(OH)<sub>2</sub> (Schweizer 1994). In some areas the dark-red layers (CP8) can also be found in between the black-grey bands (CP3 to CP5) and the malachite (CP1-CP2). Elemental chemical distribution of the SEM image of Fig. 9 shows that the black-grey layers are enriched in Sn but also contain Fe. Superior markers such as contextual Al and Si are present in the outer malachite layers. S is present both on the rim of the outer black-grey layers and in the malachite (Fig. 9, Table 3).

Fig. 7: Micrograph of the metal sample from Fig. 4 (detail) and corresponding to the stratigraphy of Fig. 10, unetched, bright field. Stratigraphy of the corrosion crust: inner light grey layer (CP3), intermediate dark grey layer with a light-grey rim (CP2) and outer grey-green layer (CP1),

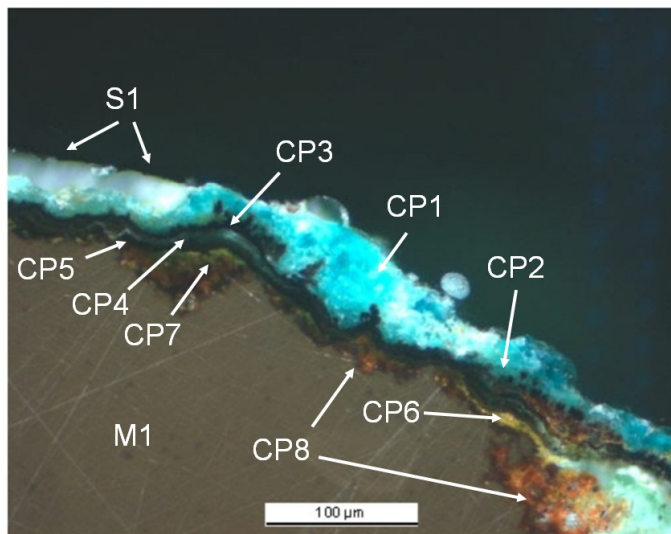
Fig. 8: Micrograph of the metal sample from Fig. 4 and corresponding to the stratigraphy of Fig. 10, polarised light. The metal appears in brown; the inner layer appears as red-orange, the intermediate layer as black and the outer layer as turquoise,

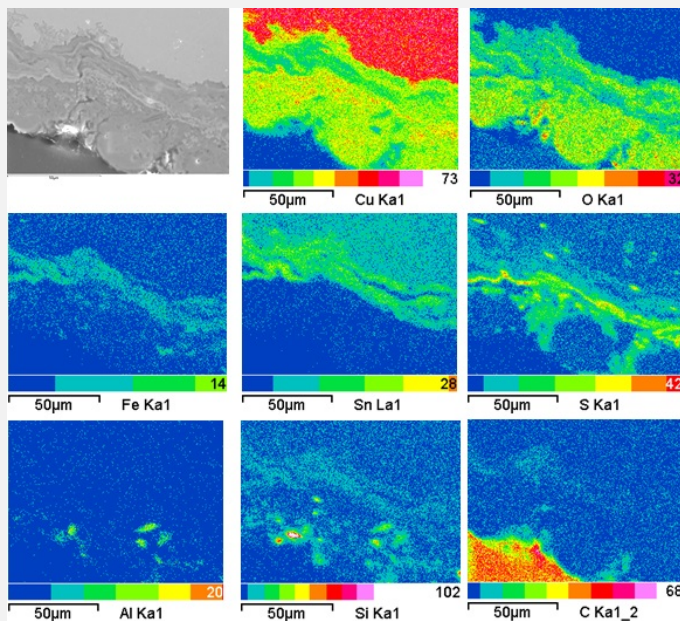
Fig. 9: SEM image, SE-mode, and elemental chemical distribution of a selected area of Fig. 4. Method of examination: SEM/EDS, Laboratory of Analytical Chemistry, Empa,
