# PIN OR NEEDLE FRAGMENT HR-3031 – TIN BRONZE – LATE BRONZE AGE – SWITZERLAND

<b>Artefact name</b>	Pin or needle fragment HR-3031
<b>Authors</b>	Marianne. Senn (EMPA, Dübendorf, Zurich, Switzerland) & Christian. Degriigny (HE-Arc CR, Neuchâtel, Neuchâtel, Switzerland)
<b>Url</b>	/artefacts/986/

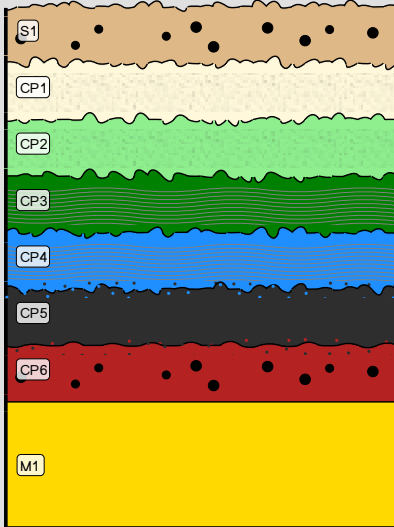
Fig. 3: Stratigraphic representation of the pin or needle fragment with green-blue patina under binocular using the MiCorr application. The characteristics of the strata are only accessible by clicking on the drawing that redirects you to the search tool by stratigraphy representation, Credit HE-Arc CR.

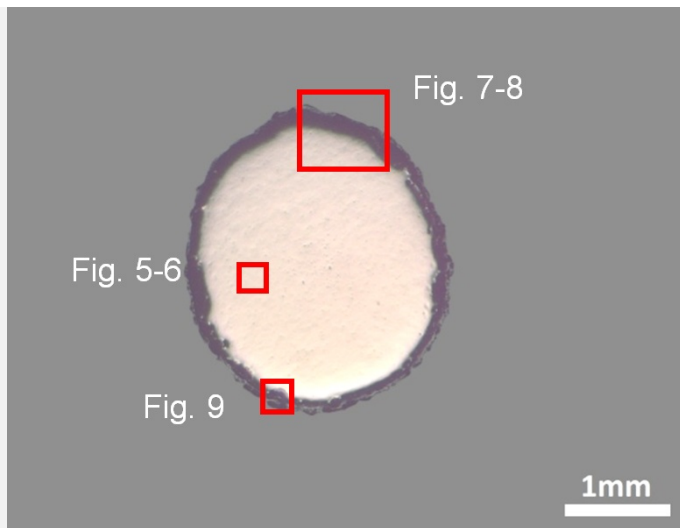
Fig. 4: Micrograph of the cross-section of the sample taken from the pin or needle fragment with green-blue patina showing the location of Figs. 5 to 9,

<b>Description of sample</b>	The cross-section is circular and is a complete section through the pin (Fig. 2). The surface is completely covered with a rather thin corrosion crust of irregular thickness (Fig. 4).
<b>Alloy</b>	Tin Bronze
<b>Technology</b>	Cold worked after annealing
<b>Lab number of sample</b>	MAH 87-195
<b>Sample location</b>	Musées d'art et d'histoire, Genève, Geneva
<b>Responsible institution</b>	Musées d'art et d'histoire, Genève, Geneva
<b>Date and aim of sampling</b>	1987, metallography and corrosion characterisation

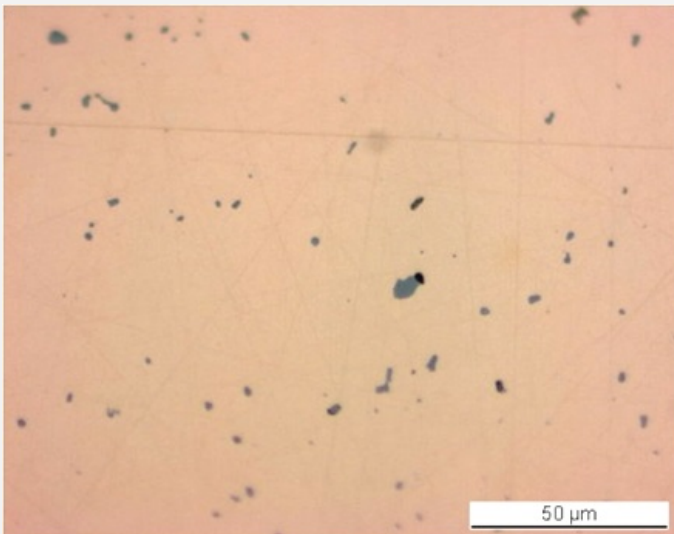
The remaining metal is a tin bronze and contains small copper sulphide and Pb-rich inclusions evenly distributed throughout the metal (Fig. 5, Tables 1 and 2). The Pb-rich inclusions are only visible with SEM appearing as white particles. The etched structure of the tin bronze shows re-crystallised and angular grains, some of them with twins (Fig. 6). Strain or slip lines are visible, especially near the metal surface. They indicate a final cold working. Copper sulphide inclusions are found both at the grain boundaries and inside the grains (Fig. 6). The average hardness of the metal is about HV1 120.

Fig. 5: Micrograph of the metal sample from Fig. 4 (detail), unetched, bright field. Grey copper sulphide inclusions are clearly visible.

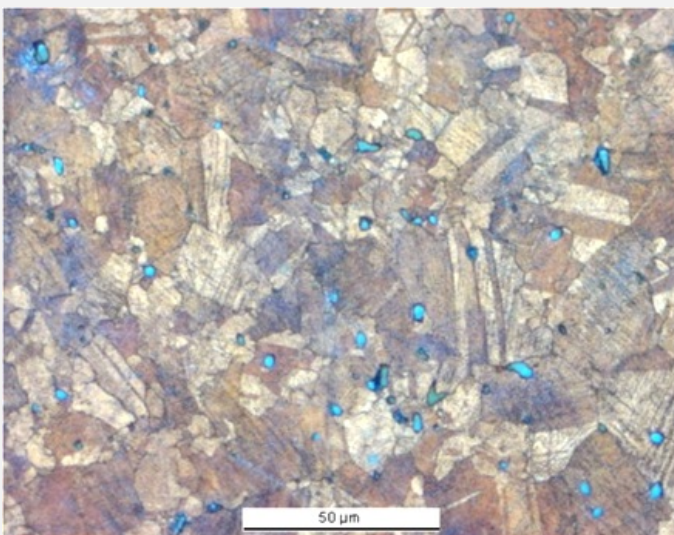
Fig. 6: Micrograph of the metal sample from Fig. 4 (detail), etched, bright field. Small angular re-crystallised grains (some with twins) with slip lines are observed. Copper sulphide inclusions appear in blue.

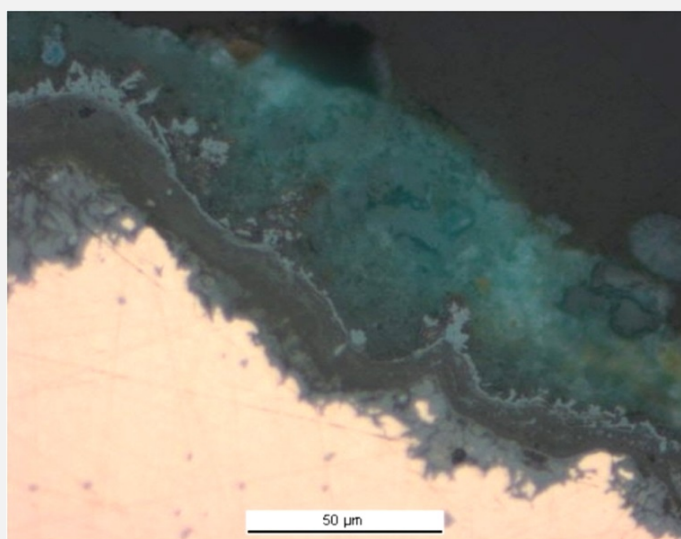
The corrosion crust has an average thickness of about 50µm (Fig. 7). In polarised light (Fig. 8), the corrosion stratigraphy is more clearly visible: it is composed of an inner dark red-green-yellow corrosion layer (CP6 to CP8, an agglomerate of nanoscale stannic oxides with cuprite) directly on the metal core (Table 3 and Fig. 9, already studied by Piccardo et al. 2007), an intermediate multi-layered black-grey bands (CP3 to CP5) and an outer turquoise-green layer (CP1-CP2) analysed with XRD by Schweizer and identified as malachite/CuCO<sub>3</sub>Cu(OH)<sub>2</sub> (Schweizer 1994). In some areas the dark-red layers (CP8) can also be found in between the black-grey bands (CP3 to CP5) and the malachite (CP1-CP2). Elemental chemical distribution of the SEM image of Fig. 9 shows that the black-grey layers are enriched in Sn but also contain Fe. Superior markers such as contextual Al and Si are present in the outer malachite layers. S is present both on the rim of the outer black-grey layers and in the malachite (Fig. 9, Table 3).

Fig. 7: Micrograph of the metal sample from Fig. 4 (detail) and corresponding to the stratigraphy of Fig. 10, unetched, bright field. Stratigraphy of the corrosion crust: inner light grey layer (CP3), intermediate dark grey layer with a light-grey rim (CP2) and outer grey-green layer (CP1),

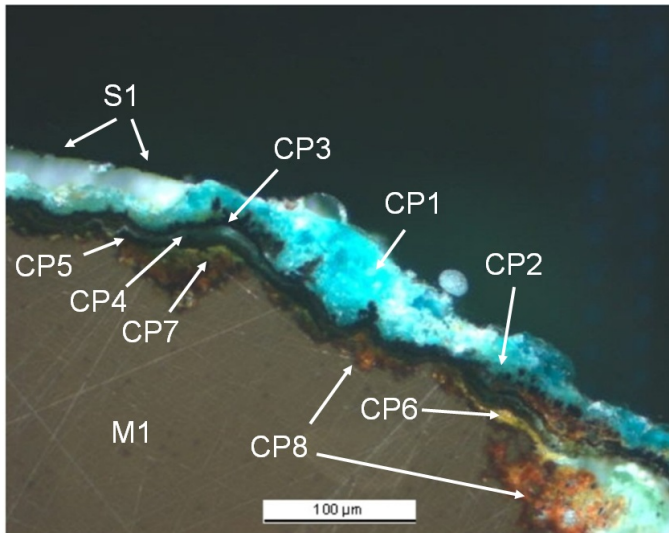
Fig. 8: Micrograph of the metal sample from Fig. 4 and corresponding to the stratigraphy of Fig. 10, polarised light. The metal appears in brown; the inner layer appears as red-orange, the intermediate layer as black and the outer layer as turquoise,

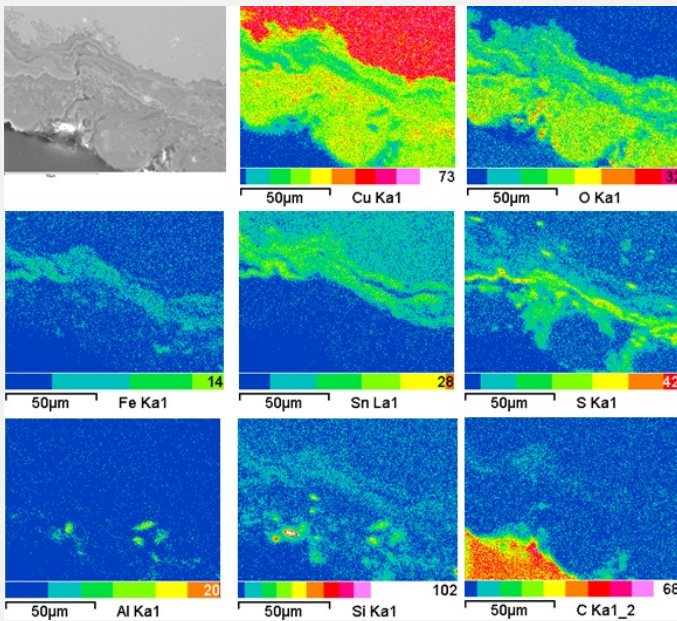
Fig. 9: SEM image, SE-mode, and elemental chemical distribution of a selected area of Fig. 4. Method of examination: SEM/EDS, Laboratory of Analytical Chemistry, Empa,
