FRAGMENT OF AN AEGIS OF NEÏTH 1886.305.0096 – LEADED BRONZE

Artefact name Fragment of an Aegis of Neïth 1886.305.0096

Authors Line. Pedersen (HE-Arc, Neuchâtel, Neuchâtel, Switzerland) & Christian. Degrigny (HE-Arc CR, Neuchâtel, Neuchâtel, Switzerland) & Valentin. Boissonnas (HE-Arc CR, Neuchâtel, Neuchâtel, Switzerland)

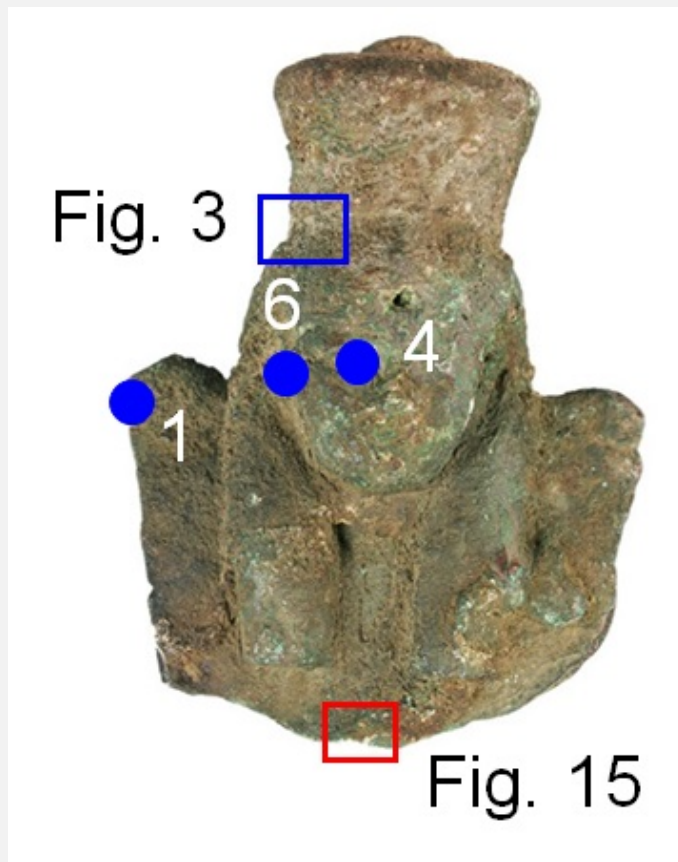
Fig. 2: Front face of the aegis with location of XRF measurements (blue spots), powder sample (red square) and gilding remains on the surface (blue square),

The metal (M2 in Fig.9 and M1 in Fig. 10) was analysed on the broken edge of the bottom of the artefact where despite a highly corroded surface, the metal seems to be the best preserved. The XRF analyses revealed that the metal is a leaded bronze with remains of gold leaf on the surface (Table 1, Au was detected in the measurement spots 4,5 and 6) (Scott 2002; Gouda 2012; Mohammed 2012).

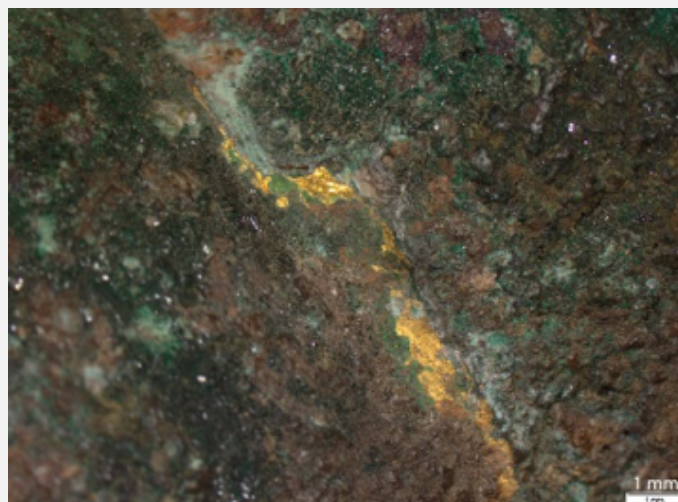
Fig. 3: Remains of foil-gilding on the corroded surface,

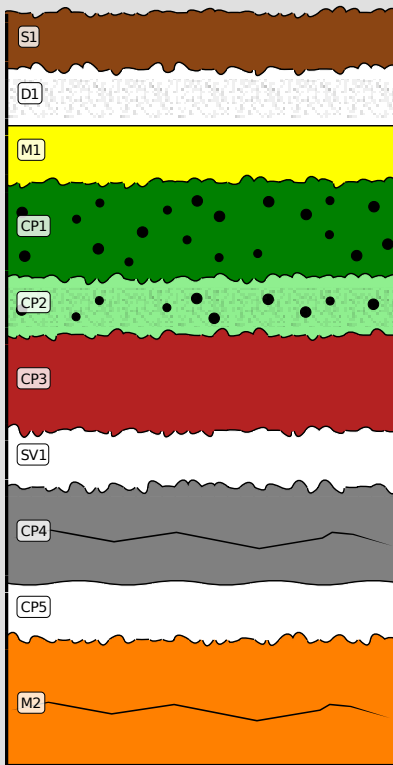
Fig.9: Schematic representation combining stratigraphies 1 and 2 under binocular microscope and using the MiCorr application. The characteristics of the strata are only accessible by clicking on the drawing that redirects you to the search tool by stratigraphy representation, Credit He-Arc CR, L.Pedersen.

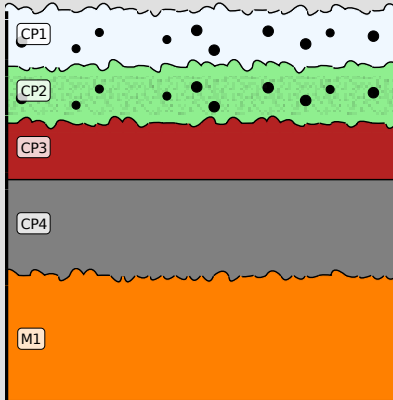
Fig.10: Schematic representation of stratigraphy 3 under binocular microscope and using the MiCorr application. CP1 is CP6 in Fig. 8. The characteristics of the strata are only accessible by clicking on the drawing that redirects you to the search tool by stratigraphy representation, Credit He-Arc CR, L. Pedersen.

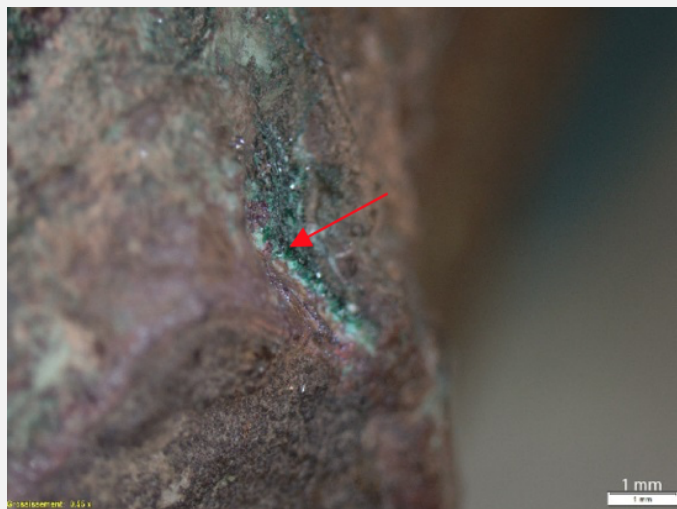
Fig. 13: Observation of the dark green corrosion product,

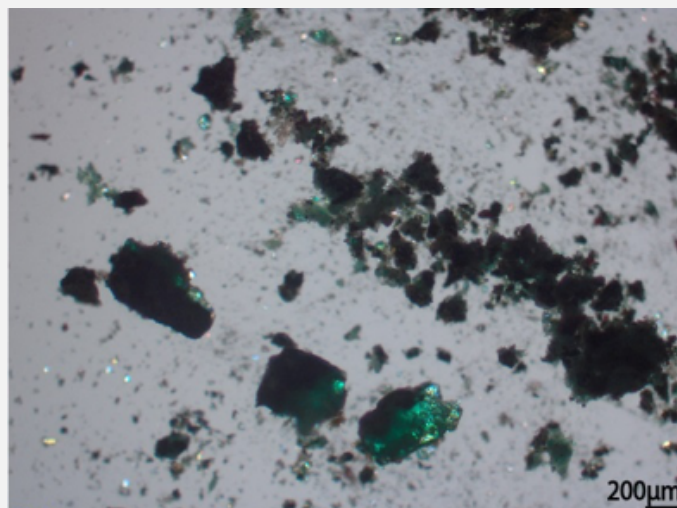
Fig. 14: Dark green corrosion product identified as paratacamite, atacamite $\text{Cu}_2\text{Cl}(\text{OH})_3$ by XRD. Microscopic examination under polarized light,

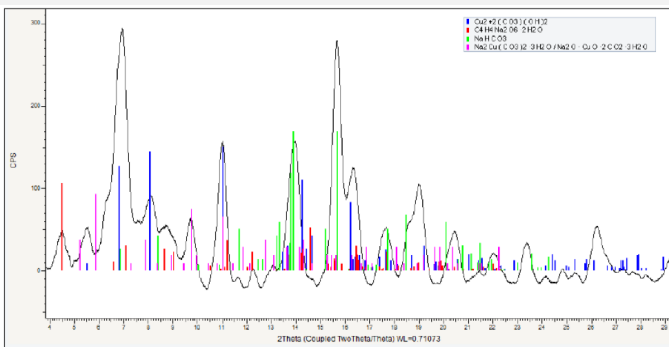
Fig. 23: XRD spectrum of the sample from the light blue corrosion product showing the presence of chalconatronite ($\text{Na}_2\text{Cu}(\text{CO}_3)_2 \cdot 3\text{H}_2\text{O}$). The other compounds are analysis supposition, but are not relevant,

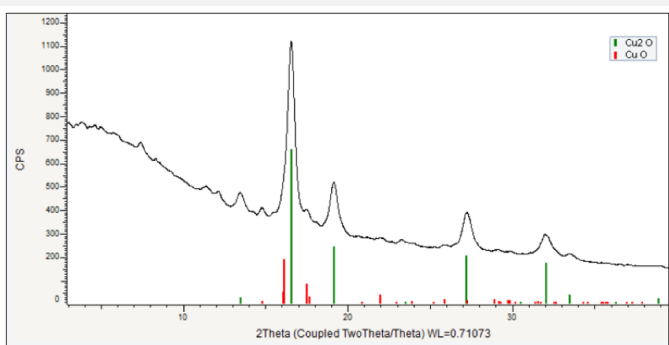
Fig. 24: XRD spectrum of the sample from the dark red corrosion product showing the presence of cuprite (Cu_2O) as major compound and tenorite (CuO) as minor compound,
