FRAGMENT OF AN AEGIS OF NEÏTH 1886.305.0096 – LEADED BRONZE

Artefact name	Fragment of an Aegis of Neïth 1886.305.0096
Authors	Line. Pedersen (HE-Arc, Neuchâtel, Neuchâtel, Switzerland) & Christian. Degrigny (HE-Arc CR, Neuchâtel, Neuchâtel, Switzerland) & Valentin. Boissonnas (HE-Arc CR, Neuchâtel, Neuchâtel, Switzerland)
Url	/artefacts/990/

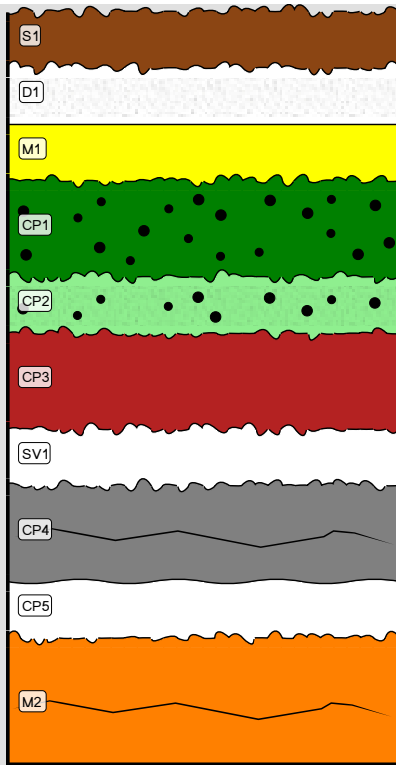
Fig.9: Schematic representation combining stratigraphies 1 and 2 under binocular microscope and using the MiCorr application. The characteristics of the strata are only accessible by clicking on the drawing that redirects you to the search tool by stratigraphy representation, Credit He-Arc CR, L.Pedersen.

The metal (M2 in Fig.9 and M1 in Fig. 10) was analysed on the broken edge of the bottom of the artefact where despite a highly corroded surface, the metal seems to be the best preserved. The XRF analyses revealed that the metal is a leaded bronze with remains of gold leaf on the surface (Table 1, Au was detected in the measurement spots 4,5 and 6) (Scott 2002; Gouda 2012; Mohammed 2012).

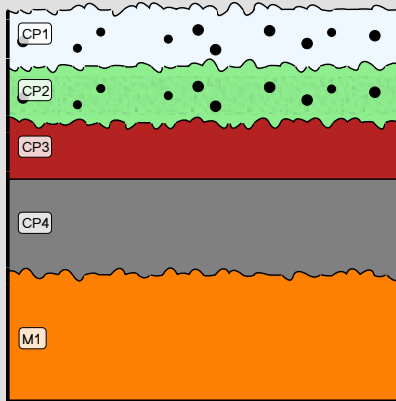
Fig.10: Schematic representation of stratigraphy 3 under binocular microscope and using the MiCorr application. CP1 is CP6 in Fig. 8. The characteristics of the strata are only accessible by clicking on the drawing that redirects you to the search tool by stratigraphy representation, Credit He-Arc CR, L. Pedersen.

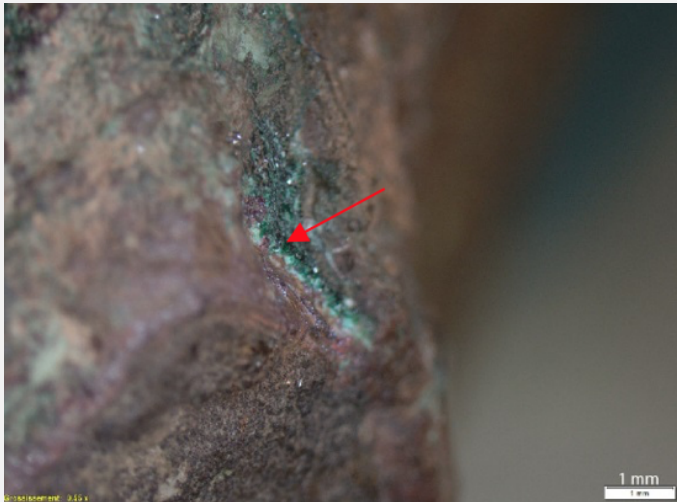
Fig. 13: Observation of the dark green corrosion product,

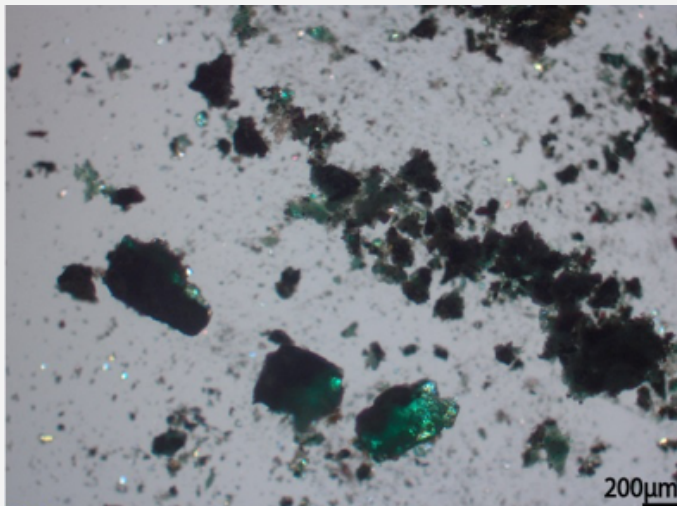
Fig. 14: Dark green corrosion product identified as paratacamite, atacamite $\text{Cu}_2\text{Cl}(\text{OH})_3$ by XRD. Microscopic examination under polarized light,
