FRAGMENT OF AN AEGIS OF NEITH 1886.305.0096 - LEADED BRONZE

Artefact name Fragment of an Aegis of Neith 1886.305.0096

Authors Line. Pedersen (HE-Arc, Neuchâtel, Neuchâtel, Switzerland) & Christian. Degrigny (HE-Arc CR, Neuchâtel, Neuchâtel, Switzerland) & Valentin. Boissonnas (HE-Arc CR, Neuchâtel, Neuchâtel, Switzerland)

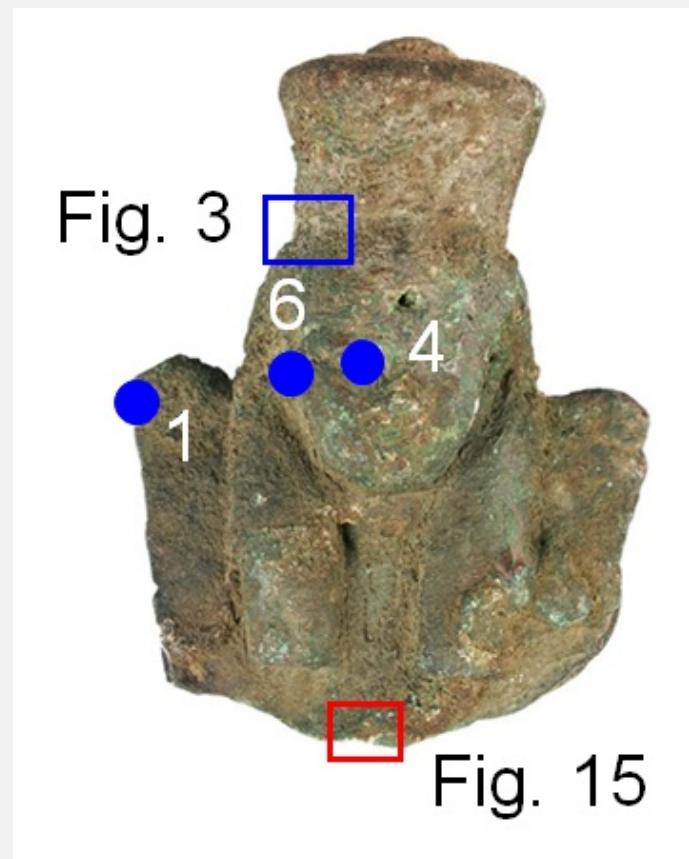
Fig. 2: Front face of the aegis with location of XRF measurements (blue spots), powder sample (red square) and gilding remains on the surface (blue square),

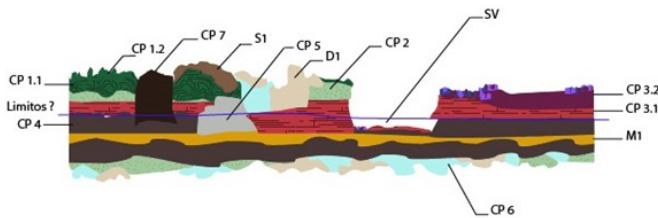
Fig. 7: Preliminary stratigraphy 2, corresponding to the back face of the aegis and interior (below part). S = soil, D = deposit, M = metal, CP = corrosion products, SV = structural void,

Captions	Colour, aspect, hardness and cohesion
S1	Brown, matte, can be scratched with scalpel blade but remains cohesive.
D1	White shiny deposit, powdery when shaved with scalpel.
CP1.1	Dark green corrosion layer, lumpy and matte, thick, hardly scratched by a scalpel blade, cohesive and compact.
CP1.2	Minor stratum of CP1.1. Dark green crystals appearing on the surface of the artefact. Easily scratched by a scalpel blade.
CP2	Light green corrosion layer, matte and thick in some places, powdery under the action of a scalpel blade. Sometimes located directly on CP4.
CP3.1	Red corrosion layer, lumpy and matte, thick, sometimes hard and sometimes powdery under the action of a scalpel blade.
CP3.2	Minor stratum of CP3.1. Purple with blue-purple crystals, hard and cohesive.
Limitos?	Interface of the limit of the original surface. Shiny, straight, black, manufacturing traces.
CP4	Dark grey with red or green reflection. Shiny, hard, straight, dense and with traces of engraving and possible inlays.

CP5	Isolated white stratum: waxy and very soft.
CP6	Light blue stratum, chalky. Isolated on the exterior surface and extends on the interior surface.
CP7	Isolated black stratum, very hard, straight and shiny.
SV: Structural Void	Void in CP4, resulting in loss of the limitos. Presence of CP1.2 crystals inside the void.
M1	Yellow stratum with metallic sheen, dense and hardly scratched by scalpel blade.

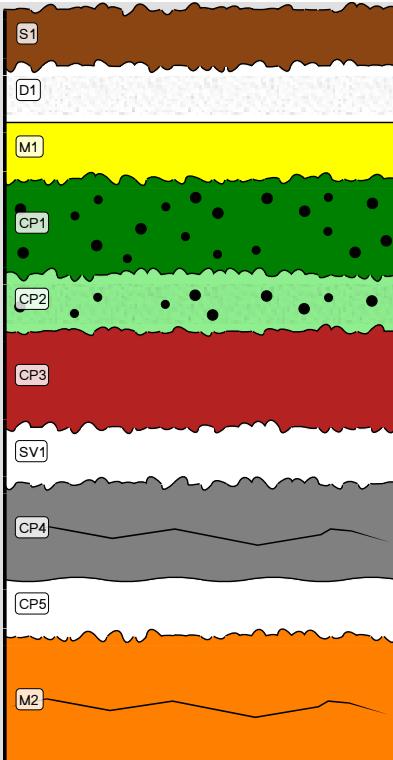
Fig.9: Schematic representation combining stratigraphies 1 and 2 under binocular microscope and using the MiCorr application. The characteristics of the strata are only accessible by clicking on the drawing that redirects you to the search tool by stratigraphy representation, Credit He-Arc CR, L.Pedersen.

The metal (M2 in Fig.9 and M1 in Fig. 10) was analysed on the broken edge of the bottom of the artefact where despite a highly corroded surface, the metal seems to be the best preserved. The XRF analyses revealed that the metal is a leaded bronze with remains of gold leaf on the surface (Table 1, Au was detected in the measurement spots 4,5 and 6) (Scott 2002; Gouda 2012; Mohammed 2012).

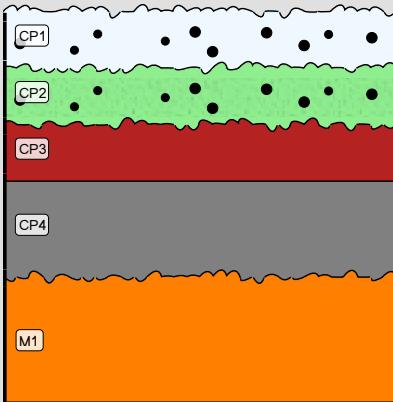
Fig.10: Schematic representation of stratigraphy 3 under binocular microscope and using the MiCorr application. CP1 is CP6 in Fig. 8. The characteristics of the strata are only accessible by clicking on the drawing that redirects you to the search tool by stratigraphy representation, Credit He-Arc CR, L. Pedersen.

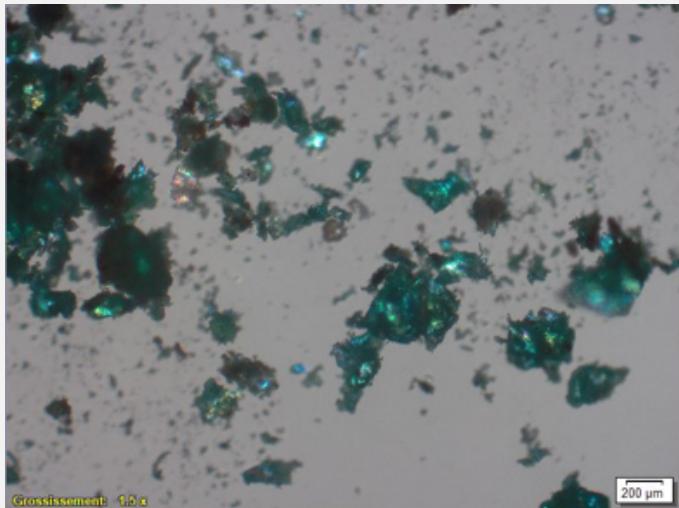
Fig. 16: Light green corrosion product identified as paratacamite, atacamite ($\text{Cu}_2\text{Cl}(\text{OH})_3$) by XRD. Microscopic examination under polarized light,

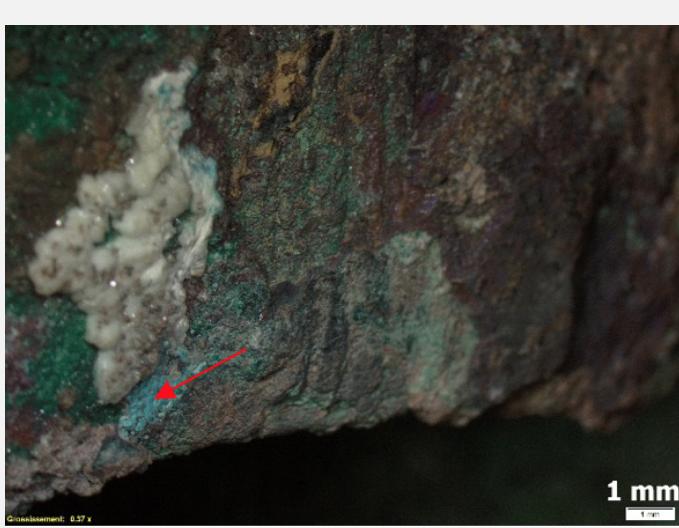
Fig. 17: Observation of the light blue corrosion product,

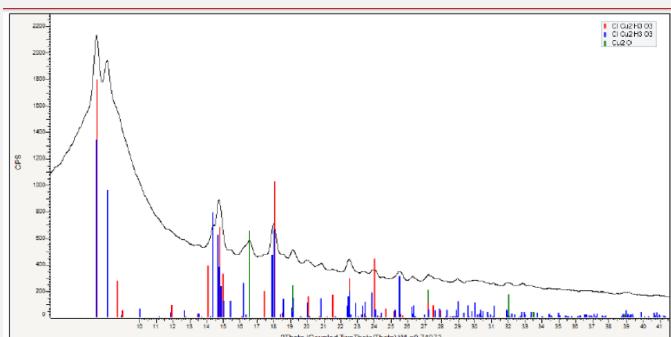
Fig. 21: XRD spectrum of the sample of the dark green corrosion product showing the presence of atacamite and paratacamite ($\text{Cu}_2\text{Cl}(\text{OH})_3$) as major compound and cuprite (Cu_2O) as minor compound,

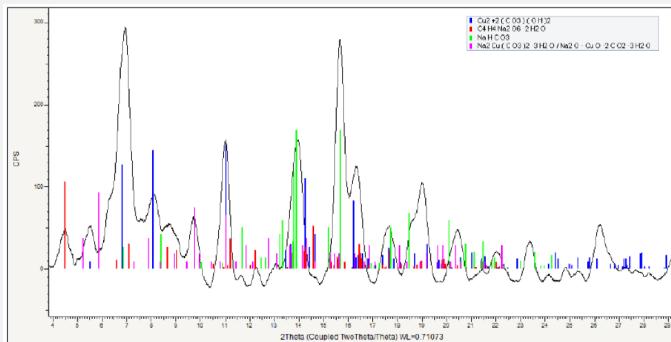
Fig. 23: XRD spectrum of the sample from the light blue corrosion product showing the presence of chalconatronite ($\text{Na}_2\text{Cu}(\text{CO}_3)_2 \cdot 3\text{H}_2\text{O}$). The other compounds are analysis supposition, but are not relevant,

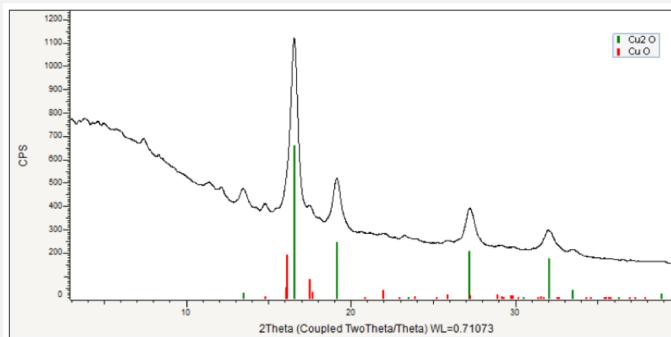
and waxy corrosion product close to the original surface. This observation and the presence of high amounts of copper oxychlorides led us to identify this white corrosion product as nantokite (CuCl). The localized light blue corrosion product (CP6 in Fig. 8, CP1 in Fig. 10) present in one area on the back (Figs. 17-18) was identified as chalconatronite ($\text{Na}_2\text{Cu}(\text{CO}_3)_2 \cdot 3\text{H}_2\text{O}$) (Fig. 23). The red corrosion layer (CP3) below the copper oxychlorides and above the dark black original surface (Figs. 19-20) was identified as a mixture of cuprite (Cu_2O) as major compound and tenorite (CuO) as minor compound (Fig. 24). It is possible that the tenorite was a contamination from the black surface below the cuprite layer.

Fig. 24: XRD spectrum of the sample from the dark red corrosion product showing the presence of cuprite (Cu_2O) as major compound and tenorite (CuO) as minor compound,
