FRAGMENT OF AN AEGIS OF NEÏTH 1886.305.0096 – LEADED BRONZE

Artefact name Fragment of an Aegis of Neïth 1886.305.0096

Authors Line. Pedersen (HE-Arc, Neuchâtel, Neuchâtel, Switzerland) & Christian. Degrigny (HE-Arc CR, Neuchâtel, Neuchâtel, Switzerland) & Valentin. Boissonnas (HE-Arc CR, Neuchâtel, Neuchâtel, Switzerland)

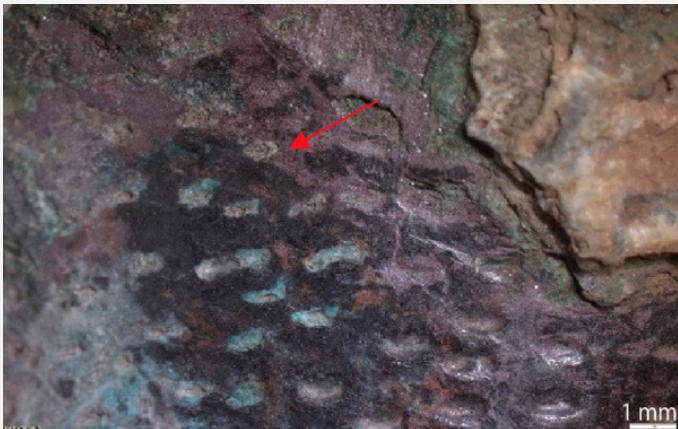
Fig. 19: Observation of the red corrosion product above the black original surface containing corresponding markers such as engravings,

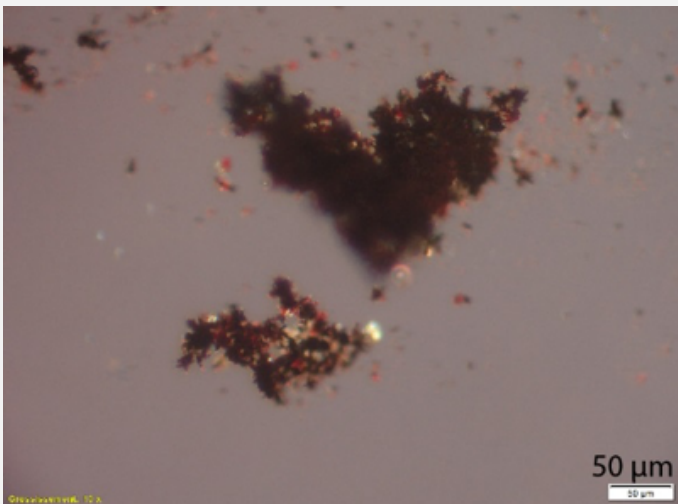
Fig. 20: Dark red corrosion product identified as cuprite Cu_2O as major component and tenorite CuO as minor component. Microscopic examination under polarized light,
