FRAGMENT OF AN AEGIS OF NEÏTH 1886.305.0096 – LEADED BRONZE

Artefact name Fragment of an Aegis of Neïth 1886.305.0096

Authors Line. Pedersen (HE-Arc, Neuchâtel, Neuchâtel, Switzerland) & Christian. Degriigny (HE-Arc CR, Neuchâtel, Neuchâtel, Switzerland) & Valentin. Boissonnas (HE-Arc CR, Neuchâtel, Neuchâtel, Switzerland)

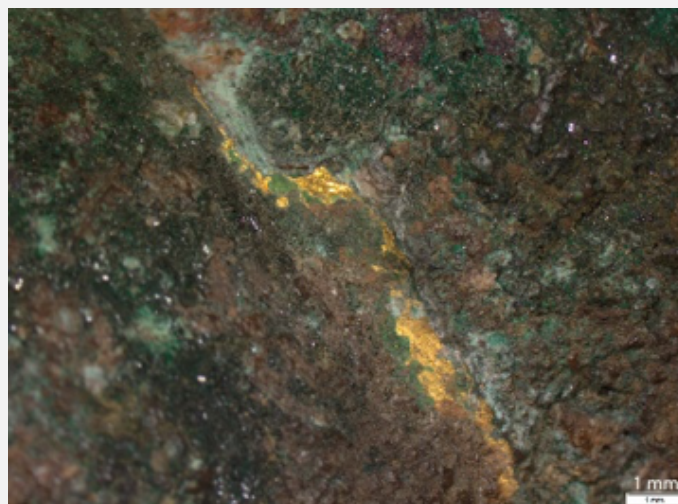
Fig. 3: Remains of foil-gilding on the corroded surface,

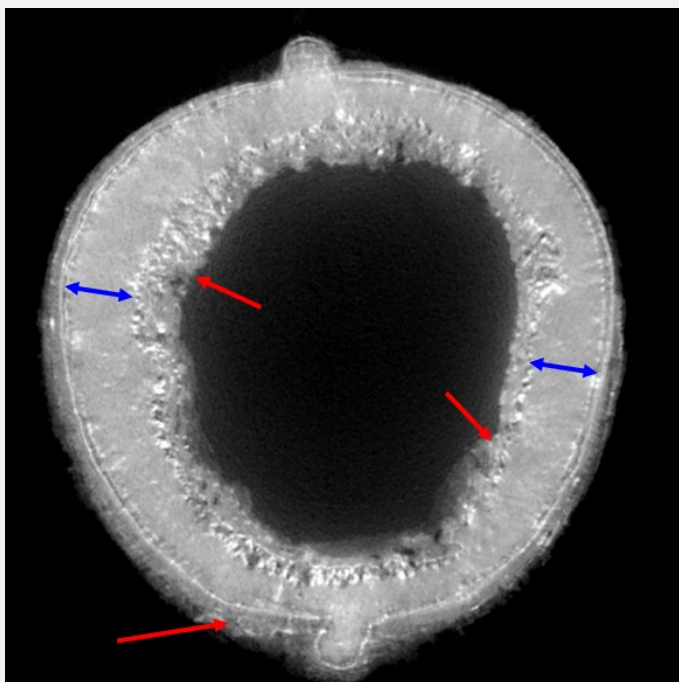
The metal seems to be a leaded bronze with remains of gold leaf on the surface (Table 1). As indicated by the X-ray tomography, the metal of the aegis seems to be well preserved (Figs. 11-12).

Fig. 11: X-ray tomography by cross section of the crown showing a dense and non-porous metal core (blue arrows). The corrosion products however are porous (red arrows). The external limit is visible as a fine line preserved under corrosion layers,

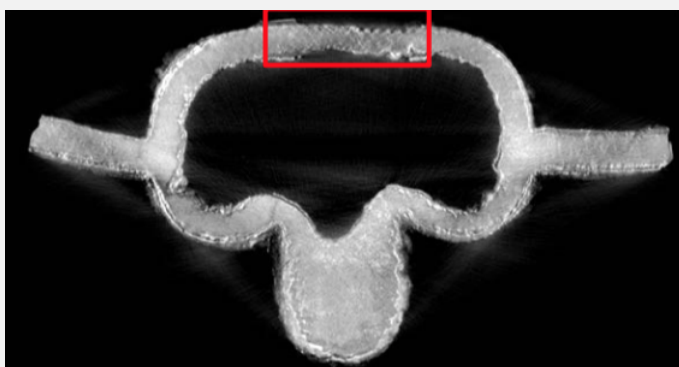
Fig. 12: X-ray tomography by cross section of the lower part showing that there are losses of the original surface (red square),

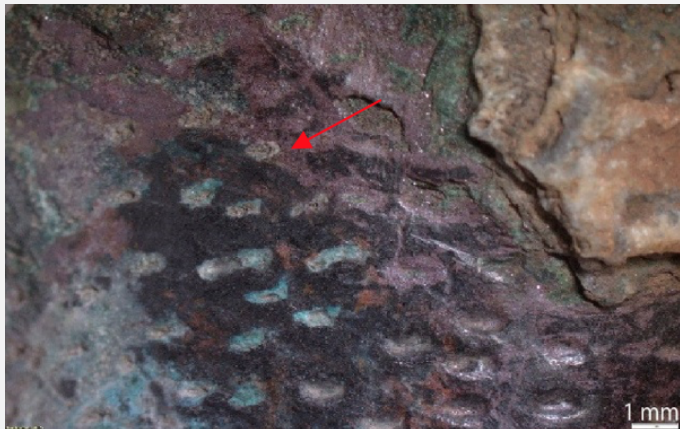
Fig. 20: Dark red corrosion product identified as cuprite Cu₂O as major component and tenorite CuO as minor component. Microscopic examination under polarized light,

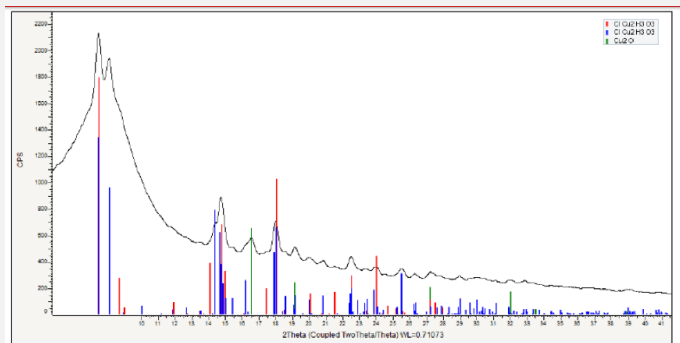
Fig. 21: XRD spectrum of the sample of the dark green corrosion product showing the presence of atacamite and paratacamite (Cu₂Cl(OH)₃) as major compound and cuprite (Cu₂O) as minor compound,
