FRAGMENT OF AN AEGIS OF NEÏTH 1886.305.0096 – LEADED BRONZE

Artefact name	Fragment of an Aegis of Neïth 1886.305.0096
Authors	Line. Pedersen (HE-Arc, Neuchâtel, Neuchâtel, Switzerland) & Christian. Degriigny (HE-Arc CR, Neuchâtel, Neuchâtel, Switzerland) & Valentin. Boissonnas (HE-Arc CR, Neuchâtel, Neuchâtel, Switzerland)
Url	/artefacts/990/

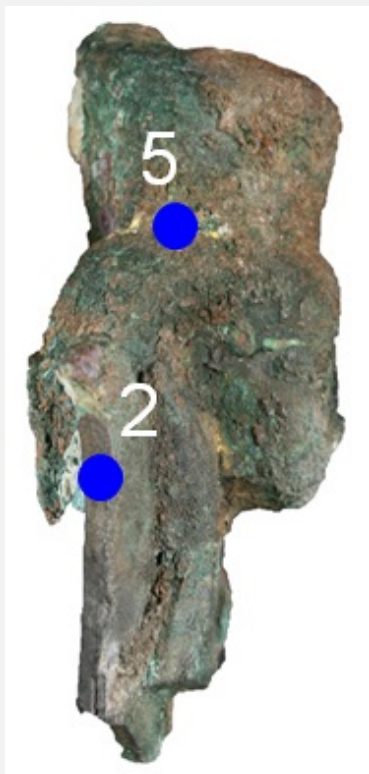
Fig. 4: Side view of the aegis with location of XRF measurements (blue spots),

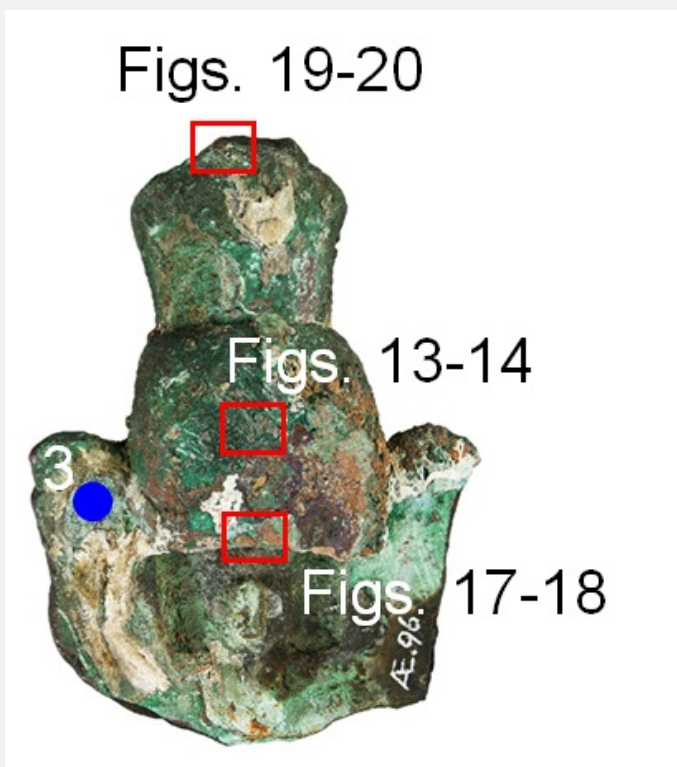
Fig. 5: Back face of the aegis with location of XRF measurement (blue spot) and powder samples (red squares),

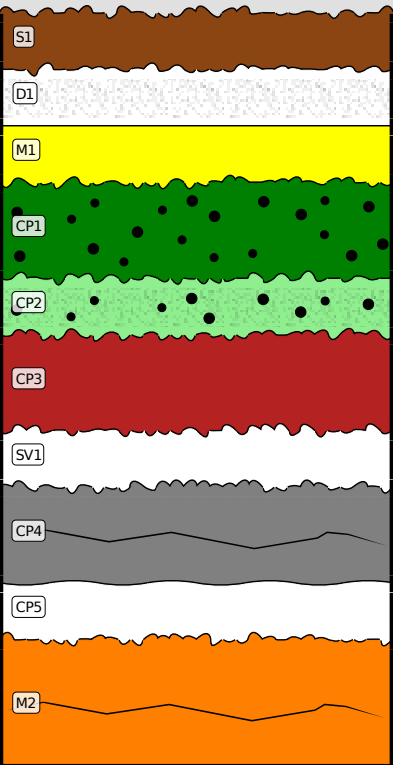
Fig.9: Schematic representation combining stratigraphies 1 and 2 under binocular microscope and using the MiCorr application. The characteristics of the strata are only accessible by clicking on the drawing that redirects you to the search tool by stratigraphy representation, Credit He-Arc CR, L.Pedersen.

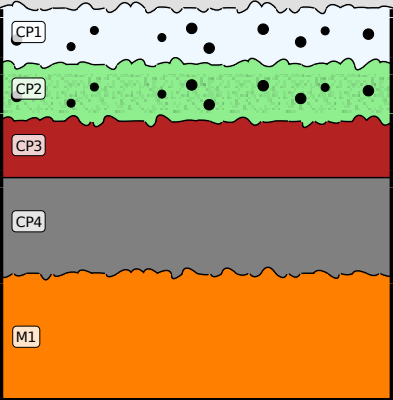
Fig.10: Schematic representation of stratigraphy 3 under binocular microscope and using the MiCorr application. CP1 is CP6 in Fig. 8. The characteristics of the strata are only accessible by clicking on the drawing that redirects you to the search tool by stratigraphy representation, Credit He-Arc CR, L. Pedersen.

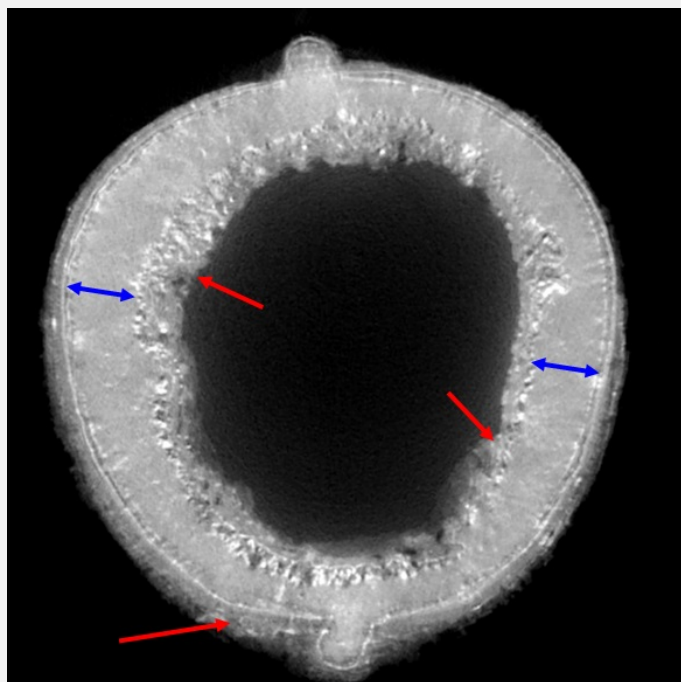
The metal seems to be a leaded bronze with remains of gold leaf on the surface (Table 1).
As indicated by the X-ray tomography, the metal of the aegis seems to be well preserved (Figs. 11-12).

Fig. 11: X-ray tomography by cross section of the crown showing a dense and non-porous metal core (blue arrows). The corrosion products however are porous (red arrows). The external limit is visible as a fine line preserved under corrosion layers,

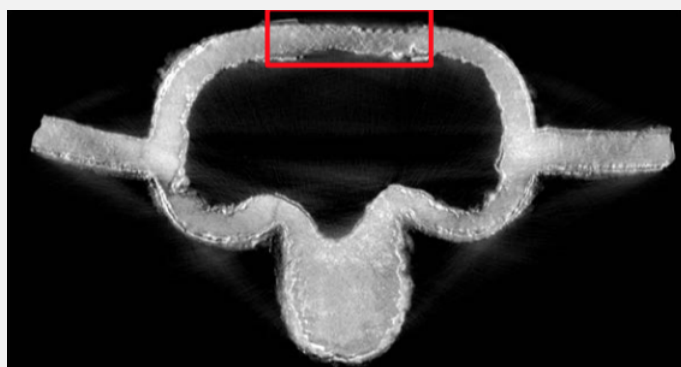
Fig. 12: X-ray tomography by cross section of the lower part showing that there are losses of the original surface (red square),

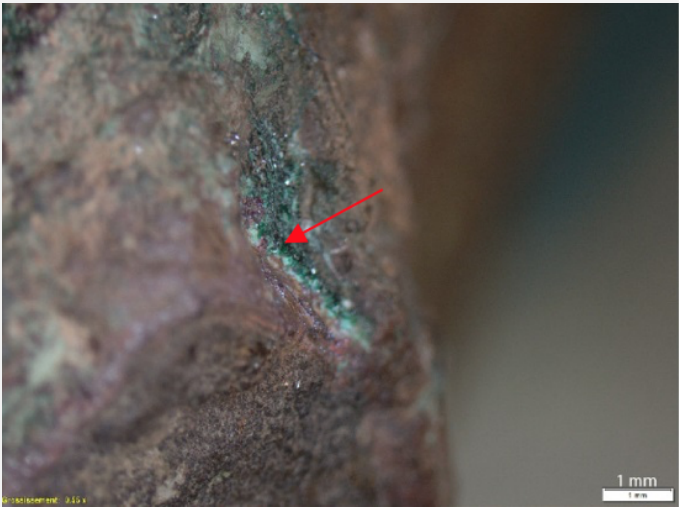
Fig. 13: Observation of the dark green corrosion product,

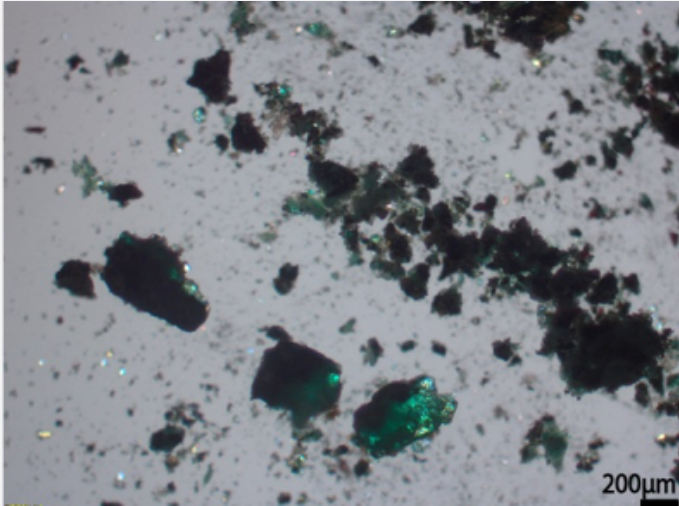
Fig. 14: Dark green corrosion product identified as paratacamite, atacamite Cu2Cl(OH)3 by XRD. Microscopic examination under polarized light,
