FRAGMENT OF AN AEGIS OF NEÏTH 1886.305.0096 – LEADED BRONZE

Artefact name Fragment of an Aegis of Neïth 1886.305.0096

Authors Line. Pedersen (HE-Arc, Neuchâtel, Neuchâtel, Switzerland) & Christian. Degrigny (HE-Arc CR, Neuchâtel, Neuchâtel, Switzerland) & Valentin. Boissonnas (HE-Arc CR, Neuchâtel, Neuchâtel, Switzerland)

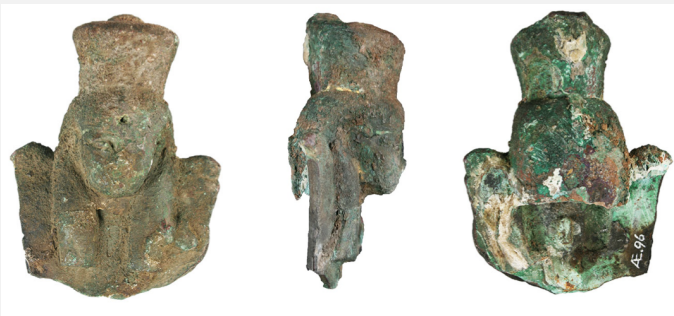
Fig. 1: Fragment of an Aegis of Neïth. From left to right: front, side view and back respectively,

Description of the artefact Fragment of an aegis surmounted by the head of Neïth, the Egyptian goddess of war (Fig. 1). Traces of leaf gilding is still present in certain areas (Fig. 3). The lower part of the collar and the upper part of the crown are broken (Fig. 2 and 4). The surface is covered with a thick and hard, green-brown corrosion crust (Fig. 2, 3 and 4). A cross-section was studied on the lower edge that was broken after excavation. Dimensions: L = 96mm; W = 72mm; T = 40mm; WT = 216g.

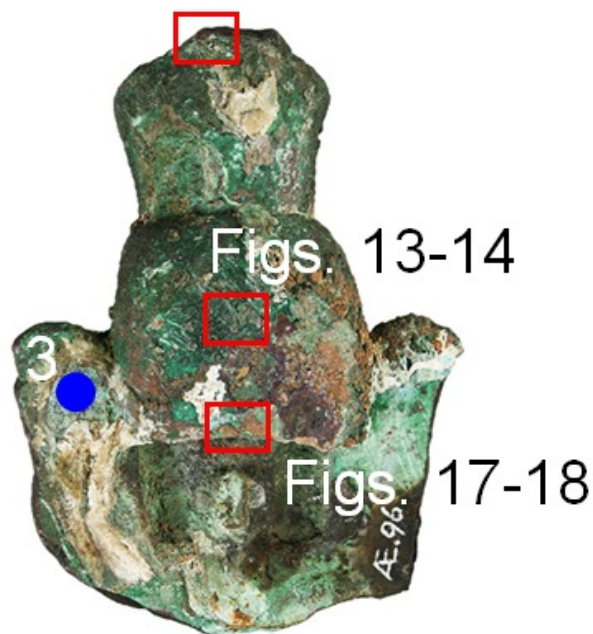
Fig. 5: Back face of the aegis with location of XRF measurement (blue spot) and powder samples (red squares),

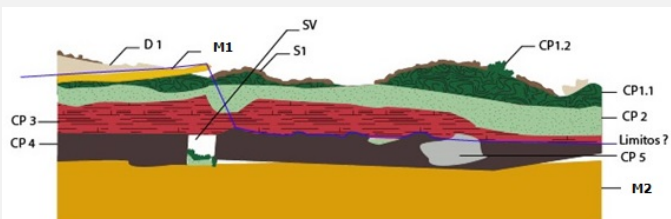
Fig. 6: Preliminary stratigraphy 1, corresponding to the front face of the aegis. S = soil, D = deposit, M = metal, CP = corrosion products, SV = structural void,

Captions	Colour, aspect, hardness and cohesion
S1	Brown, matte, can be scratched with scalpel blade but remains cohesive.
D1	White deposit: shiny, powdery when shaved with scalpel.
M1	Thin gold leaf trapped in corrosion products, brittle, yellow and not adherent.
CP1.1	Dark green corrosion layer, lumpy and matte, thick, hardly scratched by a scalpel blade, cohesive and compact.
CP1.2	Minor stratum of CP1.1. Dark green crystals appearing on the surface of the artefact. Easily scratched under the action a scalpel blade.
CP2	Light green corrosion layer, matte, thick in some places, powdery under the action of a scalpel blade. In some areas it is located directly on CP4.
CP3	Red corrosion layer, lumpy and matte, thick, sometimes hard and sometimes powdery under the action of a scalpel blade.
Limitos	Interface of the limit of the original surface. Shiny, straight and black with manufacturing traces.
CP4	Dark grey with red or green reflection. Shiny, hard, straight, dense and with traces of engraving and possible inlays.

CP5	Isolated white corrosion products: waxy and very soft.
SV	Void in CP4 resulting in loss of the limitos.
M2	Yellow stratum with metallic sheen, dense and hardly scratched by scalpel blade.

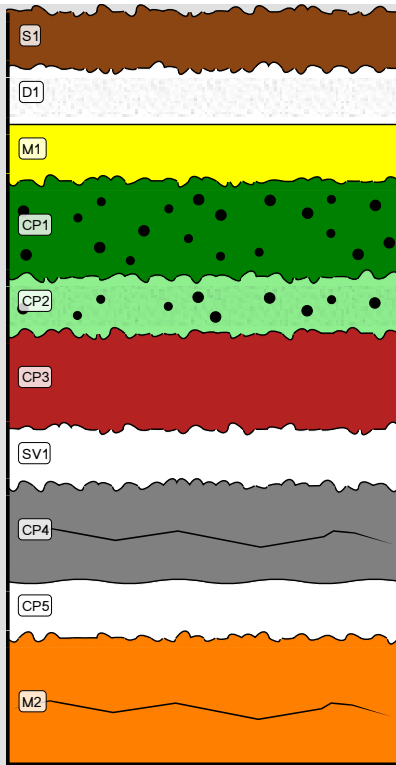
Fig.9: Schematic representation combining stratigraphies 1 and 2 under binocular microscope and using the MiCorr application. The characteristics of the strata are only accessible by clicking on the drawing that redirects you to the search tool by stratigraphy representation, Credit He-Arc CR, L.Pedersen.

The metal (M2 in Fig.9 and M1 in Fig. 10) was analysed on the broken edge of the bottom of the artefact where despite a highly corroded surface, the metal seems to be the best preserved. The XRF analyses revealed that the metal is a leaded bronze with remains of gold leaf on the surface (Table 1, Au was detected in the measurement spots 4,5 and 6) (Scott 2002; Gouda 2012; Mohammed 2012).

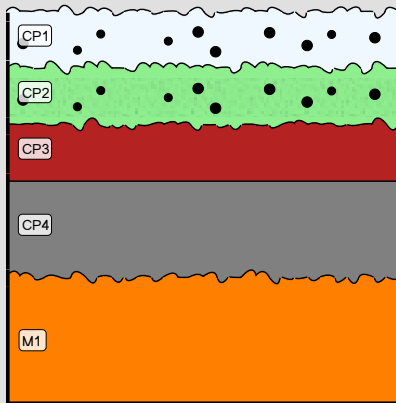
Fig.10: Schematic representation of stratigraphy 3 under binocular microscope and using the MiCorr application. CP1 is CP6 in Fig. 8. The characteristics of the strata are only accessible by clicking on the drawing that redirects you to the search tool by stratigraphy representation, Credit He-Arc CR, L. Pedersen.

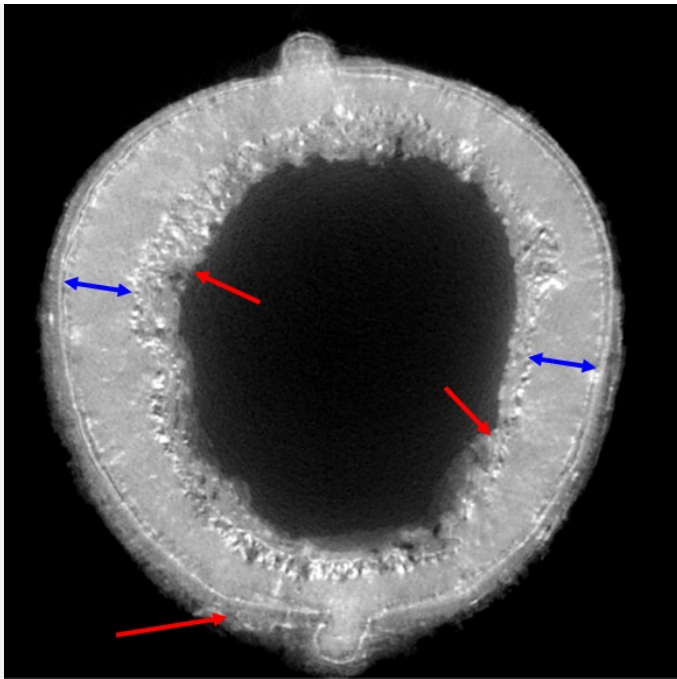
As indicated by the X-ray tomography, the metal of the aegis seems to be well preserved (Figs. 11-12).

Fig. 11: X-ray tomography by cross section of the crown showing a dense and non-porous metal core (blue arrows). The corrosion products however are porous (red arrows). The external limit is visible as a fine line preserved under corrosion layers,

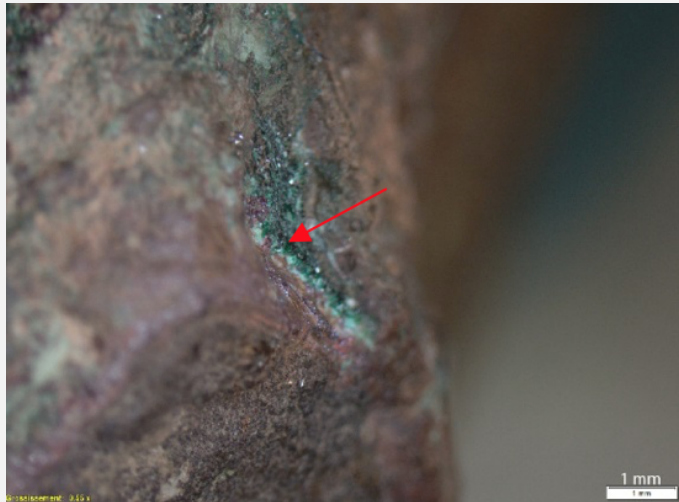
Fig. 13: Observation of the dark green corrosion product,

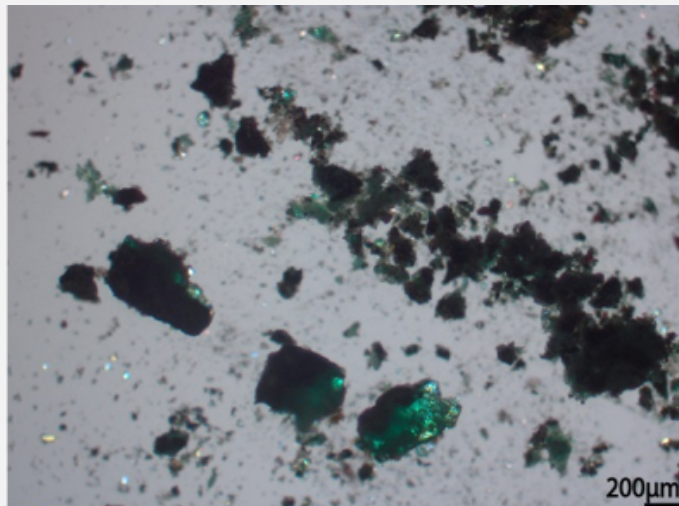
Fig. 14: Dark green corrosion product identified as paratacamite, atacamite $\text{Cu}_2\text{Cl}(\text{OH})_3$ by XRD. Microscopic examination under polarized light,

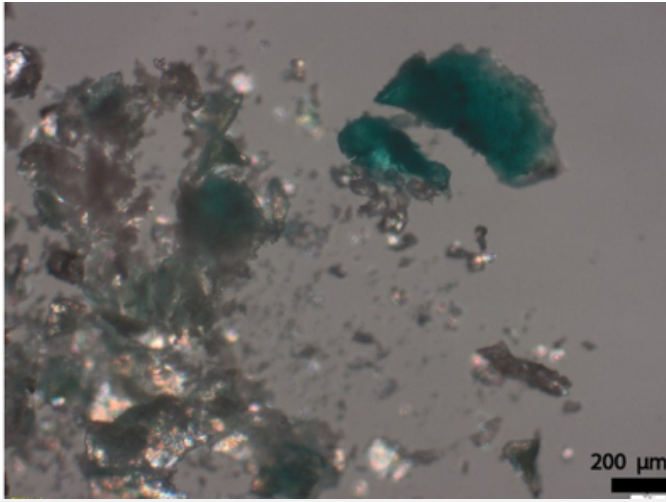
Fig. 18: Light blue corrosion product identified as chalconatronite $\text{Na}_2\text{Cu}(\text{CO}_3)_2 \cdot 3\text{H}_2\text{O}$ by XRD. Microscopic examination under polarized light,

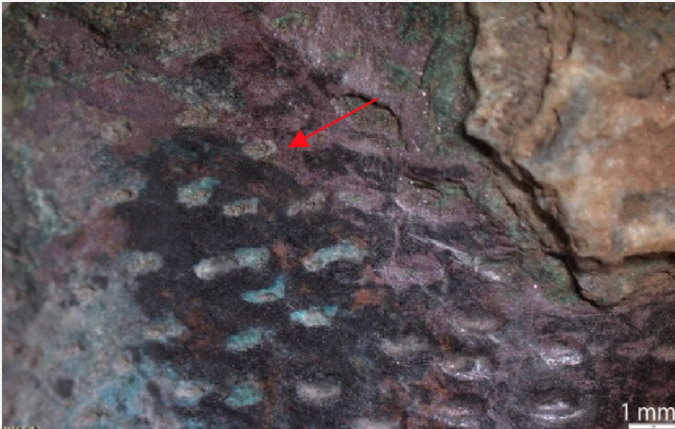
Fig. 19: Observation of the red corrosion product above the black original surface containing corresponding markers such as engravings,
