LEAD CAMES OF A STAINED GLASS WINDOW 52583 – PB SB ALLOY – UNKNOWN – SWITZERLAND

Artefact name Lead comes of a stained glass window 52583

Authors Alice Gerber. (Haute École Arc Neuchâtel, Neuchâtel, Neuchâtel, Switzerland)

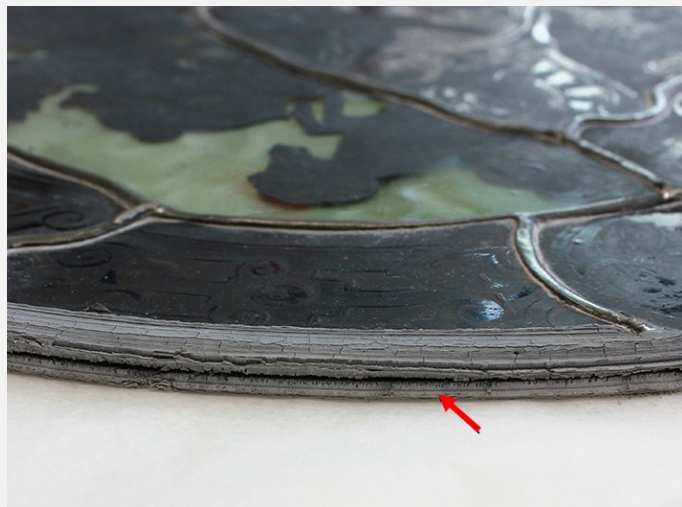
In 2009 two stained glass panels were placed in a showcase for a permanent exhibition, the lead came were then in a good conservation condition. In 2018, the lead showed voluminous efflorescence of white, powdery corrosion products.

The environment of this showcase contained a high level of acetic acid. Lead being sensitive to organic acids, it corroded strongly. This is not new, but what is interesting here is that the two objects corroded in a very heterogeneous way. One lead came may be deformed and completely covered with bulky white efflorescences, and the one next to it shows no corrosion.

The "stokar" window, which is of interest here, was restored in 2008, just before it was put on display. The restoration consisted of replacing some of the lead comes. Thus, while the object is dated to the 16th century, the replaced comes were new when they entered the display case. In 2018, they were completely corroded. In comparison, the other stained glass panel, with older lead comes, was placed in the same display case at the same time. For this second panel, the comes are slightly corroded in 2018, but not as badly as those of the 'Stokar' panel. The metal chosen by the restorer reacted more strongly with the corrosive environment (the display case) than the historical metal.

Fig. 2: Corroded "modern" lead came on the "Stokar" stained glass panel with location of the sampling area,

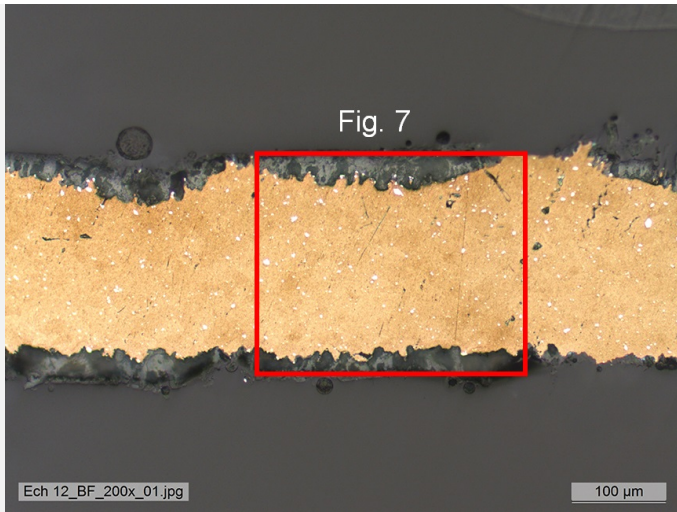
Fig. 5: Micrograph of the cross-section of the corroded lead came with location of Fig. 7, unetched, dark field. The grains of the metal are slightly visible, and the light-coloured dots in the alloy are inclusions,

The sample is a piece of metal taken from the corroded lead came of the stained glass (Fig. 2). This came was replaced during the 2009 restoration. The purpose was to understand why this new metal has been completely corroded in a few years (Fig. 2, 3 and 5), while the historical metal next to it is not affected at all.

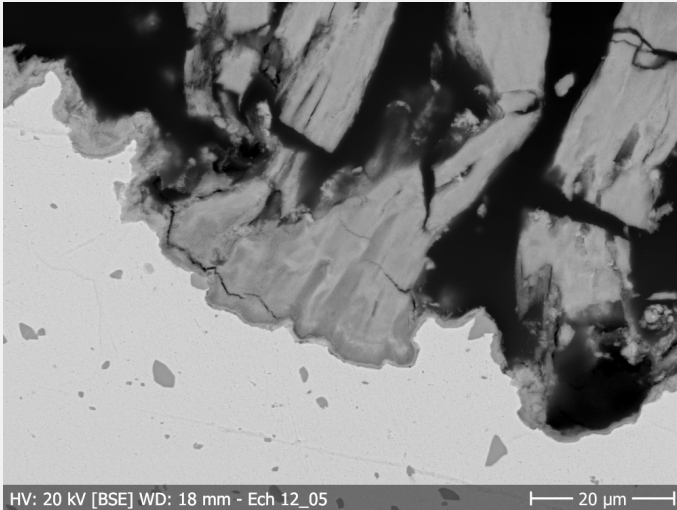
CP1 seems to be a heterogeneous compound as indicated on Figs. 8 and 9. It is heavily cracked (Fig. 9). EDX analyses do not indicate a significant difference in composition. The attack of lead by organic acids causes the formation of salts, such as lead acetate which are then transformed into basic lead carbonates by the action of CO₂ from the environment as indicated by FTIR analysis of CP1.

Fig. 9: SEM image (BSE mode) of the cross-section of the corroded lead came,

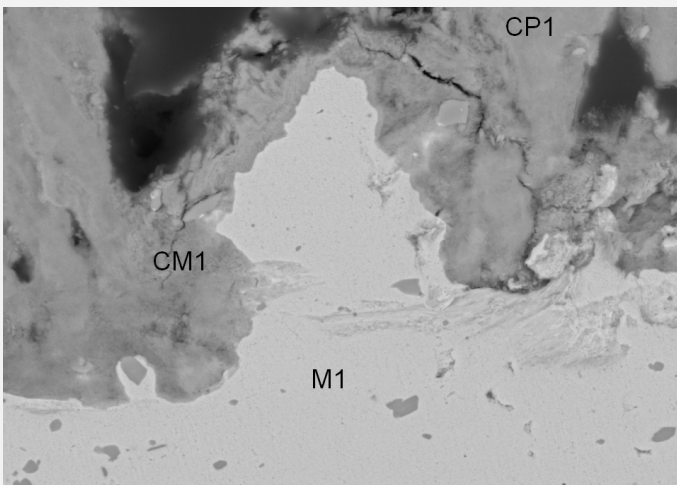
Corrosion develops specifically on comes made of a lead-antimony alloy, where antimony inclusions constitute the cathode (0.150 V/SHE) versus lead (-0.125 V/SHE) which corrodes as an anode in presence of lead acetate (the electrolyte). Fig. 8 shows that corrosion does not attack the antimony nodules in the alloy, it progresses by mineralizing the lead around these nodules.

Fig. 8: SEM image (BSE mode) of a detail of the cross-section of the corroded lead came. The area in light grey is the metal, the corrosion is in darker grey with a blurred appearance. Sb-dots are dark grey. Corrosion progresses around them, without mineralising them,

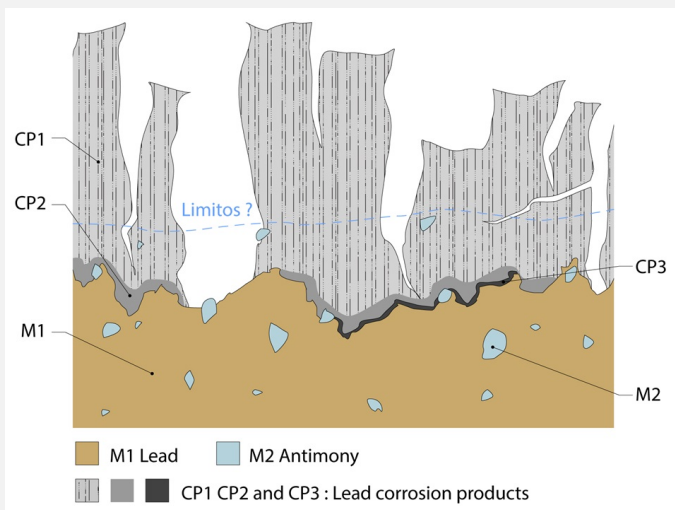
Fig. 11 shows an optimised stratigraphic representation of the corrosion structure. It is to be noted that CP1, CP2 and CP3 although visible on some cross-sections (Fig. 9) could not be differentiated by analysis.

The limit of the original surface lies somewhere in the corrosion layers. Antimony nodules are inferior markers of the limit of the original surface.

Fig. 11: Optimised stratigraphic representation of a corroded lead came integrating additional information based on the analyses carried out,
