LEAD CAMES OF A STAINED GLASS WINDOW 52583 – PB SB ALLOY – UNKNOWN – SWITZERLAND

Artefact name Lead comes of a stained glass window 52583

Authors Alice Gerber. (Haute École Arc Neuchâtel, Neuchâtel, Neuchâtel, Switzerland)

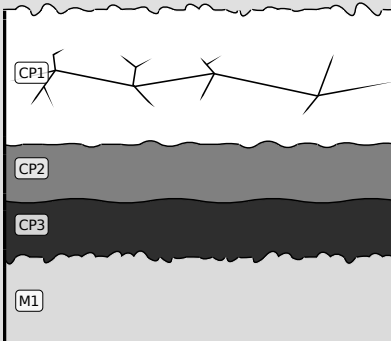
Fig. 4: Stratigraphic representation of the corrosion structure of the lead came observed macroscopically under binocular microscope using the MiCorr application. The characteristics of the strata are only accessible by clicking on the drawing that redirects you to the search tool by stratigraphy representation, Credit HE-Arc CR, A.Gerber.

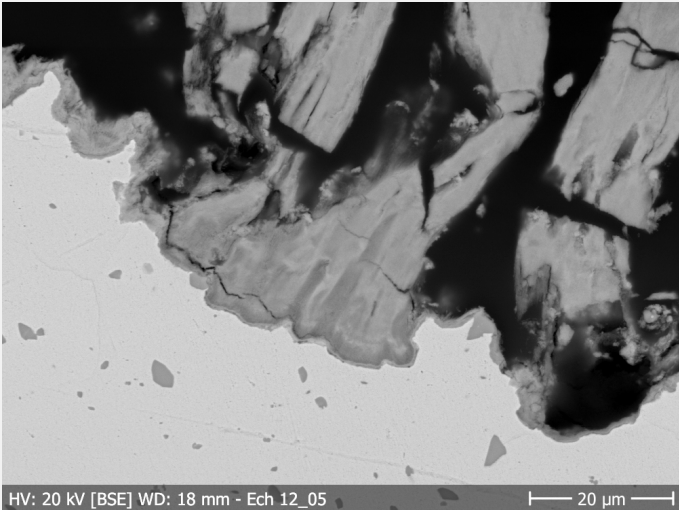
CP1 seems to be an heterogeneous compound as indicated on Figs. 8 and 9. It is heavily cracked (Fig. 9). EDX analyses do not indicate a significant difference in composition. The attack of lead by organic acids causes the formation of salts, such as lead acetate which are then transformed into basic lead carbonates by the action of CO2 from the environment as indicated by FTIR analysis of CP1.

Fig. 9: SEM image (BSE mode) of the cross-section of the corroded lead came,

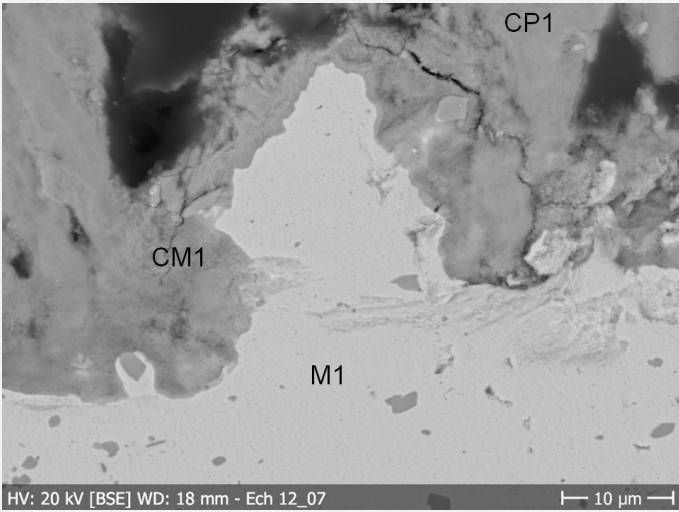
Corrosion develops specifically on comes made of a lead-antimony alloy, where antimony inclusions constitute the cathode (0.150 V/SHE) versus lead (-0.125 V/SHE) which corrodes as an anode in presence of lead acetate (the electrolyte). Fig. 8 shows that corrosion does not attack the antimony nodules in the alloy, it progresses by mineralizing the lead around these nodules.

Fig. 8: SEM image (BSE mode) of a detail of the cross-section of the corroded lead came. The area in light grey is the metal, the corrosion is in darker grey with a blurred appearance. Sb-dots are dark grey. Corrosion progresses around them, without mineralising them,

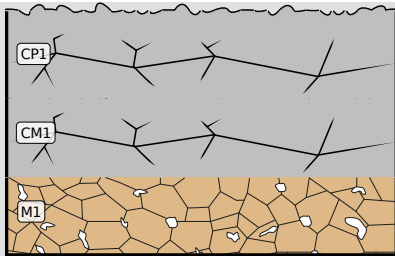
Fig. 10: Stratigraphic representation of the lead came in cross-section (dark field) using the MiCorr application with

reference to Fig. 8. The characteristics of the strata are only accessible by clicking on the drawing that redirects you to the search tool by stratigraphy representation, Credit HE-Arc CR, A.Gerber

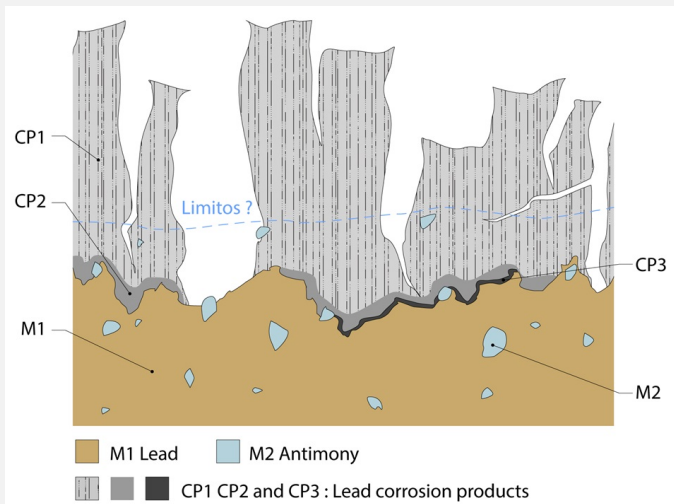
Fig. 11 shows an optimised stratigraphic representation of the corrosion structure. It is to be noted that CP1, CP2 and CP3 although visible on some cross-sections (Fig. 9) could not be differentiated by analysis.

The limit of the original surface lies somewhere in the corrosion layers. Antimony nodules are inferior markers of the limit of the original surface.

Fig. 11: Optimised stratigraphic representation of a corroded lead came integrating additional information based on the analyses carried out,
