LEAD CAMES OF A STAINED GLASS WINDOW 52583 – PB SB ALLOY – UNKNOWN – SWITZERLAND

Artefact name Lead comes of a stained glass window 52583

Authors Alice Gerber. (Haute École Arc Neuchâtel, Neuchâtel, Neuchâtel, Switzerland)

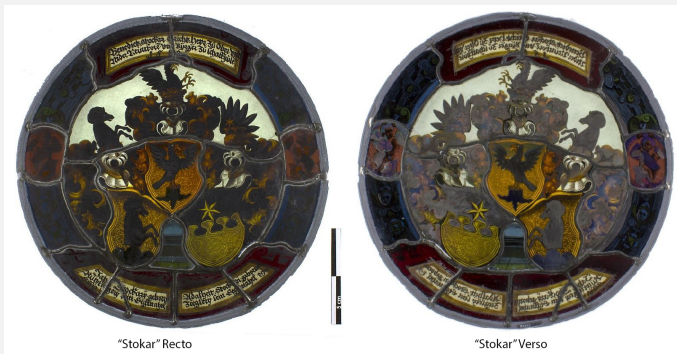
Fig. 1: Stained glass panel "Stokar" both sides,

The object is made of incolor and colored glass (light blue, pink and red) decored with grisaille, silver yellow stain and blue enamel. The glass parts are crimped with lead-alloy comes. The comes are fastened to one another by welding points of a lead-tin alloy on both side of the panel (Fig. 1).

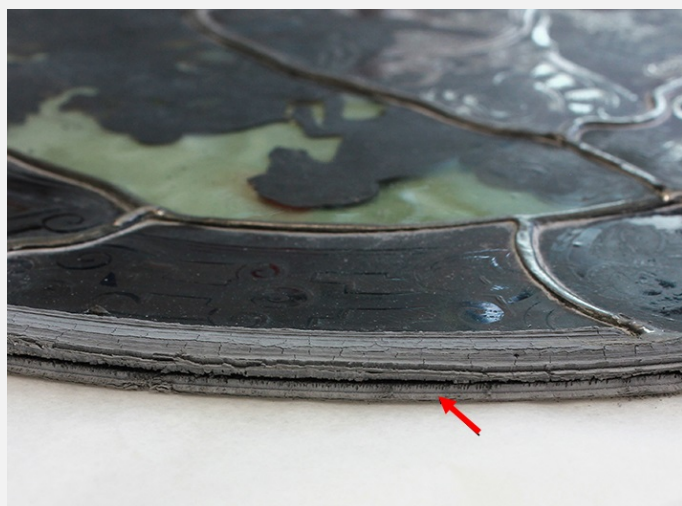
In 2009 two stained glass panels were placed in a showcase for a permanent exhibition, the lead came were then in a good conservation condition. In 2018, the lead showed voluminous efflorescence of white, powdery corrosion products.

The environment of this showcase contained a high level of acetic acid. Lead being sensitive to organic acids, it corroded strongly. This is not new, but what is interesting here is that the two objects corroded in a very heterogeneous way. One lead came may be deformed and completely covered with bulky white efflorescences, and the one next to it shows no corrosion.

The "stokar" window, which is of interest here, was restored in 2008, just before it was put on display. The restoration consisted of replacing some of the lead came. Thus, while the object is dated to the 16th century, the replaced came were new when they entered the display case. In 2018, they were completely corroded. In comparison, the other stained glass panel, with older lead came, was placed in the same display case at the same time. For this second panel, the came are slightly corroded in 2018, but not as badly as those of the 'Stokar' panel. The metal chosen by the restorer reacted more strongly with the corrosive environment (the display case) than the historical metal.

Fig. 2: Corroded "modern" lead came on the "Stokar" stained glass panel with location of the sampling area,

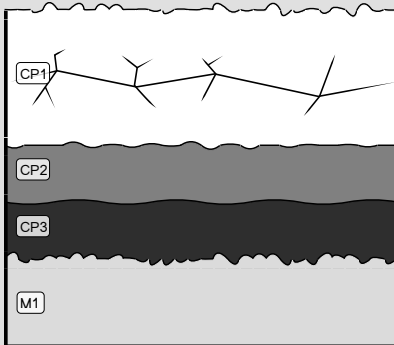
Fig. 4: Stratigraphic representation of the corrosion structure of the lead came observed macroscopically under binocular microscope using the MiCorr application. The characteristics of the strata are only accessible by clicking on the drawing that redirects you to the search tool by stratigraphy representation, Credit HE-Arc CR, A.Gerber.

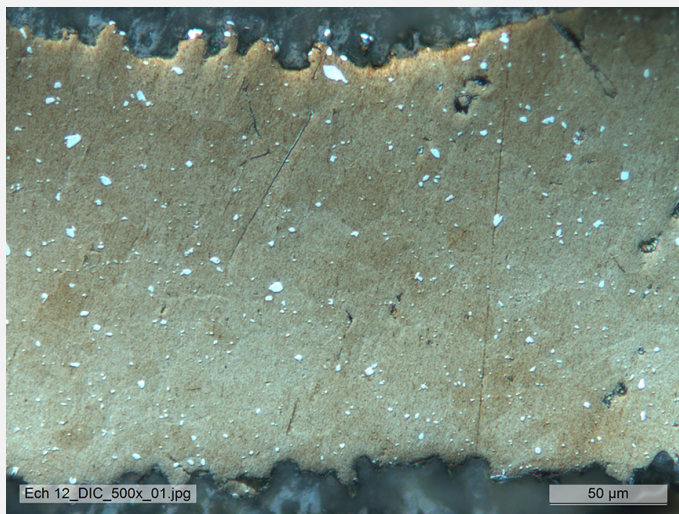
The lead alloy contains approximately 1.5% antimony. The grains of the metal are slightly visible, even without etching. The light-coloured dots in the alloy are Sb-rich inclusions (Fig. 7).

Fig. 7: Micrograph (detail of Fig. 5), unetched, dark field,

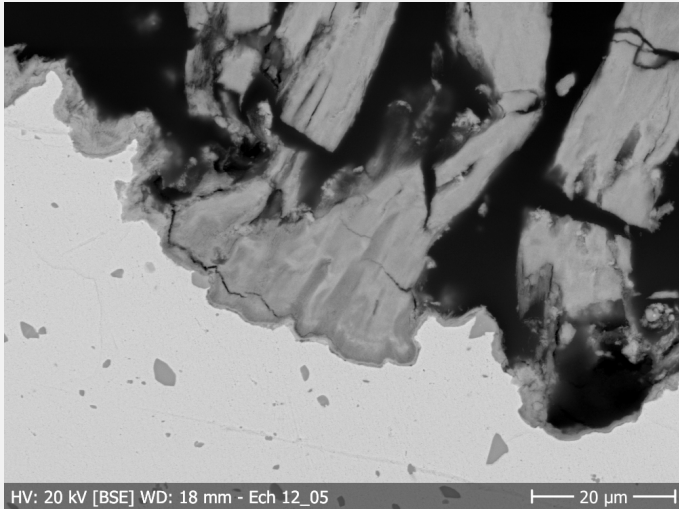
CP1 seems to be a heterogeneous compound as indicated on Figs. 8 and 9. It is heavily cracked (Fig. 9). EDX analyses do not indicate a significant difference in composition. The attack of lead by organic acids causes the formation of salts, such as lead acetate which are then transformed into basic lead carbonates by the action of CO₂ from the environment as indicated by FTIR analysis of CP1.

Fig. 9: SEM image (BSE mode) of the cross-section of the corroded lead came,

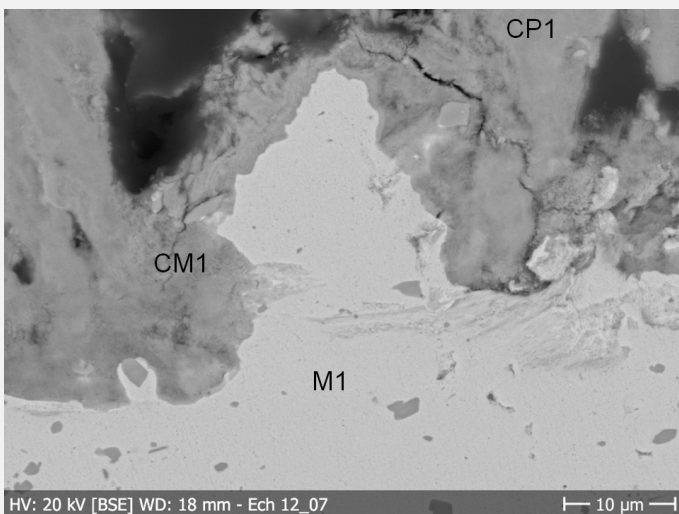
Corrosion develops specifically on comes made of a lead-antimony alloy, where antimony inclusions constitute the cathode (0.150 V/SHE) versus lead (-0.125 V/SHE) which corrodes as an anode in presence of lead acetate (the electrolyte). Fig. 8 shows that corrosion does not attack the antimony nodules in the alloy, it progresses by mineralizing the lead around these nodules.

Fig. 8: SEM image (BSE mode) of a detail of the cross-section of the corroded lead came. The area in light grey is the metal, the corrosion is in darker grey with a blurred appearance. Sb-dots are dark grey. Corrosion progresses around them, without mineralising them,

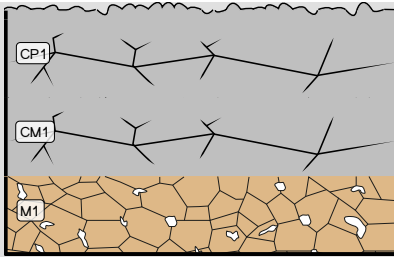
Fig. 10: Stratigraphic representation of the lead came in cross-section (dark field) using the MiCorr application with reference to Fig. 8. The characteristics of the strata are only accessible by clicking on the drawing that redirects you to the search tool by stratigraphy representation, Credit HE-Arc CR, A.Gerber
