LEAD CAMES OF A STAINED GLASS WINDOW 52583 – PB SB ALLOY – UNKNOWN – SWITZERLAND

Artefact name Lead comes of a stained glass window 52583

Authors Alice Gerber. (Haute École Arc Neuchâtel, Neuchâtel, Neuchâtel, Switzerland)

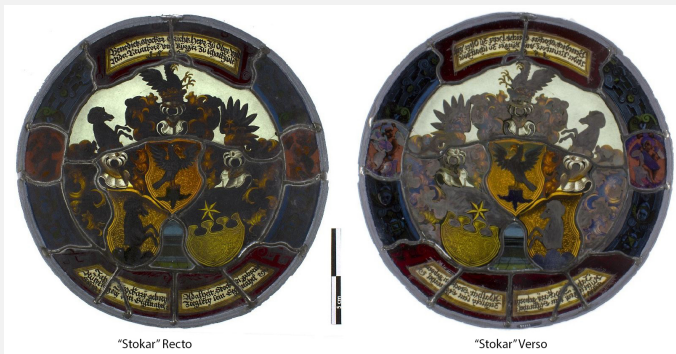
Fig. 1: Stained glass panel "Stokar" both sides,

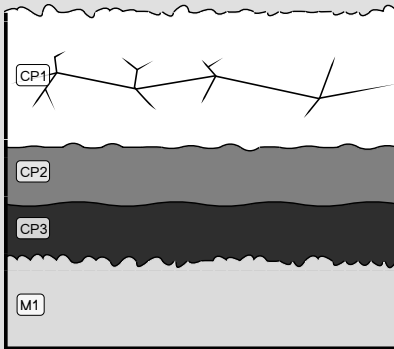
Fig. 4: Stratigraphic representation of the corrosion structure of the lead came observed macroscopically under binocular microscope using the MiCorr application. The characteristics of the strata are only accessible by clicking on the drawing that redirects you to the search tool by stratigraphy representation, Credit HE-Arc CR, A.Gerber.

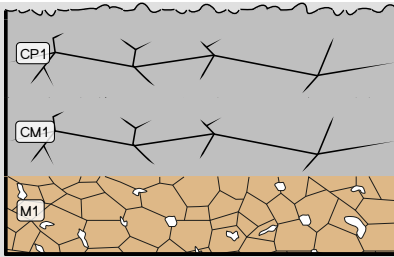
Fig. 10: Stratigraphic representation of the lead came in cross-section (dark field) using the MiCorr application with reference to Fig. 8. The characteristics of the strata are only accessible by clicking on the drawing that redirects you to the search tool by stratigraphy representation, Credit HE-Arc CR, A.Gerber
