LEAD CAMES OF A STAINED GLASS WINDOW 52583 – PB SB ALLOY – UNKNOWN – SWITZERLAND

Artefact name Lead comes of a stained glass window 52583

Authors Alice Gerber. (Haute École Arc Neuchâtel, Neuchâtel, Neuchâtel, Switzerland)

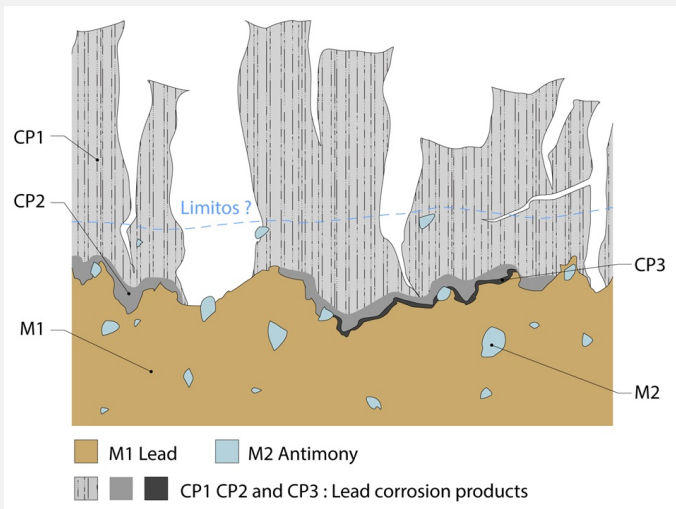
Fig. 11 shows an optimised stratigraphic representation of the corrosion structure. It is to be noted that CP1, CP2 and CP3 although visible on some cross-sections (Fig. 9) could not be differentiated by analysis.

The limit of the original surface lies somewhere in the corrosion layers. Antimony nodules are inferior markers of the limit of the original surface.

Fig. 11: Optimised stratigraphic representation of a corroded lead came integrating additional information based on the analyses carried out,
