# BUGATTI 37 CYLINDER HEAD GASKET 0416 - AL ALLOY - MODERN TIMES - FRANCE

**Artefact name** Bugatti 37 cylinder head gasket 0416

**Authors** Christian. Degriigny (HE-Arc CR, Neuchâtel, Neuchâtel, Switzerland) & Elodie. Granget (HE-Arc CR, Neuchâtel, Neuchâtel, Switzerland) & Brice. Chalançon (MNAM (Musée National de l'Automobile de Mulhouse), Mulhouse, Alsace, France)

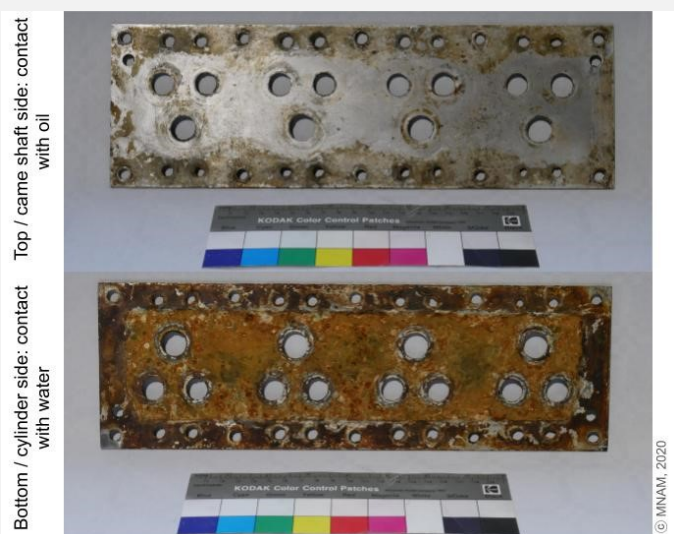
Fig. 1: General picture of the corroded cylinder head gasket of the Bugatti Type 37. Top side facing the camshaft and bottom part in contact with the coolant of the block,

The Bugatti Type 37 will be restored. When the car was dismantled, this gasket was deemed too corroded to be kept. A new part will be put in its place during the restoration. Consequently, this part has been classified as study material, allowing for sampling for metallography.

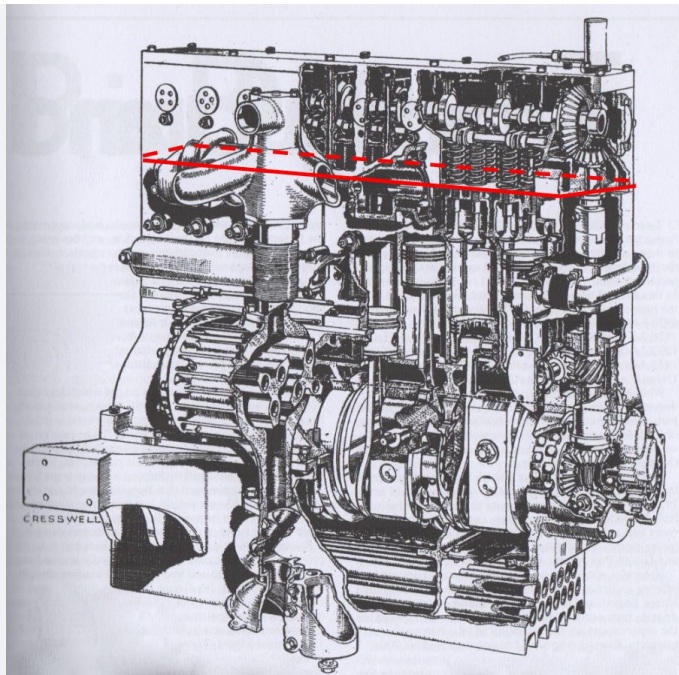
Fig. 2: Gasket located in red on technical drawing of the engine from Cresswell,

A coolant flows through the cylinder block inside galleries. This aluminium gasket is making a tight junction between the camshaft and the top of the block (Fig. 2). It keeps the water or coolant (water + glycol-based antifreeze) from mixing with the lubricant used on the shaft, the pistons and the cylinders. The wet side is facing the cylinder block. The other side is dry.

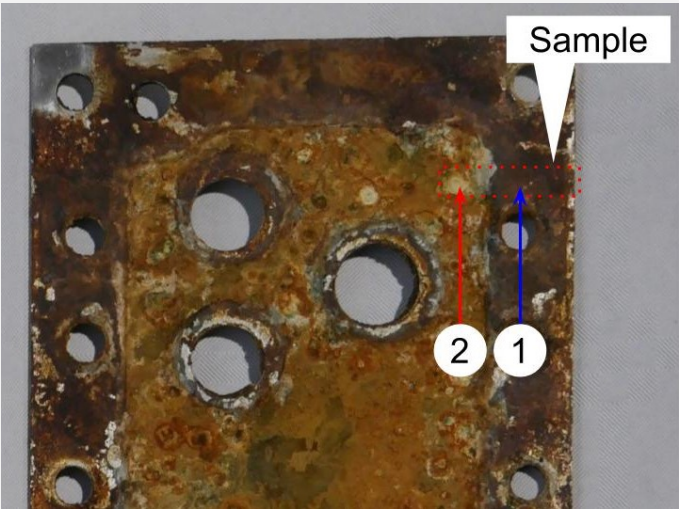
Fig. 3: Bugatti Type 37 cylinder head gasket. Location of the sampling area (red rectangle). Stratigraphic observation sites, in contact with the block [1] and in contact with the coolant [2],

Fig.3 clearly shows the limit where the gasket is in contact with the cylinder block ([1] edges and circular openings in the center) and where it is in contact with the coolant ([2] center).

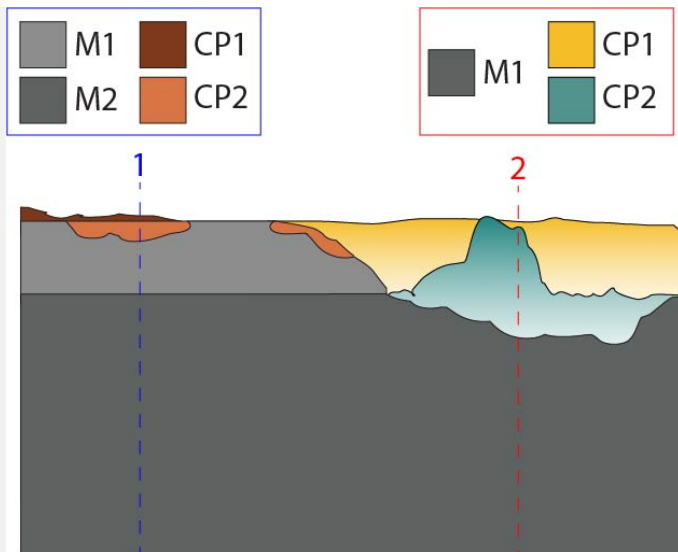
The schematic representation below gives an overview of the corrosion layers encountered on these areas (Fig. 4). The metal core (M1) is colaminated on both sides with metal M2.

Stratigraphy [1]	Stratigraphy [2]
The metal contains the strata M1 and M2.	The first metal stratum is missing and only the core metal (M2 in strat.[1], now M1) remains.
The CP1 is a thin brown layer loosely attached to the surface of M1. It can be removed with a firm brush.	The CP1 is a thick bright orange layer, really powdery and easily detached. It can be partly removed with a firm brush. The coloration is less important closer to the metal interface, where the products are white. This layer is also really fragile and friable.
In some places, CP2 develops within M1. It is colored in bright orange and can be broken in pieces with a toothpick.	The CP2 is peaking through CP1 in some places, colored in green.

Fig. 4: Stratigraphic representation of corrosion zones in contact with the block [1] and in contact with the coolant [2],

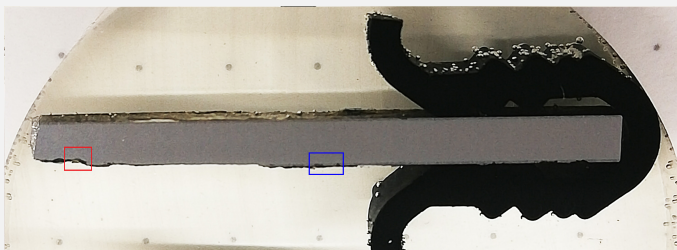
Fig. 5: Micrograph of the cross-section sampled from the Bugatti T37 gasket showing the location of zone 1 in blue (Fig. 6) and zone 2 in red (Fig. 8),

<b>Description of sample</b>	<p>The sample shown on Fig.5 is a transversal cut of the gasket presenting 3 different corrosion sites.</p> <p>Bottom side: Contact with coolant [1]. Contact with block [2].</p> <p>Top side: Contact with oil (not presented in this artefact sheet).</p>
<b>Alloy</b>	Al Alloy
<b>Technology</b>	Rolled (probably hot rolling) and annealed
<b>Lab number of sample</b>	None
<b>Sample location</b>	HE-Arc CR, Neuchâtel, Neuchâtel
<b>Responsible institution</b>	MNAM (Musée National de l'Automobile de Mulhouse), Mulhouse, Alsace
<b>Date and aim of sampling</b>	31.12.2019 - Sampled for Metallography

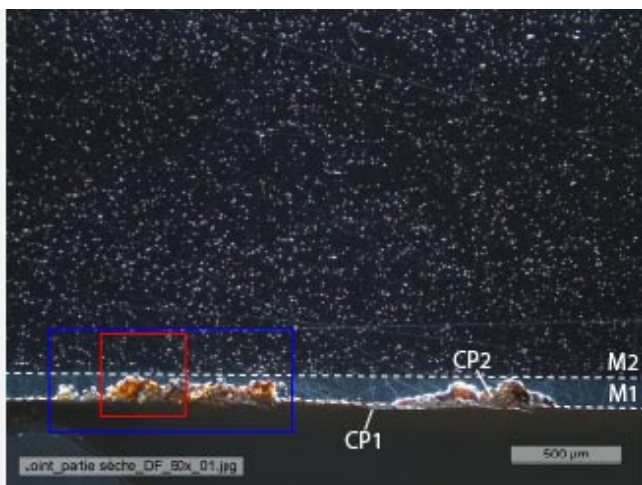
Fig. 6: Micrograph of the cross-section of the gasket, zone 1, shown on Fig. 5 unetched, dark field, showing the location of the EDS elemental chemical distribution of Fig. 10 to 13 (in blue) and of the SEM image of Fig. 7 (in red),

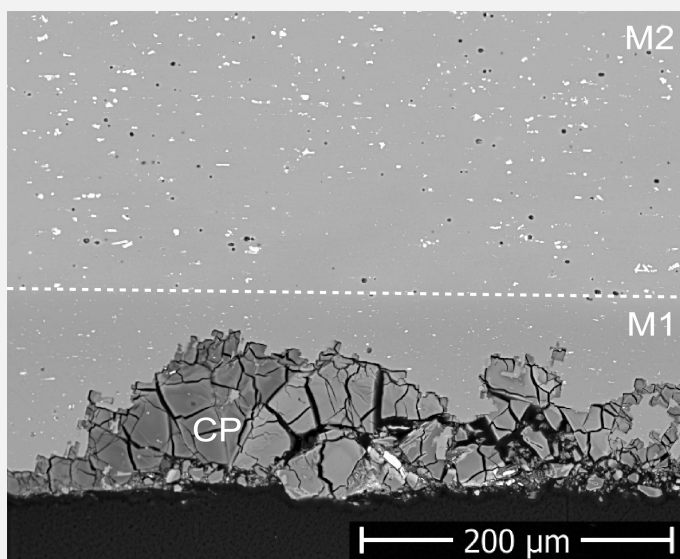
Fig. 7 shows oriented inclusions on both M1 and M2, as well as a lot of small pores in M2.

Local analyses on each phase appearing on Fig. 7 showed that the roll-bounded metal M1 is a compact (non-porous) sheet of pure Al (Table 1) with oriented inclusions of Fe and Si. The core M2 is a very porous alloy composed of Al with bigger oriented inclusions of Si, Mn, Fe, Mg.

Fig 7: SEM detail (BSE mode) of zone 1 of the colaminated sheet in cross-section. The core metal (M2) is porous (in black) and shows oriented inclusions (in white) and the colaminated metal (M1) is compact and has smaller oriented inclusions (in white). Corrosion products (in dark grey) are limited to M1,

Fig. 7 shows that the corrosion products progress through M1 and develop a network of cracks. Fig. 8 shows that the corrosion can expand even further through M2 (zone 2), the corrosion products being more stratified (Fig. 9).

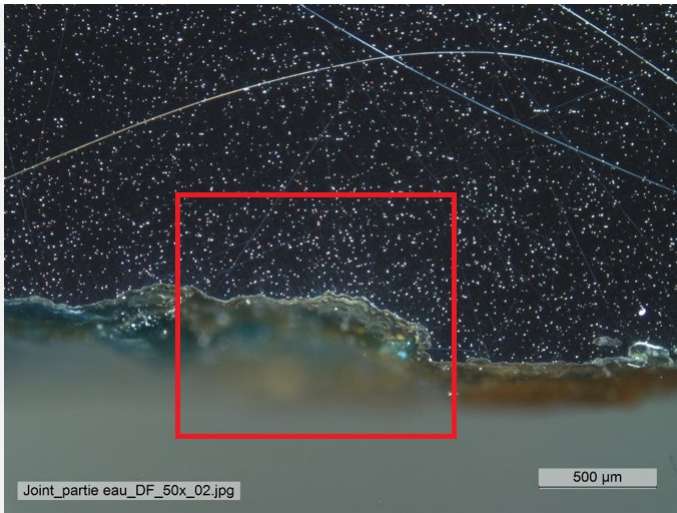
Fig. 8: Micrograph of the cross-section of the gasket, zone 2, shown on Fig. 5 unetched, dark field, showing the location of the SEM image of Fig. 9 (in red),

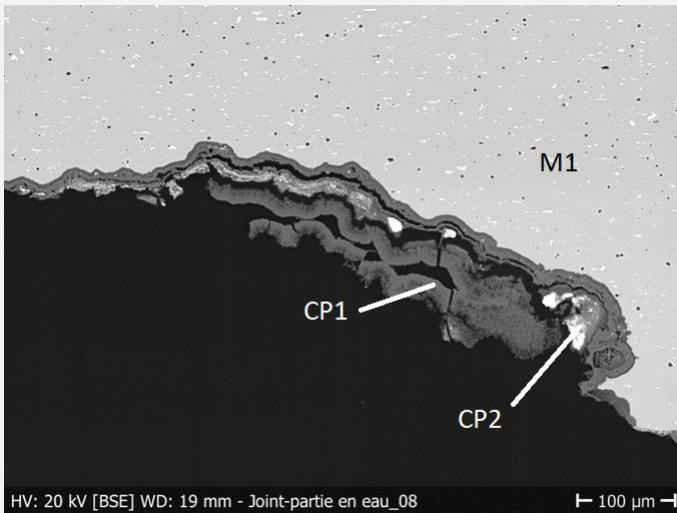
Fig 9: SEM detail (BSE mode) of zone 2 of the gasket in cross-section. The colaminated Al is missing. The core metal (now M1) is porous (black spots) and shows oriented inclusions (in white). The corrosion products (CP1) are very friable and retain clusters of inclusions that are also corroded (CP2),

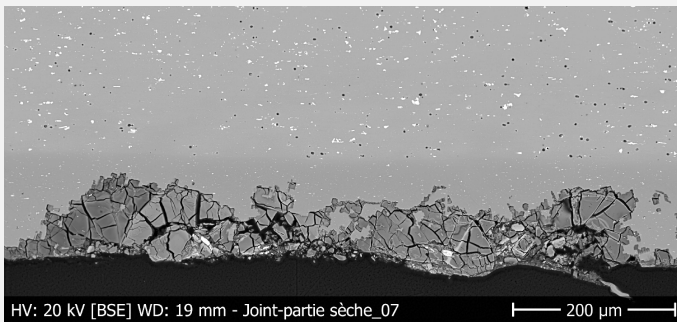
Fig. 10: SEM image (BSE mode) of the cross-section of zone 2 of the gasket (detail of Fig. 6) showing the core metal on top (M2) and the heavily corroded colaminated metal (M1),

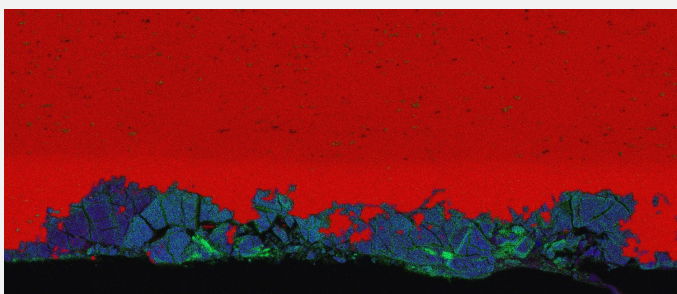
The EDS elemental chemical distribution of zone 1 is given in Fig. 11 to 13. The corrosion layers contain S (probably aluminium sulfate (Fig. 12), polluted with Fe (Fig. 11)). The presence of sulfur can be explained by the proximity of the gasket to the combustion chamber. As for the iron, it is probably coming from the steel block.

Fig. 11: Al (red), O (blue) and Fe (green) chemical distribution of the area of Fig. 10. Method of analysis: SEM-EDS. Lab. of Electronic Microscopy and Microanalysis, Néode, HEI Arc.

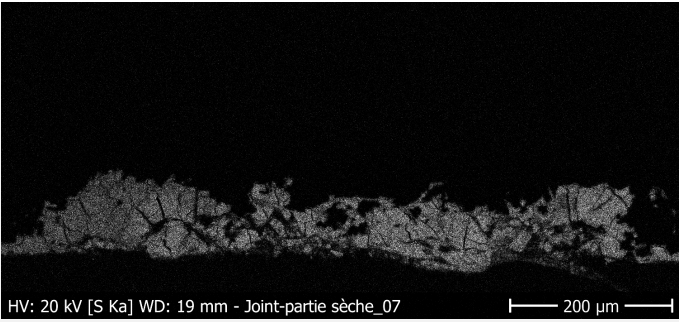
Fig. 12: S chemical distribution of the area of Fig. 10. Method of analysis: SEM-EDS. Lab. of Electronic Microscopy and Microanalysis, Néode, HEI Arc.

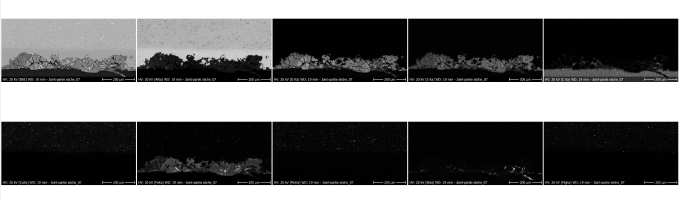
Fig. 13: SEM image and elemental chemical distribution of the area of Fig. 10. Method of analysis: SEM-EDS. Lab. of Electronic Microscopy and Microanalysis, Néode, HEI Arc.

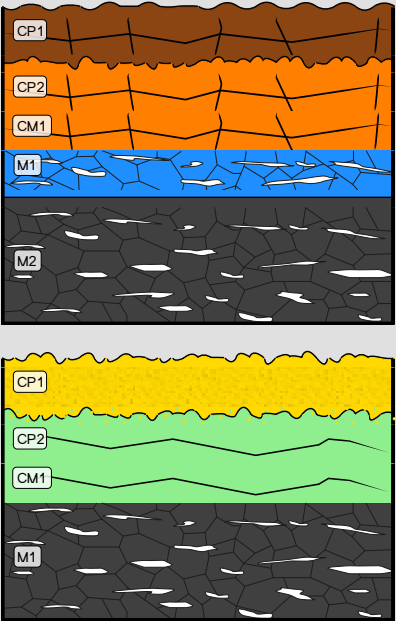
Fig. 14: Stratigraphic representation of the gasket (zone 1) in cross-section (dark field), using the MiCorr application. The characteristics of the strata are only accessible by clicking on the drawing that redirects you to the search tool by stratigraphy representation. This representation can be compared to Fig. 7, Credit HE-Arc CR, E.Granget.

Fig. 15: Stratigraphic representation of the gasket (zone 2) in cross-section (dark field), using the MiCorr application. The characteristics of the strata are only accessible by clicking on the drawing that redirects you to the search tool by stratigraphy representation. This representation can be compared to Fig. 9, Credit HE-Arc CR, E.Granget.

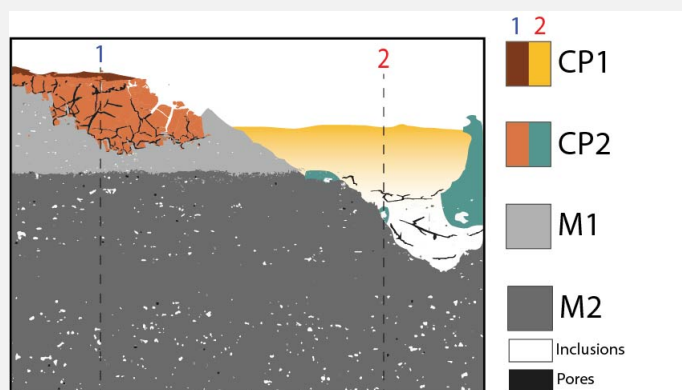
The schematic representations of corrosion layers of Figs. 6 and 7 integrating additional information based on the analyses carried out is given in Fig. 16.

No analyses could be carried out on the top thicker part of CP1.

Fig. 16: Improved stratigraphic representation of the 2 corrosion structures of the Bugatti cylinder head gasket. CP1 could not be analysed,

The side of the gasket facing the cylinder block has a different corrosion pattern depending on whether the area is immersed or not. The surface in contact with the cylinder block shows a priori corrosion consisting of highly cracked aluminium sulphate (network). The surface immersed in the coolant is heavily corroded. The colaminated Al sheet has been completely consumed, and the corrosion progresses through the support metal, retaining inclusions of the alloy in its products. This layer is very brittle and tends to delaminate.

All the corrosion products are contaminated with iron oxides, probably from the block. The immersed part is covered with a thick crust of what is believed to be a mixture of ferrous and aluminium-based products.
