FUNERAL MASK IVC 11595 - CU/AG, WITH SURFACE ENRICHMENT (AG) - UNKNOWN

Artefact name Funeral mask Ivc 11595

Authors Christian. Degriigny (HE-Arc CR, Neuchâtel, Neuchâtel, Switzerland) & Naima. Gutknecht (HE-Arc CR, Neuchâtel, Neuchâtel, Switzerland) & Valentin. Boissonnas (HE-Arc CR, Neuchâtel, Neuchâtel, Switzerland)

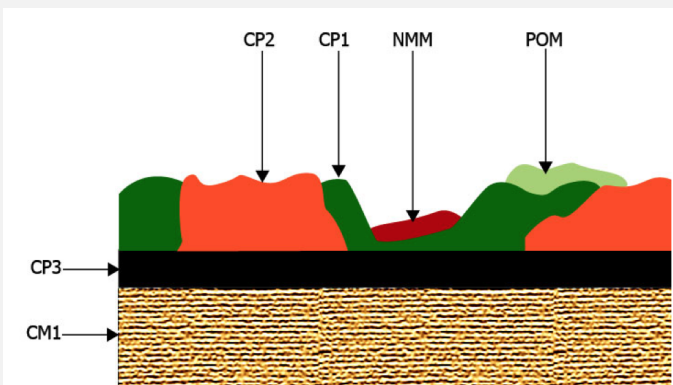
Fig. 3a: Stratigraphic representation of the front face of the funeral mask by visual macroscopic observation,

Fig. 3b: Stratigraphic representation of the back face of the funeral mask by visual macroscopic observation,

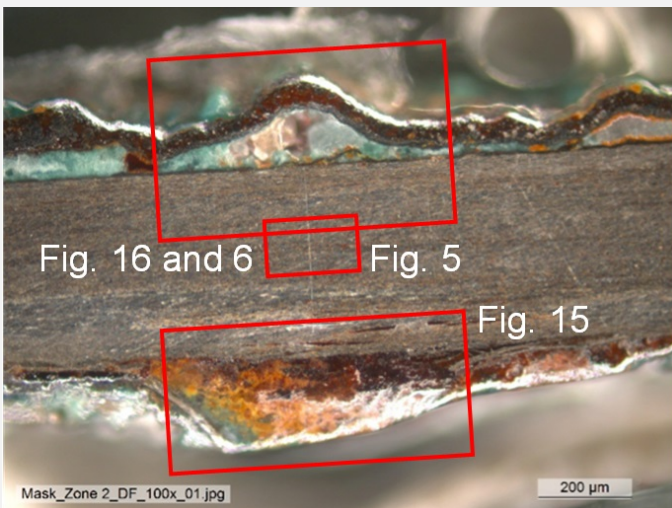
Fig. 4: Micrograph of the cross-section of the sample temporarily taken from the detached fragment of Fig. 2 showing the locations of Figs. 15 (corresponding to the front of the funeral mask), 16 (back of the funeral mask), 5 and 6,

A polished section was made from an already detached fragment that was temporarily embedded in resin (Fig. 2). On Fig. 4 the upper part of the sample corresponds to the back face of the funeral mask while the lower part corresponds to its front face. Both sides have developed subsequent layers of corrosion. In areas, these have buckled and become detached.

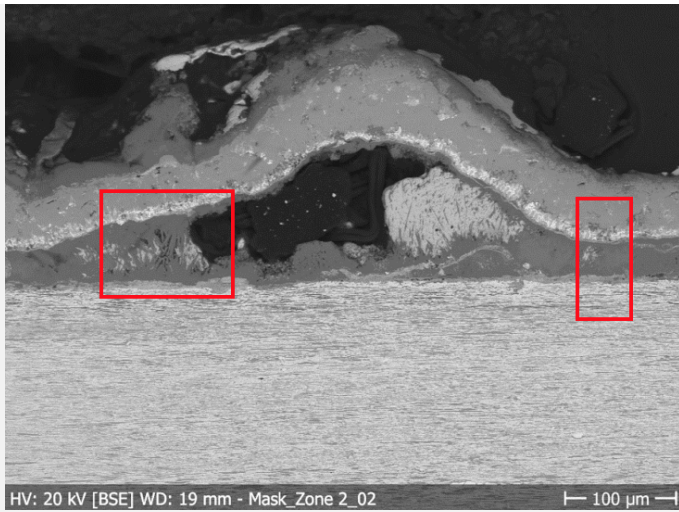
Fig. 6: SEM image (BSE-mode) of the metal sample from Fig. 4 with detail (Fig. 7) indicated by the left red rectangle. The

selected area for elemental chemical distribution (Fig. 8) is marked by the right red rectangle,

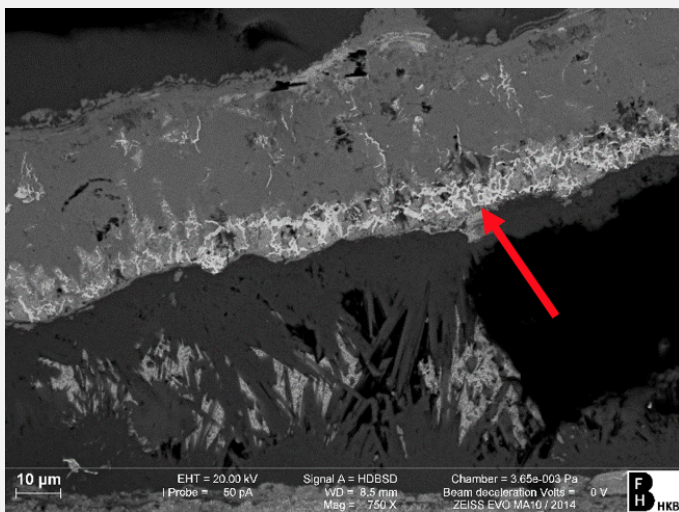
A layer of mercury can be seen with EDS (Figs. 6 and 7). Mercury was not used by the pre-Columbians in metallic form (Scott 2000 and McEwan 2000) but was common as a pigment in form of mercury sulfide (cinnabar).

Fig. 7: SEM image of a partially refilled structural void with a silver-, copper- and mercury-rich layer (red arrow),

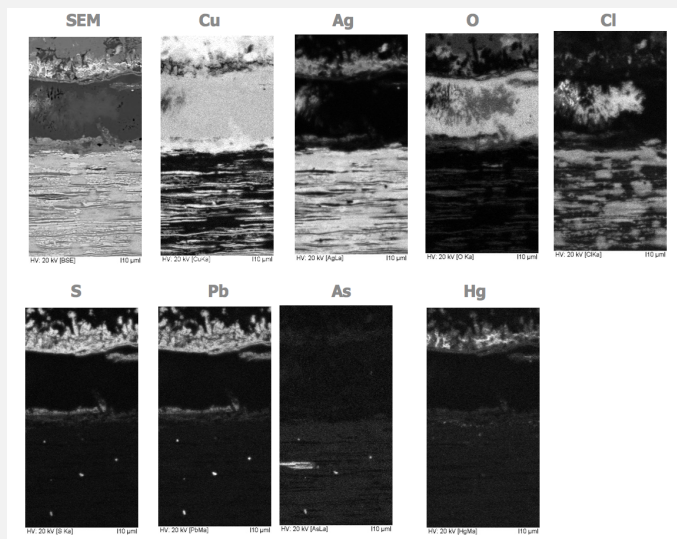
The remaining metal shows a preferential corrosion of copper and the presence of chlorides throughout the entire corroded metal, most likely in the form of Cu and Ag corrosion products (Fig. 8, Table 1). There is a preferential corrosion of copper that has fragilized the structure of the sheet metal.

Fig. 8: SEM image (BSE-mode) and elemental chemical distribution of the selected area on Fig. 6. Method of examination: SEM/EDS,

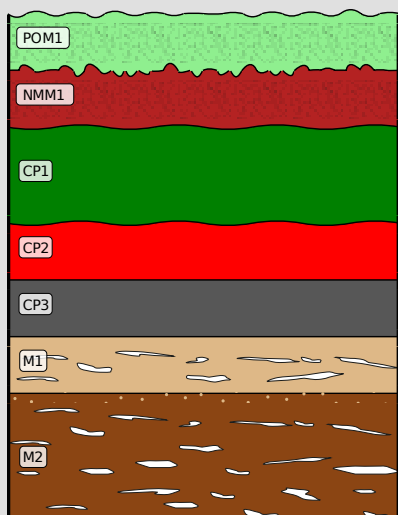
Fig. 15: Stratigraphic representation of the cross-section (dark field) from Figs. 3a or 4 (front of the object) using the MiCorr application. The characteristics of the strata are only accessible by clicking on the drawing that redirects you to the search tool by stratigraphy representation, Credit HE-Arc CR, N. Gutknecht.

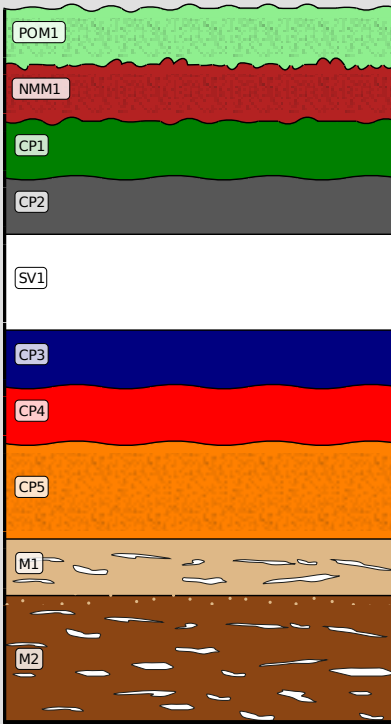
Fig. 16: Stratigraphic representation of the cross-section (dark field) from Figs. 3b and 4 (back of the object) using the MiCorr application. CP2 is CP3 while CP3 is CP4 and CP4 is CP2 in Fig. 3b. The characteristics of the strata are only accessible by clicking on the drawing that redirects you to the search tool by stratigraphy representation, Credit HE-Arc CR, N. Gutknecht.

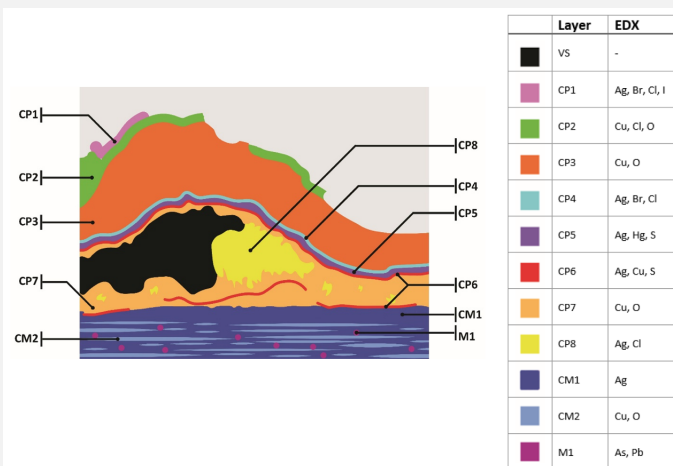
Fig. 17: Improved stratigraphic representation of the funeral mask (Fig. 3) based on the results from the SEM-EDS analyses,

The artefact is a repeatedly hammered, annealed and pickled Cu-Ag tumbaga. The cuprite and hydroxycarbonate layers and the presence of chlorides are typical for the corrosion of tumbaga alloys in an archaeological context. Cinnabar has been identified as pigment applied to the surface before burial. Over the centuries, it was partially incorporated into the growing copper corrosion layers. Close to the enriched silver surface and below the cuprite layer a silver- and mercury-rich stratum has formed. Only one publication mentions the reaction of cinnabar with a gold-enriched tumbaga surface but does not go into details about the possible mechanism involved (Masuda 1997).

The presence of a silver-sulphur compound below this silver-mercury stratum could indicate that the cinnabar was reduced by electrochemical processes to mercury, releasing sulphur that reacted with the silver enriched surface. The mercury itself formed a silver-mercury layer above the latter. More research is needed to fully comprehend this phenomenon.
