# FUNERAL MASK IVC 11595 – CU/AG, WITH SURFACE ENRICHMENT (AG) – UNKNOWN

**Artefact name** Funeral mask IVC 11595

**Authors** Christian. Degriigny (HE-Arc CR, Neuchâtel, Neuchâtel, Switzerland) & Naima. Gutknecht (HE-Arc CR, Neuchâtel, Neuchâtel, Switzerland) & Valentin. Boissonnas (HE-Arc CR, Neuchâtel, Neuchâtel, Switzerland)

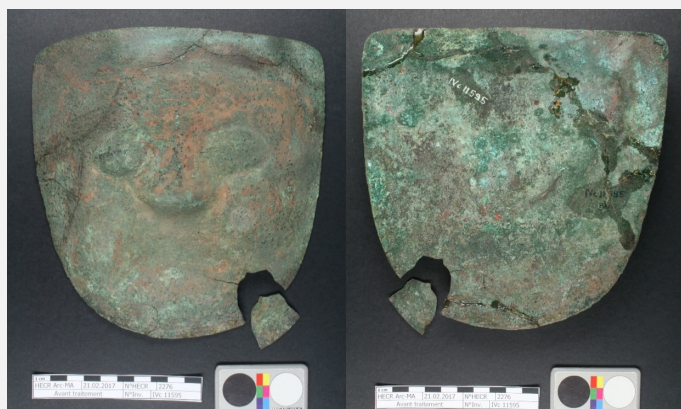
Fig. 1: Funeral mask, front and back face to the left and right respectively,

**Description of the artefact** Peruvian funeral mask (Fig. 1). There are remains of red pigment and of a mineralised textile on both sides of the object. It is heavily corroded in green and red corrosion layers. It is deformed and broken. Dimensions: Length = 180mm; Width = 170mm; Height = 20 mm; WT = 158,6g.

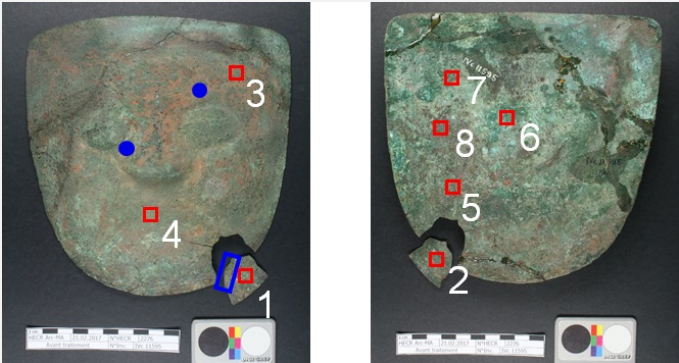
Fig. 2: Front (left) and back (right) faces showing the location of XRF analyses (red squares), sampling areas for SEM-EDS (blue points) and sampling area for examination on cross-section (blue rectangle),

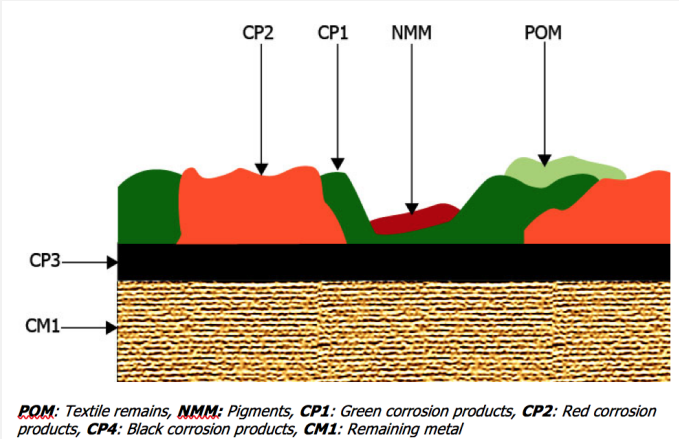
Fig. 3a: Stratigraphic representation of the front face of the funeral mask by visual macroscopic observation,

Fig. 3b: Stratigraphic representation of the back face of the funeral mask by visual macroscopic observation,

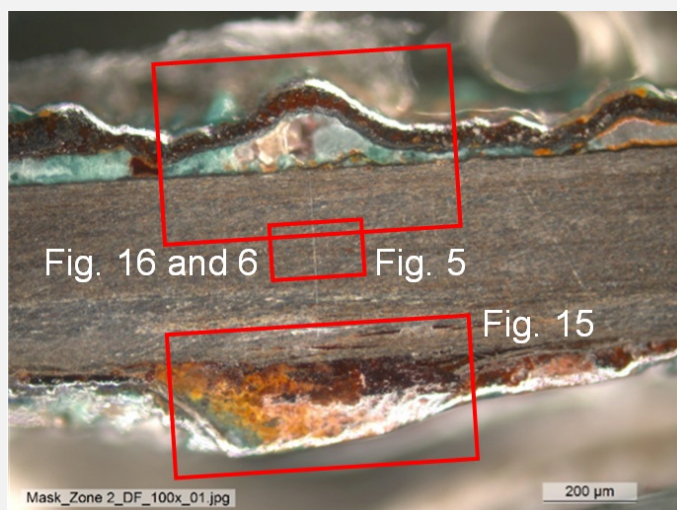
Fig. 4: Micrograph of the cross-section of the sample temporarily taken from the detached fragment of Fig. 2 showing the locations of Figs. 15 (corresponding to the front of the funeral mask), 16 (back of the funeral mask), 5 and 6,

A polished section was made from an already detached fragment that was temporarily embedded in resin (Fig. 2). On Fig. 4 the upper part of the sample corresponds to the back face of the funeral mask while the lower part corresponds to its front face. Both sides have developed subsequent layers of corrosion. In areas, these have buckled and become detached.

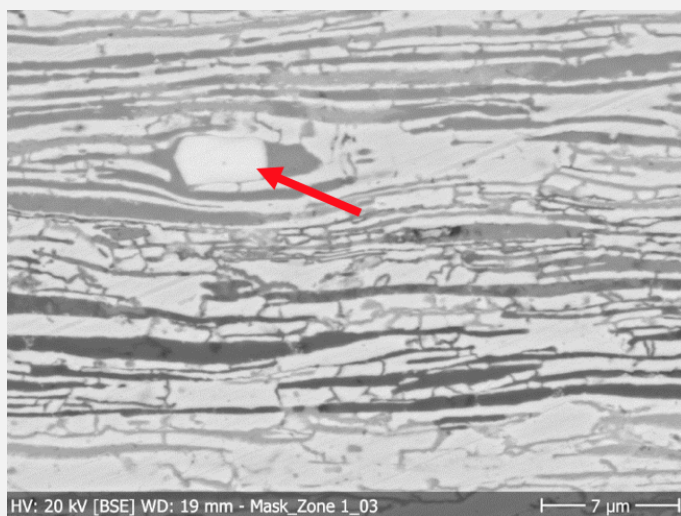
The SEM/EDS analysis of the core metal shows that there are Cu-rich phases alternating with Ag-rich phases. There are inclusions of Pb and As (Fig. 5). The surface of the metal has been decuprified (Fig. 6) according to the tumbaga making process (Scott 2000 and McEwan 2000). This pre-Columbian repeatedly hammered and annealed the metal, which would create a copper oxide scale on the surface. The latter was then dissolved in acidic plant juices (Scott 2000). This process was repeated until the surface was enriched with silver, giving it the appearance of a silver artefact.

Fig. 5: SEM image (BSE-mode) of the metal sample from Fig. 4 (detail), the elongated grains are the result of repeated hammering. Absence of strain lines indicates that the metal is annealed. The darker areas are Cu-rich phases and the lighter areas are Ag-rich phases. The arrow shows an As- and Pb inclusion,

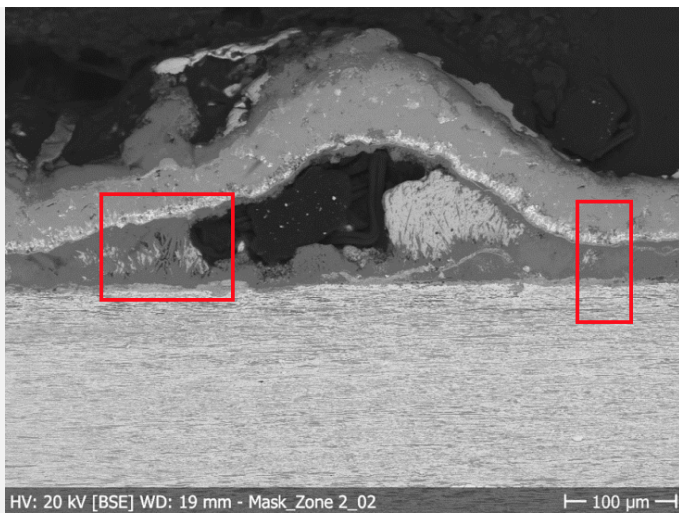
A layer of mercury can be seen with EDS (Figs. 6 and 7). Mercury was not used by the pre-Columbians in metallic form (Scott 2000 and McEwan 2000) but was common as a pigment in form of mercury sulfide (cinnabar).

Fig. 6: SEM image (BSE-mode) of the metal sample from Fig. 4 with detail (Fig. 7) indicated by the left red rectangle. The

selected area for elemental chemical distribution (Fig. 8) is marked by the right red rectangle,

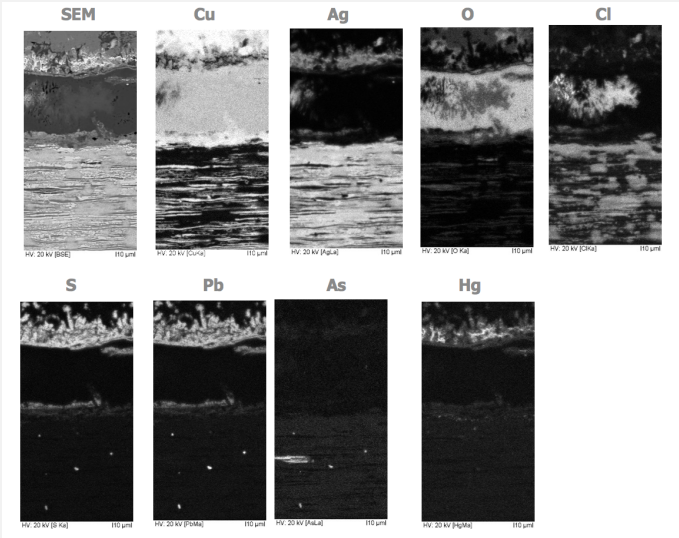
The remaining metal shows a preferential corrosion of copper and the presence of chlorides throughout the entire corroded metal, most likely in the form of Cu and Ag corrosion products (Fig. 8, Table 1). There is a preferential corrosion of copper that has fragilized the structure of the sheet metal.

Fig. 8: SEM image (BSE-mode) and elemental chemical distribution of the selected area on Fig. 6. Method of examination: SEM/EDS,

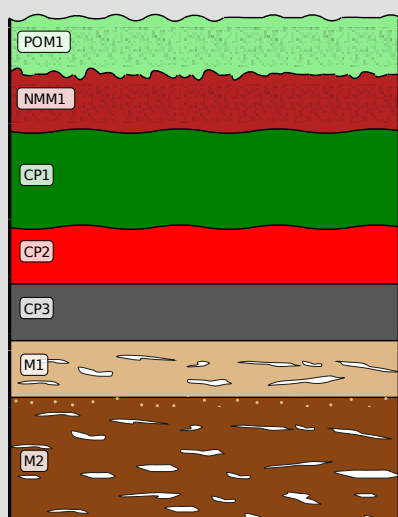
Fig. 15: Stratigraphic representation of the cross-section (dark field) from Figs. 3a or 4 (front of the object) using the MiCorr application. The characteristics of the strata are only accessible by clicking on the drawing that redirects you to the search tool by stratigraphy representation, Credit HE-Arc CR, N. Gutknecht.

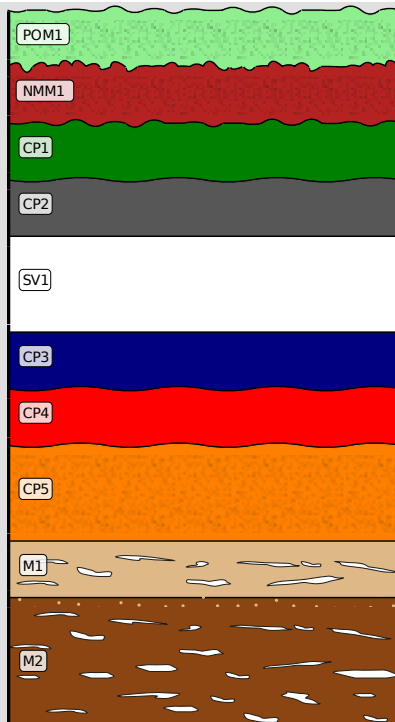
Fig. 16: Stratigraphic representation of the cross-section (dark field) from Figs. 3b and 4 (back of the object) using the MiCorr application. CP2 is CP3 while CP3 is CP4 and CP4 is CP2 in Fig. 3b. The characteristics of the strata are only accessible by clicking on the drawing that redirects you to the search tool by stratigraphy representation, Credit HE-Arc CR, N. Gutknecht.

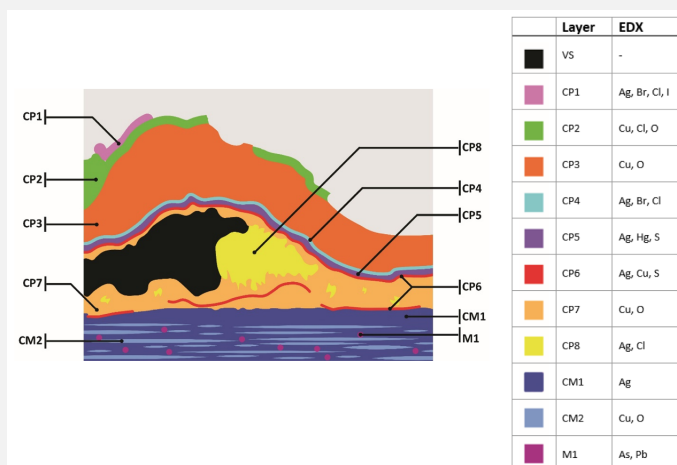
The schematic representation of corrosion layers of Fig. 3 integrating additional information based on the analyses carried out is given in Fig. 17.

Fig. 17: Improved stratigraphic representation of the funeral mask (Fig. 3) based on the results from the SEM-EDS analyses,
