FUNERAL MASK IVC 11595 – CU/AG, WITH SURFACE ENRICHMENT (AG) – UNKNOWN

Artefact name Funeral mask IVC 11595

Authors Christian. Degriigny (HE-Arc CR, Neuchâtel, Neuchâtel, Switzerland) & Naima. Gutknecht (HE-Arc CR, Neuchâtel, Neuchâtel, Switzerland) & Valentin. Boissonnas (HE-Arc CR, Neuchâtel, Neuchâtel, Switzerland)

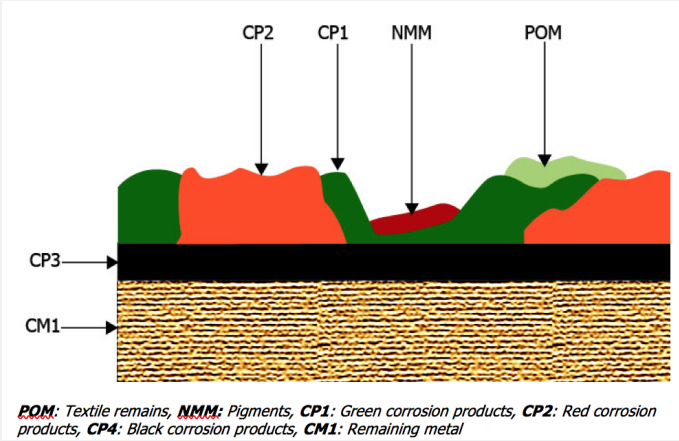
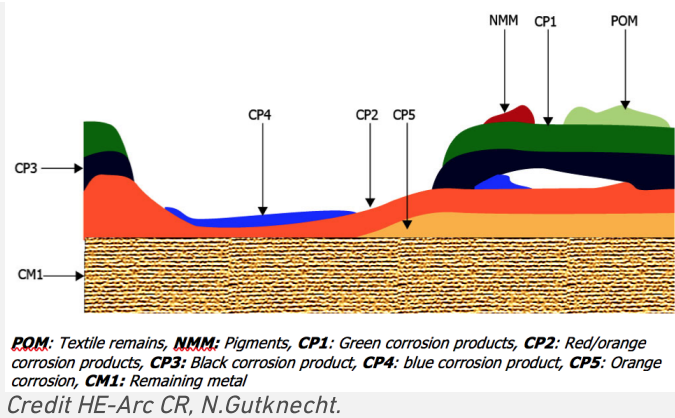
Fig. 3a: Stratigraphic representation of the front face of the funeral mask by visual macroscopic observation,

Fig. 3b: Stratigraphic representation of the back face of the funeral mask by visual macroscopic observation,

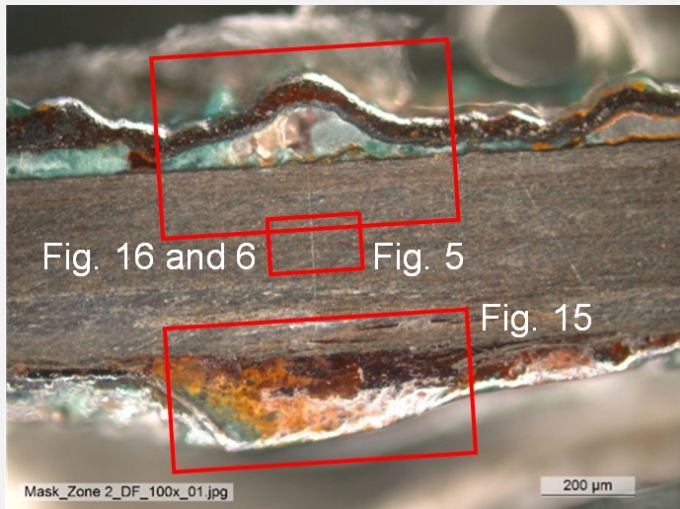
Fig. 4: Micrograph of the cross-section of the sample temporarily taken from the detached fragment of Fig. 2 showing the locations of Figs. 15 (corresponding to the front of the funeral mask), 16 (back of the funeral mask), 5 and 6,

A polished section was made from an already detached fragment that was temporarily embedded in resin (Fig. 2). On Fig. 4 the upper part of the sample corresponds to the back face of the funeral mask while the lower part corresponds to its front face. Both sides have developed subsequent layers of corrosion. In areas, these have buckled and become detached.

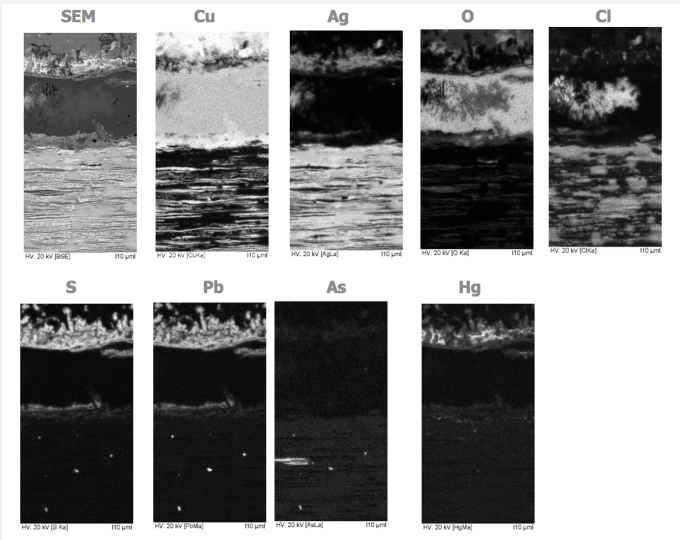
The remaining metal shows a preferential corrosion of copper and the presence of chlorides throughout the entire corroded metal, most likely in the form of Cu and Ag corrosion products (Fig. 8, Table 1). There is a preferential corrosion of copper that has fragilized the structure of the sheet metal.

Fig. 8: SEM image (BSE-mode) and elemental chemical distribution of the selected area on Fig. 6. Method of examination: SEM/EDS,

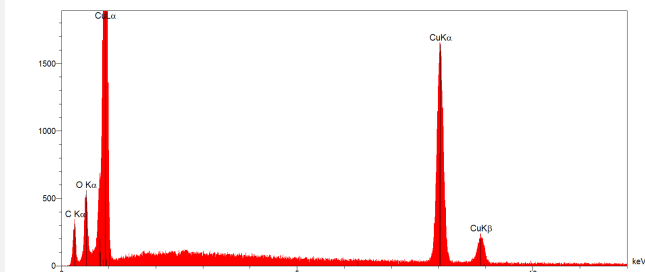
Fig. 9: EDS analysis of the red corrosion layer (Fig. 4). Method of analysis: SEM-EDS, Lab of Electronic Microscopy and Microanalysis, IMA (Néode), HEI Arc,

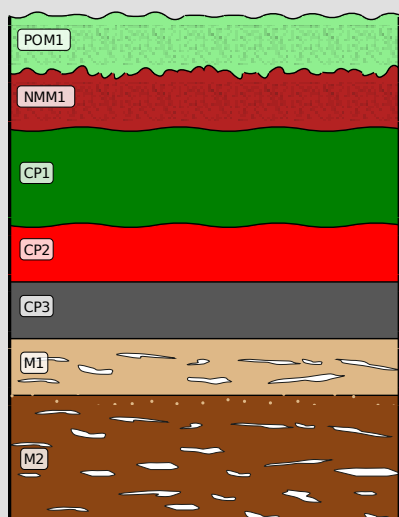
Fig. 15: Stratigraphic representation of the cross-section (dark field) from Figs. 3a or 4 (front of the object) using the MiCorr application. The characteristics of the strata are only accessible by clicking on the drawing that redirects you to the search tool by stratigraphy representation, Credit HE-Arc CR, N. Gutknecht.

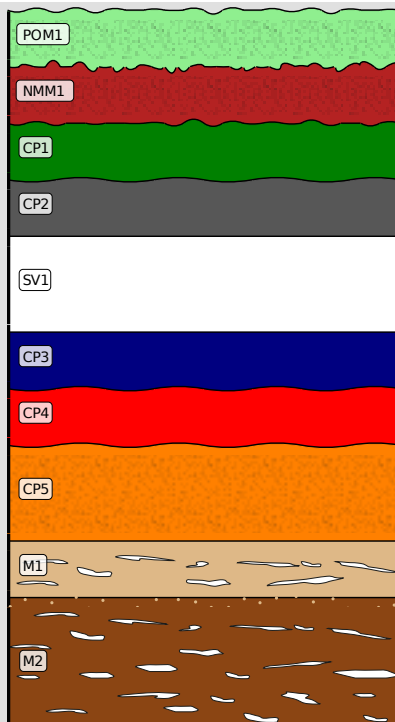
Fig. 16: Stratigraphic representation of the cross-section (dark field) from Figs. 3b and 4 (back of the object) using the MiCorr application. CP2 is CP3 while CP3 is CP4 and CP4 is CP2 in Fig. 3b. The characteristics of the strata are only accessible by clicking on the drawing that redirects you to the search tool by stratigraphy representation, Credit HE-Arc CR, N. Gutknecht.
