VOTIVE FIGURE OF A BAT IVB4168 – GILDED BRASS – MODERN TIMES

Artefact name Votive figure of a bat IVb4168

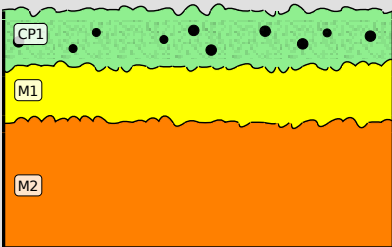
Fig 5: Stratigraphic representation of the corrosion structure of area 1 (Fig. 4) observed macroscopically under binocular microscope using the MiCorr application. The characteristics of the strata are only accessible by clicking on the drawing that redirects you to the search tool by stratigraphy representation, Credit HE-Arc CR, N.Gutknecht.

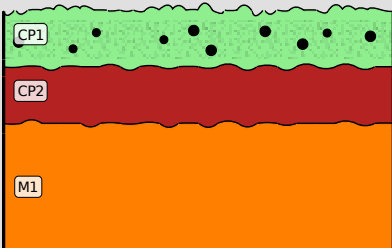
Fig. 6: Stratigraphic representation of the corrosion structure of area 2 (Fig. 4) observed macroscopically under binocular microscope using the MiCorr application. M1 is M2 in Fig. 5. The characteristics of the strata are only accessible by clicking on the drawing that redirects you to the search tool by stratigraphy representation, Credit HE-Arc CR, N.Gutknecht.
