# GILDED SILVER PLATES OF THE GREAT SHRINE OF ST MAURICE – AG ALLOY – HIGH MEDIEVAL TIMES

Romain. Jeanneret (Abbaye de St-Maurice, Saint-Maurice, Valais, Switzerland)

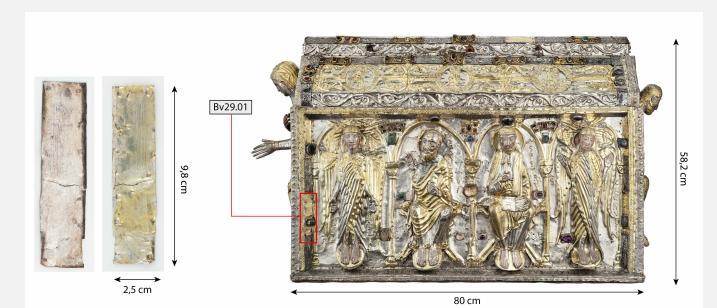
Fig.1: Front and reverse sides of the gilded plate Bv29.01 and

its location on the Great Shrine of saint Maurice,

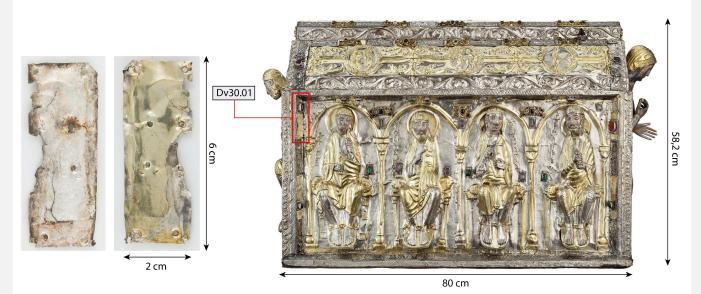
Fig.2: Front and reverse sides of the gilded plate Dv30.01 and its location on the Great Shrine of saint Maurice,

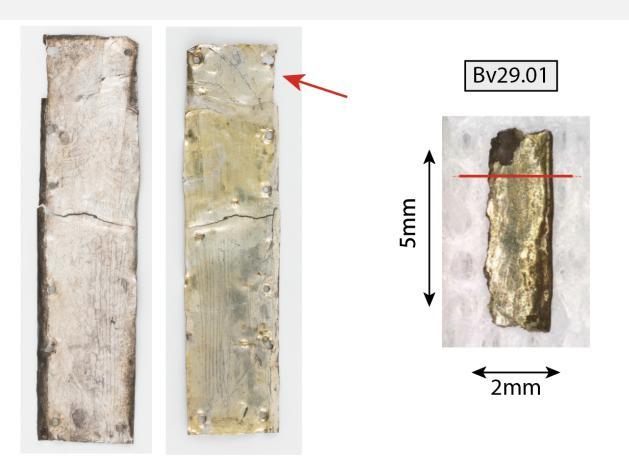
Fig. 3: Location of the loose analysed fragment of gilded plate Bv29.01 and its sampling area. Size of the sample:  $5 \times 2$  mm,

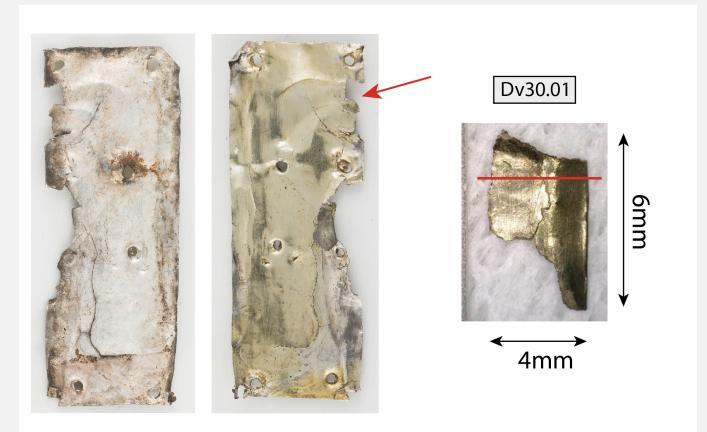
Fig. 4: Location of the loose analysed fragments of gilded plate Dv30.01 and its sampling area. Size of the sample: 6 x 4 mm,

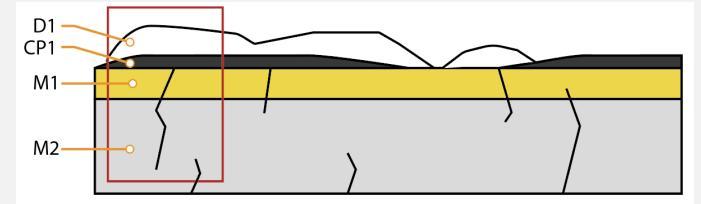
Fig. 5: Stratigraphic representation of the corrosion structures of both gilded plates Bv29.01 and Dv30.01 by macroscopic and binocular observation with indication of the corrosion structure (before conservation treatment) used to build the MiCorr stratigraphy of Fig. 6 (red rectangular),

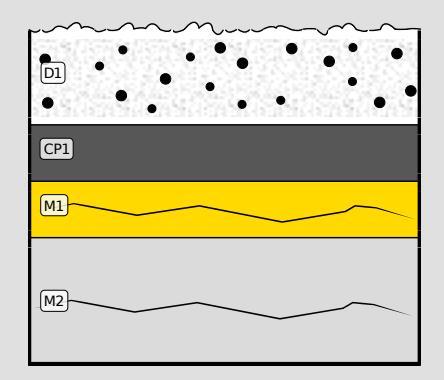
Fig.6: Stratigraphic representation of the corrosion structures of the both Bv29.01 and Dv30.01 gilded plates (before conservation treatment) observed macroscopically under binocular microscope using the MiCorr application with reference to Fig. 5. The characteristics of the strata are only accessible by clicking on the drawing that redirects you to the search tool by stratigraphy representation. Credit ABSM, R.Jeanneret.

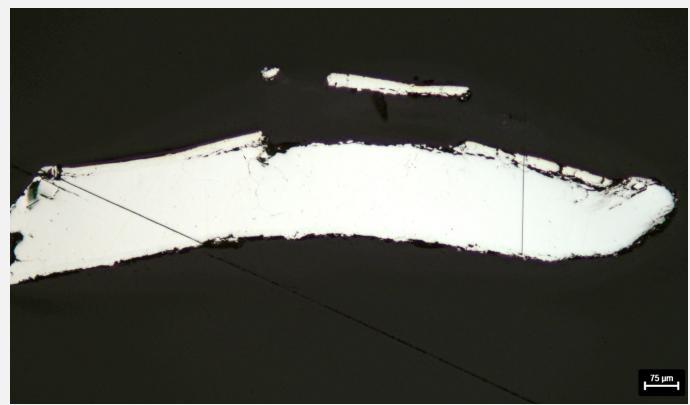
Fig.7: Micrograph of the cross-section of the sample taken from gilded plate Bv29.01 (Fig.3),

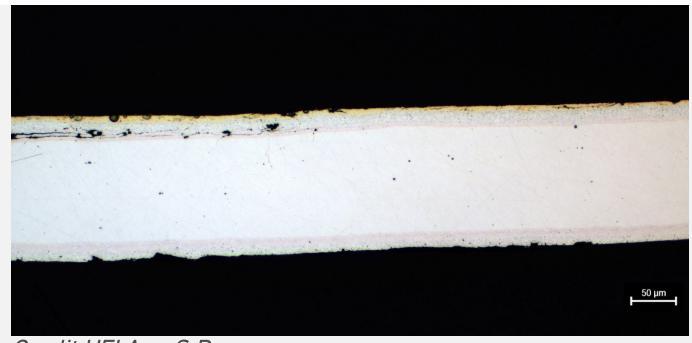
Fig.8: Micrograph of the cross-section of the sample taken from gilded plate Dv30.01 (Fig.4),

Under the Dv30.01 gilding, there is a pink layer about 10um thick visible on the micrograph (Fig.8). While this may appear to be a highly enriched copper layer, it is not confirmed by composition line analysis. This layer is also found on the non-gilded side, indicating that it is maybe related to the gilding process. This is not clearly visible on plate Bv29.01.

The pinkish stratum (M3) and porous layer (M2) are clearly visible on the micrograph (Fig. 8) but compositional line analysis did not demonstrate any difference from the metal.

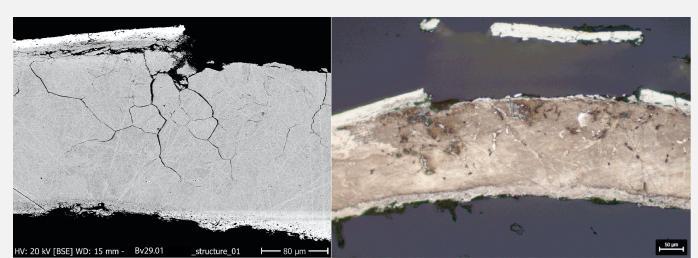
SEM images (Figs. 10 and 12) show that the metal surface of the underlying metal is slightly porous. This suggests a surface enrichment due to the repoussé work and successive annealing. This is reinforced by the etching of the two samples (Figs 9 & 11) indicating a very different reaction between the first 25 microns and the core of the alloys. Despite these differences, the composition line (Figs 10 & 12) analysis shows no variation in copper content.

The grain structure of the silver core (large polygonal grains, which may indicate recrystallization of the material(s)) is only visible in the SEM, BSE mode, and by increasing the beam intensity to 10nA (Figs. 9 and 11).

Fig. 9: SEM image (BSE mode, current 10nA) and micrograph of sample etched of the cross-section of the sample taken from gilded plate Bv29. 01 revealing partly the microstructure,

The majority of cracks are due to cold work. It is possible that this phenomenon was amplified and/or followed by intergranular corrosion. Nevertheless, the mercury-enriched interface seems to have suffered the most from cold working leading to loss of local adhesion of the gilding. This could be explained by differences in the ductility of the different metal layers. Some of the cracks reach the center of the metal (Figs. 9 & 11).

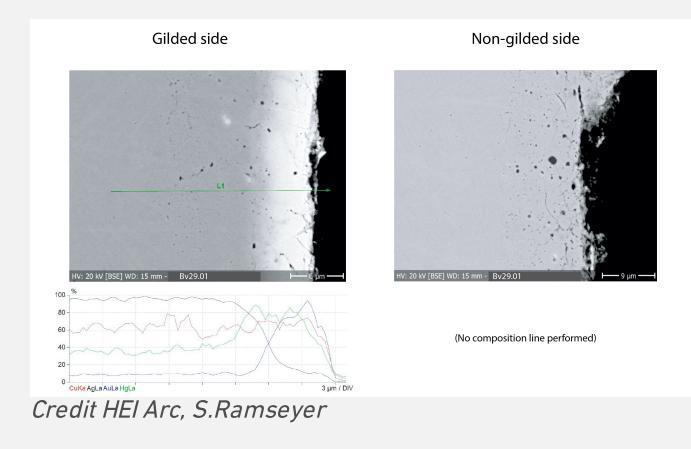
The metal of the plates is silver with a low percentage of copper (about 1-2wt%). The plates are gilded only on their visible side (Figs. 7 and 8). The gilding was studied in cross-section by EDS analysis using a composition line (Figs. 10 & 12). The results are similar for both plates and indicate a presence of mercury bound to both gold and silver and decreasing as we get away from the interface. These results are consistent with what has been studied by Kilian Anhauser on mercury gilding samples reproduced in the laboratory (Anhauser, 1999) and on medieval gilded silver (Schweizer & Degli Agosti, 2007).

Fig.10: SEM images (BSE mode) and EDS analysis by line of composition of the cross-section of the sample (gilded side only) taken from the gilded plate Bv29.01,

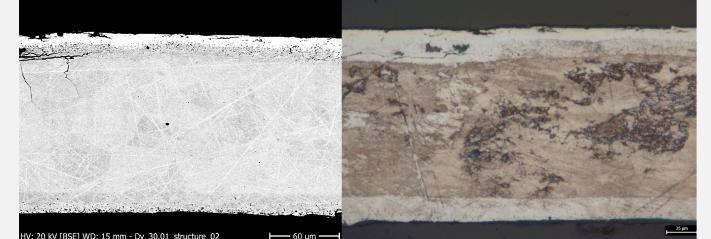
Fig. 11: SEM image (BSE mode, current 10nA) and micrograph of sample etched of the cross-section of the sample taken from gilded plate Dv30.01 revealing partly the microstructure,

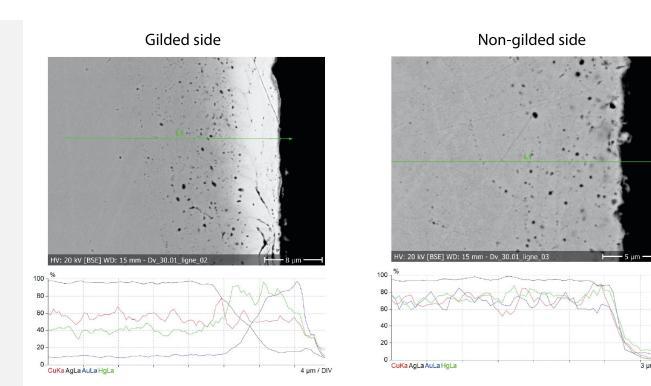
Fig.12: SEM images (BSE mode) and EDS analyses by line of composition of the cross-section of the sample (both sides) taken from the gilded plate Dv30.01,

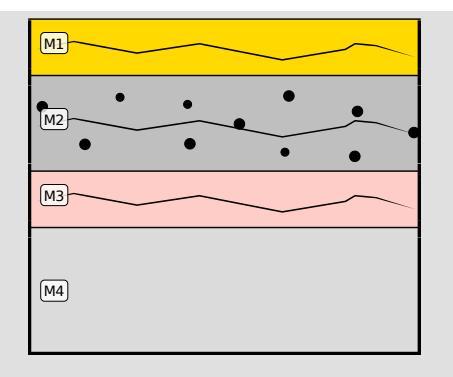
Fig.13: Stratigraphic representation of the sample taken from Dv30.01 in cross-section using the MiCorr application. The characteristics of the strata are only accessible by clicking on the drawing that redirects you to the search tool by stratigraphy representation. Credit ABSM, R. Jeanneret.

The observation in cross-section does not allow the identification of the surface deposits observed under the binocular microscope. This is due to the fact that the observations of the object are made before treatment while the fragment analyzed in cross-section has been treated (degreasing and reduction of tarnish). An intergranular corrosion may also have developed and increased the cracking.
