AIRCRAFT REAR FASTENING PLATE VHS-497 - AL ALLOY - MODERN **TIMES**

Artefact name Aircraft rear fastening plate VHS-497

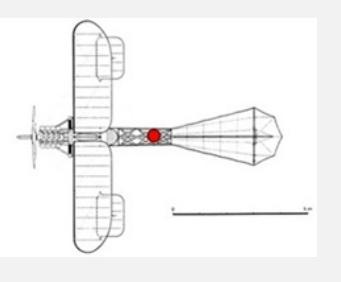
Fig. 1: Fastening plate from the back of the Dufaux IV (left) and top view of the aeroplane showing its location (red dot, right) (www.hepta.aero),

Description of the artefact	Metal fastening plate for the wooden construction of the rear of the aeroplane (Fig. 1) covered with a thin corrosion layer.		
Type of artefact	Aeroplane part		
Origin	Dufaux IV aeroplane		
Recovering date	Biplane built by Henri and Armand Dufaux in 1909/10		
Chronology category	Modern Times		
chronology tpq	1909 A.D. 🗸		
chronology taq	1910 A.D. 🗸		
Chronology comment			
Burial conditions / environment	Outdoor to indoor atmosphere		
Artefact location	Swiss Museum of Transport, Luzern, Lucerne		
Owner	Swiss Museum of Transport, Luzern, Lucerne

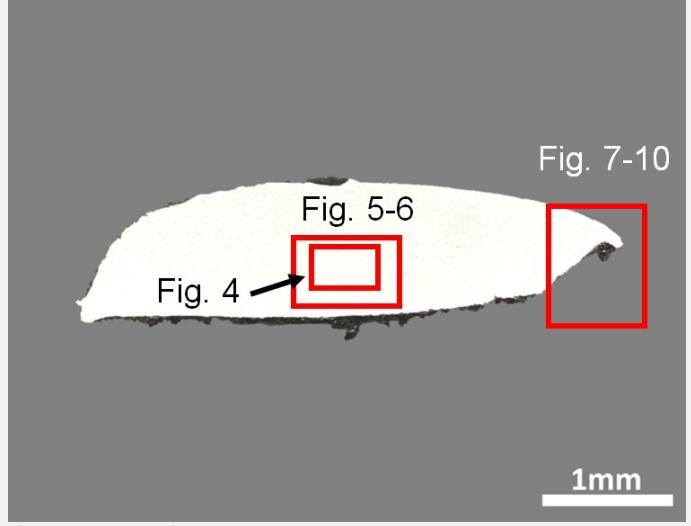
Fig. 3: Micrograph of the cross-section of the sample taken from the back fastening plate showing the location of Figs. 4 to 10,

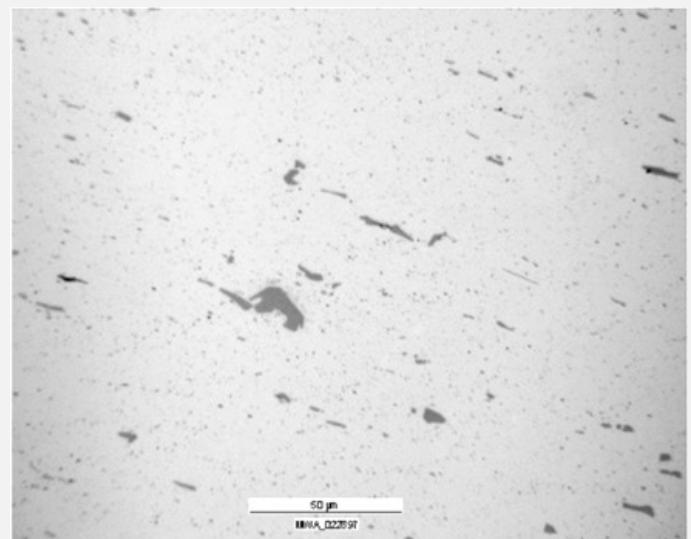
The metal is a relatively pure aluminium alloy with numerous inclusions (Table 1). From the chemical composition of the inclusions they can be interpreted as alpha-AlFeSi intermetallic compounds. In bright field we observe elongated inclusions indicating that the metal was rolled (Fig. 4). The alloy composition is similar to an unalloyed primary aluminium (Al content between 99 and 99.8 mass%). The 0 content reflects the immediate oxidation of the metal and is not part of the alloy. After etching the organisation of inclusions in rows is more easily seen (Fig. 5). The SEM image shows large grains formed after annealing (Fig. 6). The average hardness of the metal is HV1 40.

Fig. 4: Micrograph of the metal sample from Fig. 3 (detail), unetched, bright field. The metal matrix is in white, the elongated inclusions in grey,

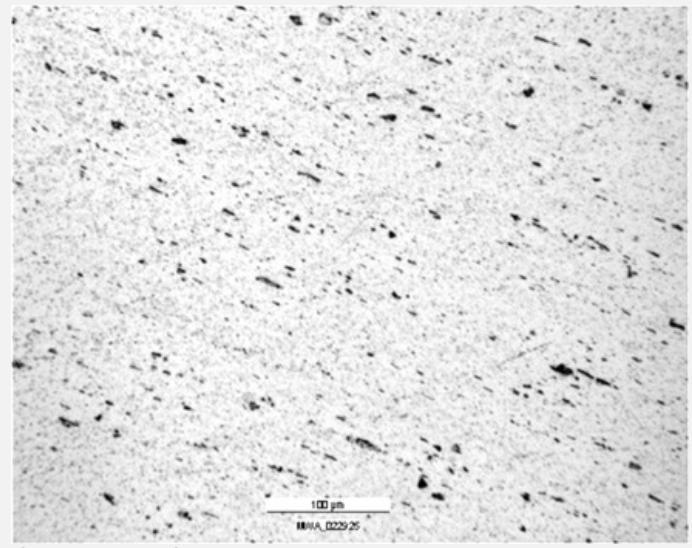
Fig. 5: Micrograph of the metal sample from Fig. 3 (detail), etched, bright field. The metal matrix is in white, the elongated inclusions in dark-grey and black,

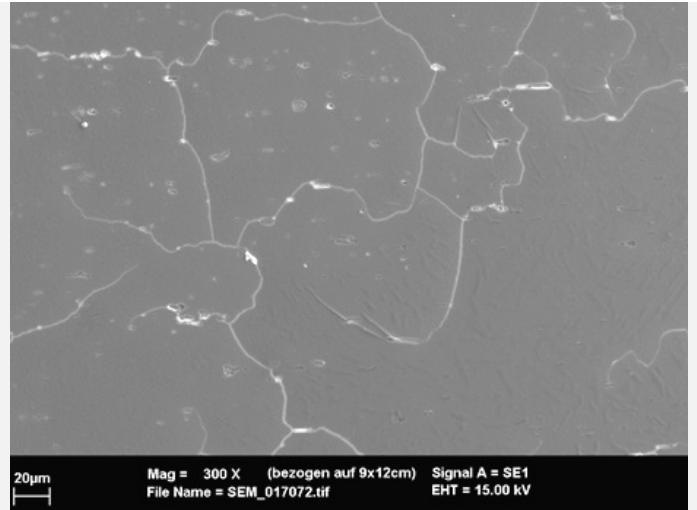
Fig. 6: SEM image of the metal sample from Fig. 3 (detail), SE-mode, etched. We observe the presence of large grains and numerous elongated inclusions,

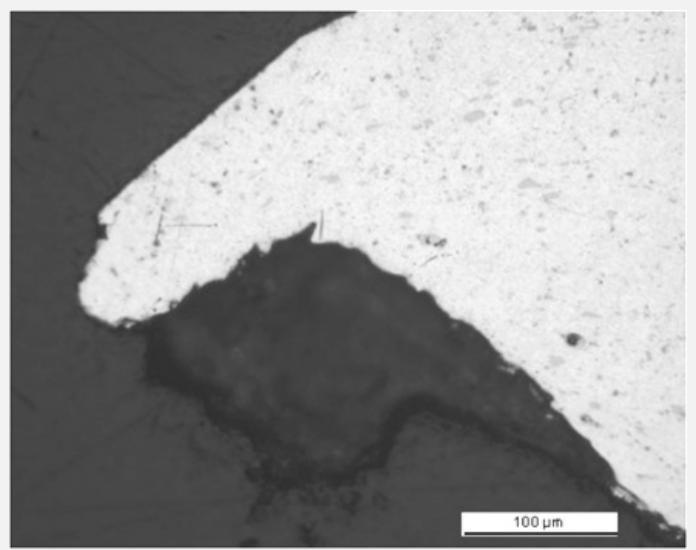
The metal is covered by a very thin corrosion layer (CP1). In addition to this, locally thicker adhering materials can be observed (NMM1, appearing as dark-grey area in Fig. 7). Under polarized light, they appear blue-brown (Fig. 8). Analysis by SEM-EDS indicates that the metal is, as expected, covered by a very thin Al and O-rich layer whereas the particles in the adherent material contain C, O, Si, Ca, Fe, Zn, S and even Ti (Figs. 9 and 10). The location of the adherent material and the presence of both Zn and Ti suggest that it is a residue of a paint coating.

Fig. 7: Micrograph showing the metal - adhering material interface from Fig. 3 (reversed picture, detail), unetched, bright field. We observe in white the metal matrix and darkgrey the adhering material,

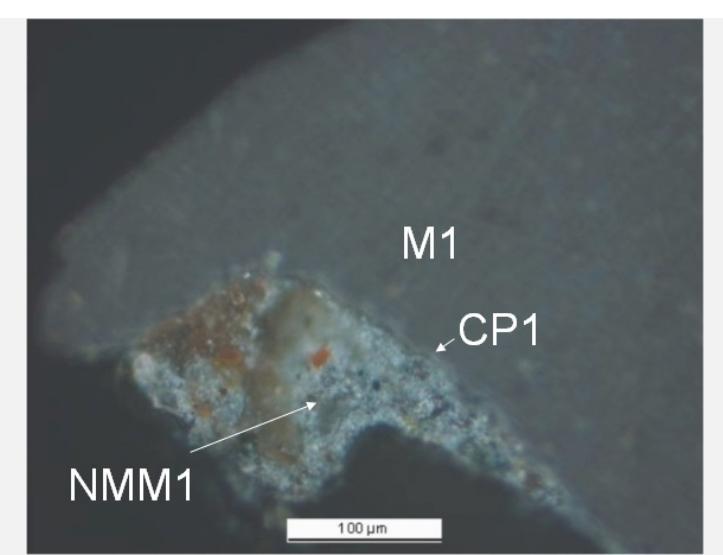
Fig. 8: Micrograph (same as Fig. 7) and corresponding to the stratigraphy of Fig. 11, unetched, polarised light. We observe

in grey the metal matrix and blue-brown the adhering material,

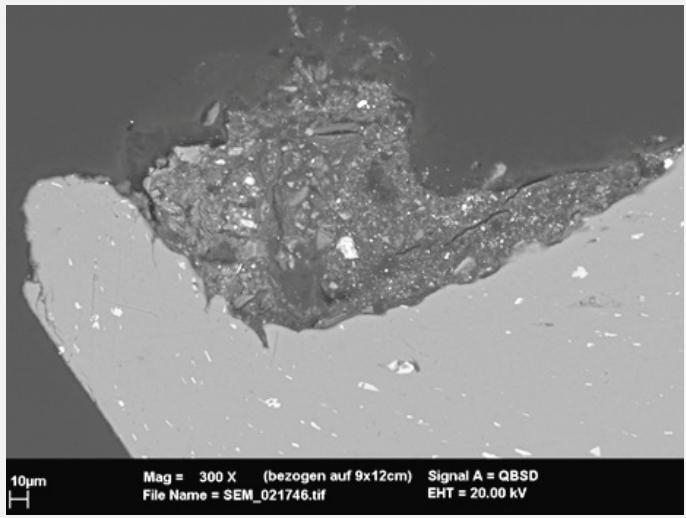
Fig. 9: SEM image (same as Fig. 7, inverted picture, detail), BSE-mode, unetched,

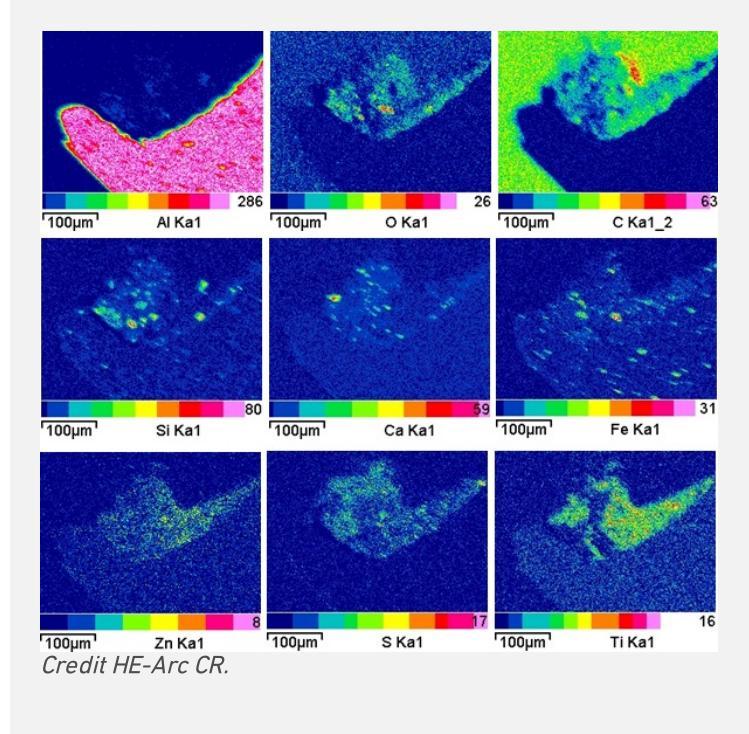
Fig. 10: Elemental chemical distribution of the selected area from Fig. 9. Method of examination: SEM/EDS, Laboratory of Analytical Chemistry, Empa,

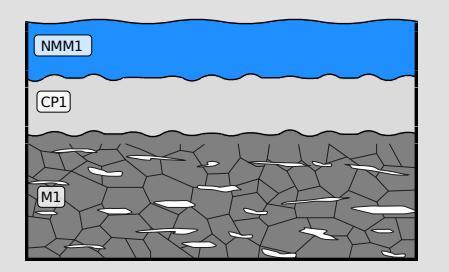
Fig. 11: Stratigraphic representation of the sample taken from the back fastening plate in cross-section (dark field) using the MiCorr application. The characteristics of the strata are only accessible by clicking on the drawing that redirects you to the search tool by stratigraphy representation. This representation can be compared to Fig. 8, Credit HE-Arc CR.
