# CHISEL POINT DEV 995 1069 PR – EUTECTOID TO HYPEREUTECTOID STEEL – EARLY MEDIEVAL TIMES – SWITZERLAND

**Artefact name** Chisel point DEV 995 1069 PR

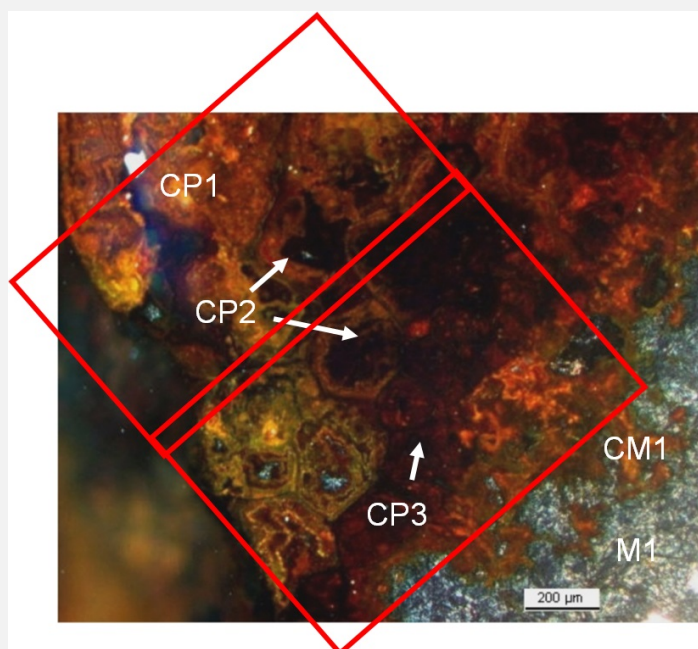
Table 3: Chemical composition (mass %) of the corrosion crust (from Figs. 10-13). Method of analysis: SEM/EDS, Laboratory of Analytical Chemistry, Empa.

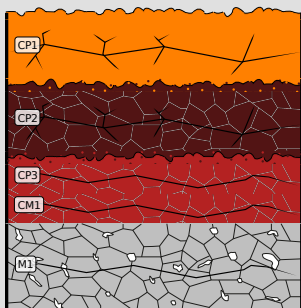
Fig. 14: Stratigraphic representation of the chisel point in cross-section (dark field) using the MiCorr application. The characteristics of the strata are only accessible by clicking on the drawing that redirects you to the search tool by stratigraphy representation. This representation can be compared to Fig. 10, Credit HE-Arc CR.
