ARMATURE FROM A CLOCK MOVEMENT MIH IV-212 - ZN AL SN CU ALLOY - MODERN TIMES

Armature from a clock movement MIH IV-212

Marianne. Senn (Empa, Dübendorf, Zurich, Switzerland) & Christian. Degrigny (HE-Arc CR, Neuchâtel, Neuchâtel, Switzerland)

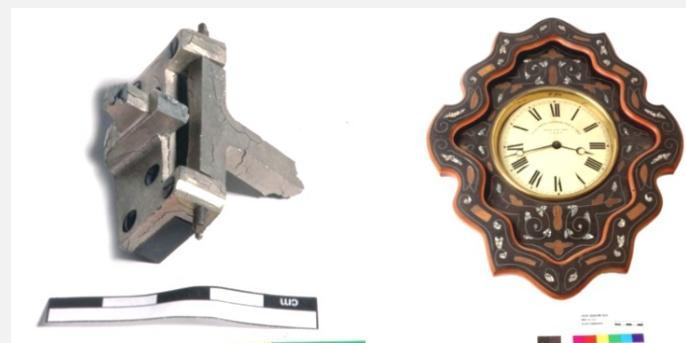
Fig. 1: Broken armature (left) from the clock movement of a wooden wall clock (right) (after Seematter 2009),

Description of the artefact	Armature from the clock movement of a wooden wall clock with electric movement, broken in two elements (Fig. 1 and Fig. 2) with a heavily cracked surface.				
Type of artefact	Horological object				
Origin	Wooden wall clock				
Recovering date	1902-1904				
Chronology category	Modern Times				
chronology tpq	1902 A.D. 🗸				
chronology taq	1904 A.D. 🗸				
Chronology comment					
Burial conditions / environment	Indoor atmosphere

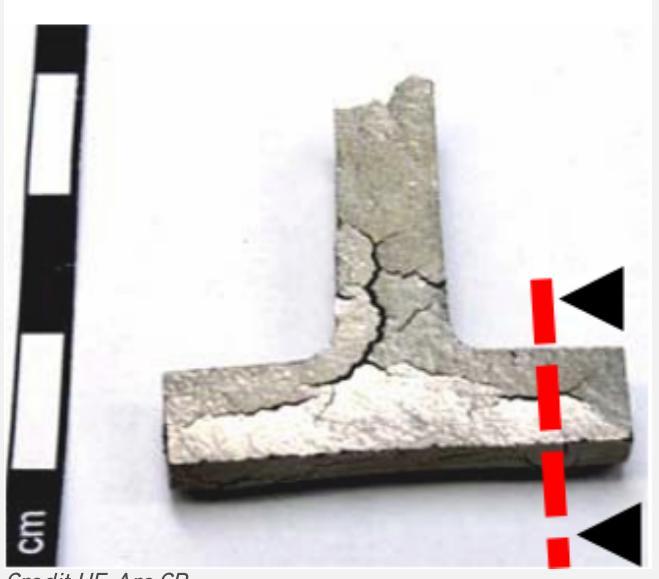
Fig. 2: Location of sampling area on one of the two broken elements of the armature,

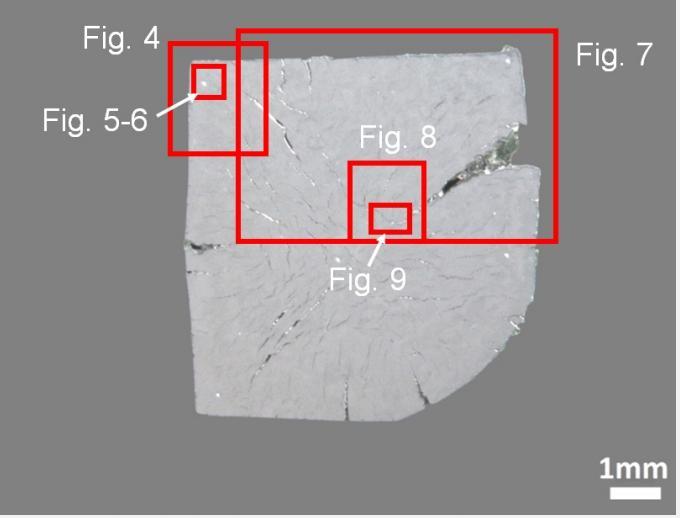
Fig. 3: Micrograph of the cross-section of the fragment sampled from the armature showing the location of Figs. 4 to 9,

Description of sample	This sample is the complete cross-section from one of the two broken elements of the armature (Fig. 2). The metal has large cracks radiating from the centre to the outside which have deformed the armature (Fig. 3).
Alloy	Zn Al Sn Cu Alloy
Technology	As-cast
Lab number of sample	MIH-VI-212
Sample location	HE-Arc CR, Neuchâtel, Neuchâtel
Responsible institution	International museum of horology (IMH), La Chaux-de-Fonds, Neuchâtel
Date and aim of sampling	2009, metal analysis

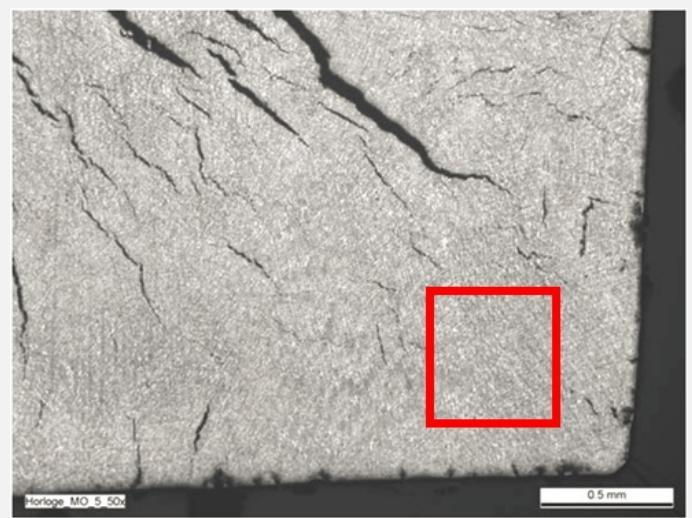
The metal is a Zn-Al-Sn-Cu alloy (Table 1) with an average hardness of HV1 105. A fine dendritic structure is observed (Fig. 4) which consists of clearly separated Zn, Al-Cu and Sn-rich phases (Figs. 5 and 6). Pb is associated with Sn but also forms tiny nodules.

Fig. 4: Micrograph of the metal sample from Fig. 3 (inverted picture, rotated by 270°, detail), unetched, bright field. A dendritic structure is visible. The micrograph of Fig. 5 is marked by a square,

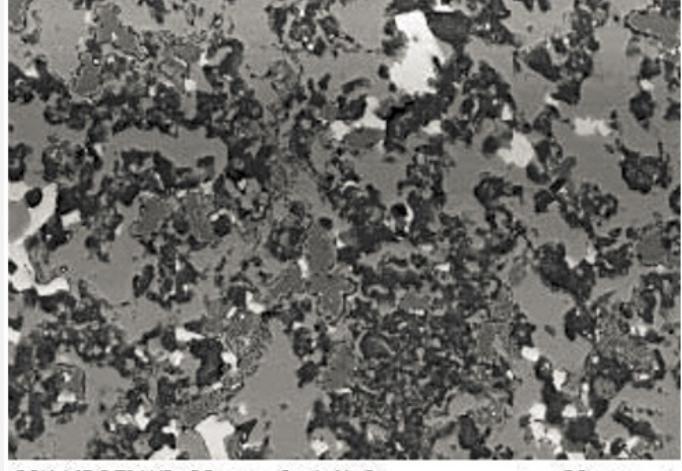
Fig. 5: SEM image, BSE-mode, detail from Fig. 4 (detail), unetched, bright field. Three phases appear: in light-grey the Zn-rich phase, in dark-grey the Al and Cu-rich phase and in white the Sn-rich phase,

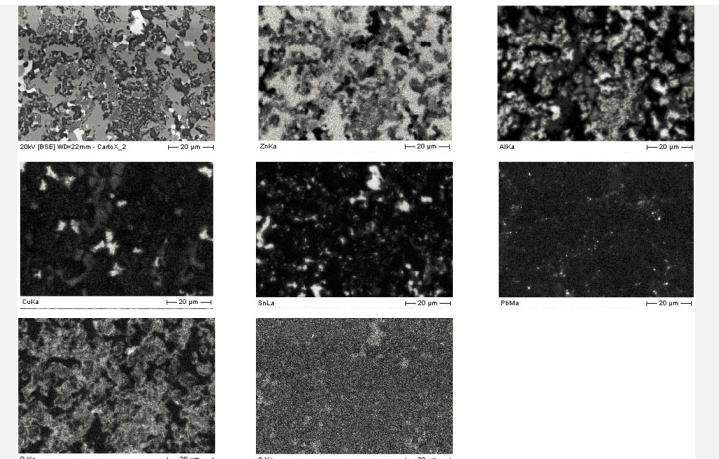
Fig. 6: SEM image, BSE-mode, and elemental chemical distribution of the selected area from Fig. 5. Method of examination: SEM/EDS, Lab of Electronic Microscopy and microanalysis, IMA (Néode), HEI Arc,

The Zn-rich phase is heavily oxidised internally (Fig. 6). The corrosion has developed throughout the entire metal body, generating cracks (Figs. 7 and 8). The cracks are Zn, O and C-rich (Fig. 9) and could be composed of zinc carbonate.

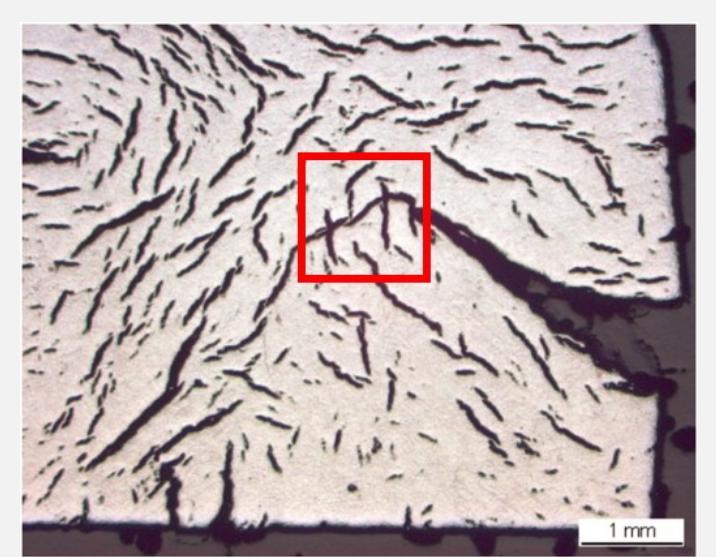
Fig. 7: Micrograph showing the metal - "corrosion products" interface from Fig. 3 (reversed picture, detail), unetched, bright field,

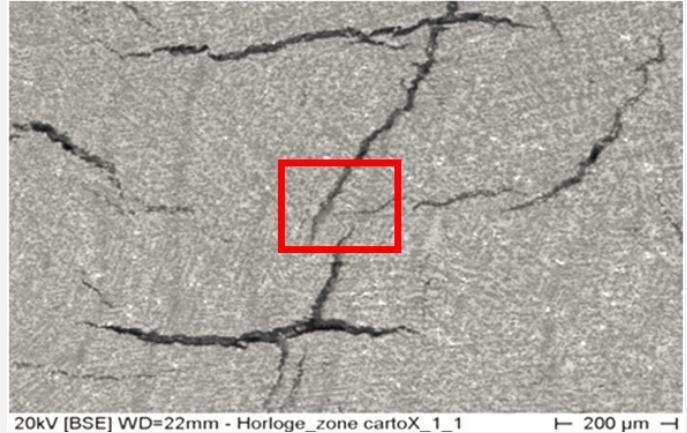
Fig. 8: Micrograph of the metal sample, detail from Fig. 7 (reversed and rotated by 90°), unetched, bright field. A dendritic structure is visible. The area selected for elementary mapping (Fig. 9) is marked by a rectangle. Can be compared to the stratigraphy representation of Fig. 10,

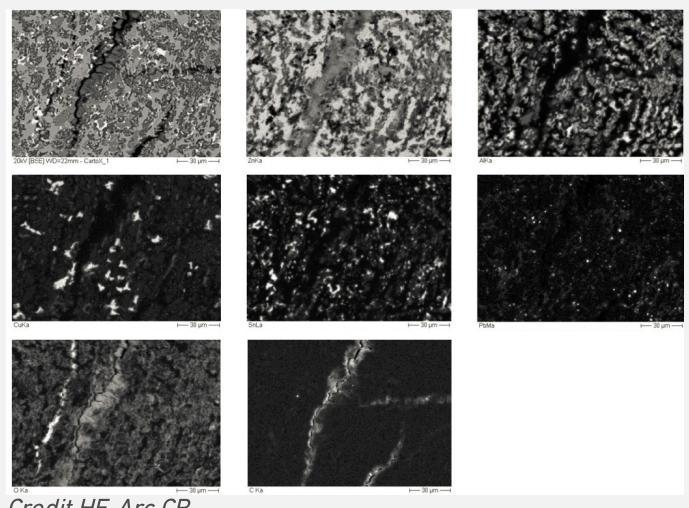
Fig. 9: SEM image, BSE-mode, and elemental chemical distribution of the selected area from Fig. 8 (detail). Method of examination: SEM/EDX, Lab of Electronic Microscopy and microanalysis, IMA (Néode), HEI Arc,

Corrosion form	Internal cracking
Corrosion type	zinc pest
