DOMED CAP NUT - ZN AL SN CU ALLOY - MODERN TIMES - FRANCE

Domed cap nut

Christian. Degrigny (HE-Arc CR, Neuchâtel, Neuchâtel, Switzerland) & Mathea. Hovind (University of Oslo, Department of archaeology, conservation and history (IAKH-UiO), Oslo, Oslo, Norway)

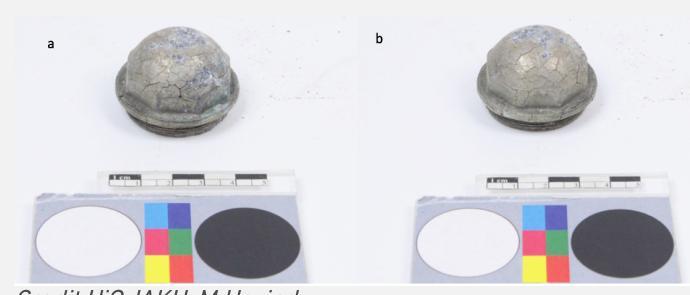
Fig. 1: Octogonal domed cap nut. Profile "a" and "b", to the left and right, respectively,

Description of the artefact	A domed cap nut made of a cast alloy with a metallic plating (Fig. 1). Its shape is octagonal and the inside is hollow. The plating is heavily cracked, leading to surface flaking. The metal underneath appears to be consumed by some kind of internal corrosion. Dimensions: $L(\emptyset) = 40$ mm; H = 28mm; T = 5mm; WT = 49g.					
Type of artefact	Сар					
Origin	Château de Germolles (14th	century), Mellecey, Bourgogne, France				
Recovering date	Unknown					
Chronology category	Modern Times					
chronology tpq	1900	A.D. 🗸				
chronology taq	2000	A.D. 🗸				
Chronology comment	19th - 20th century					
Burial conditions / environment	Outdoor atmosphere					
Artefact location	HE-Arc CR Neuchâtel Neuc	hâtel

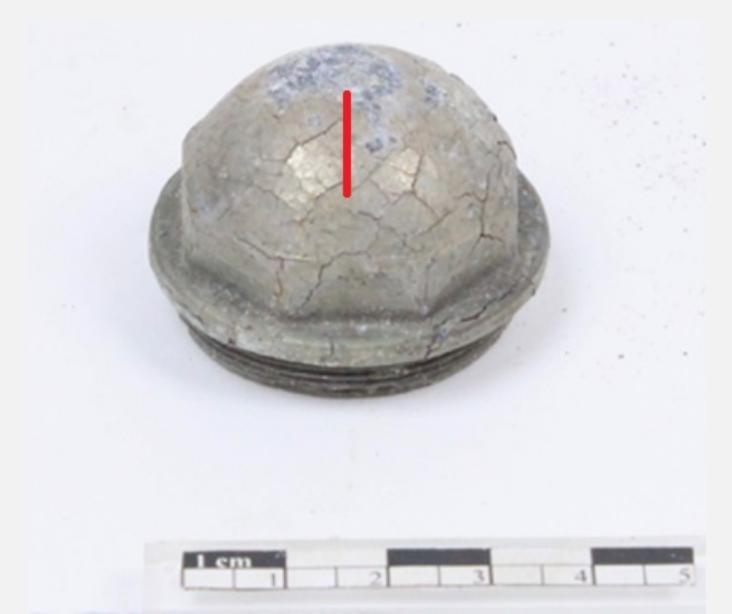
Fig. 2: Zone of the artefact submitted to visual observation and location of sampling area (a cross-section of the metal marked by the red line),

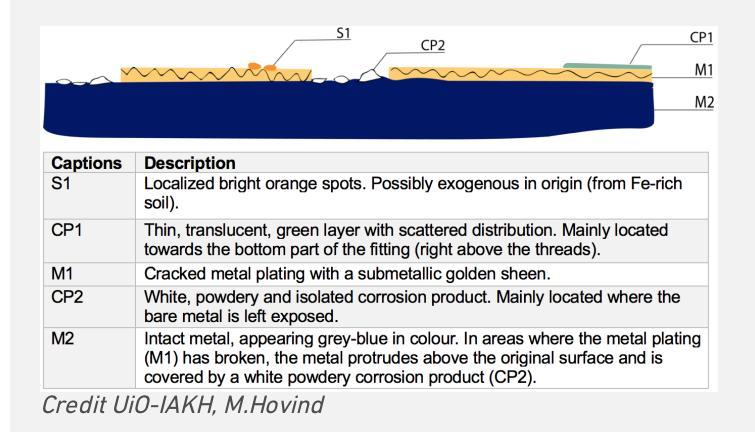
Fig. 3: Preliminary stratigraphy of the corrosion structure from visual macroscopic observation,

The external corrosion products and deposits (Fig. 3) were documented but not analyzed as they were considered to be mainly exogenous in origin and not the main reason behind the deterioration of the object. The orange deposit (S1) is probably soil from Fe-rich environment, while the thin green layer (CP1) is most likely consisting of an oxide of Ni from the nickel plating (M1). The white corrosion product (CP2) can either be a salt from the environment, corrosion products of Zn/Al or zinc carbonate.

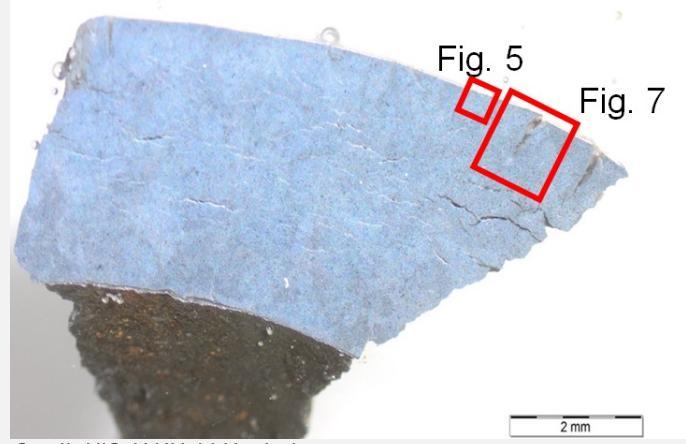
Fig. 4: Micrograph of the cross-section of the sample taken from the domed cap nut showing the locations of Figs. 5 and 7,

Description of sample	The sample is a cross section of the metal, representative of the domed cap nut. It shows external cracks extending from the metal surface and into its structure in addition to internal cracks, visible as thin lines along its longitudinal axis (Fig. 4).
Alloy	Zn Al Sn Cu Alloy
Technology	Cast and plated
Lab number of sample	NZC2018 (Ni/Zn Cap, sampled in 2018)
Sample location	HE-Arc CR, Neuchâtel, Neuchâtel
Responsible institution	HE-Arc CR, Neuchâtel, Neuchâtel
Date and aim of sampling	March 2018, study of corrosion stratigraphy and chemical analyses

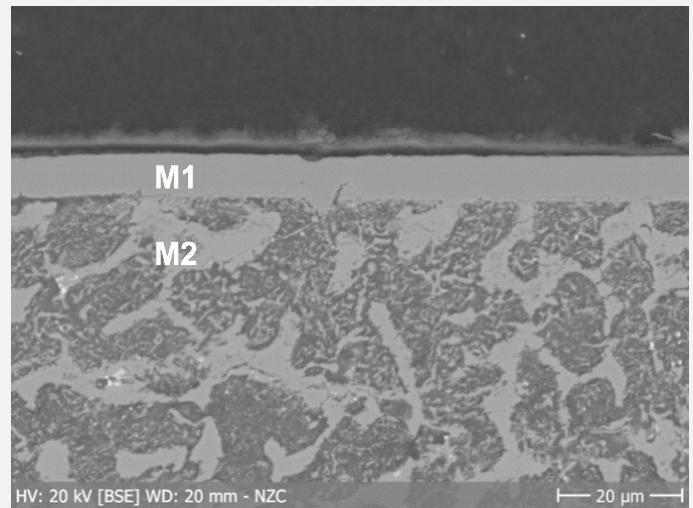
The metal of the domed cap nut (M2) consists of a Zn/Al/Pb/Cu/Sn alloy (Table 1) externally covered by a nickelbased plating (M1) (Figs. 5 and 6) containing some cobalt (Co). The bulk metal (M2) has a dendritic microstructure appearing light grey in bright field, while the interdendritic phase appears white (Fig. 7). The latter is Zn-rich, while the dendritic phase consists of approximately equal amounts of Zn and Al (Table 2, Fig. 9). Observation in SEM (BSEmode) reveals the presence of Pb-nodules, visible as white irregular spots with a scattered distribution, in addition to opaque grey patches which are rich in Al and Fe (Fig. 8).

Fig. 5: SEM-image (BSE-mode) of a selected area from Fig. 4 (detail), showing the metal plating (M1) and the bulk metal (M2),

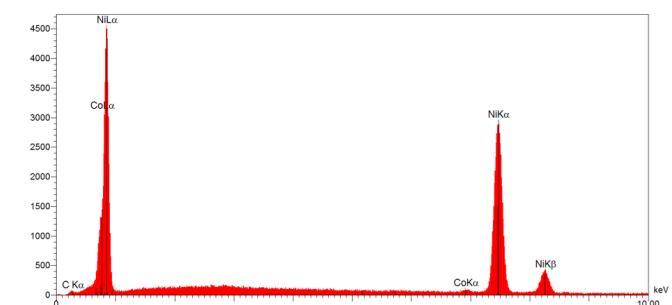
Fig. 6: EDS-spectrum showing the chemical composition of the metal plating (M1). Method of analysis: SEM-EDS. Lab. of Electronic Microscopy and and Microanalysis, Néode, HEI Arc,

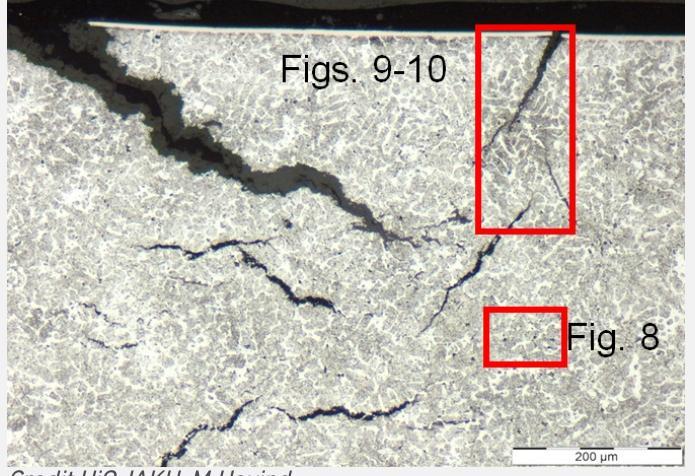
Fig. 7: Micrograph of the metal sample from Fig. 4 (detail), unetched, bright field. The dendrites appear light to dark grey while the interdendritic phase appears white. The metal is characterized by surface cracks as well as internal cracks. The lower red rectangle corresponds to Fig. 8 while the areas selected for elemental chemical distributions (Figs. 9 and 10) are marked by the upper red rectangle,

The dendritic phase is heavily oxidized compared to the interdendritic phase (Table 2 and Fig. 10). The corrosion has developed throughout the entire metal body, generating cracks (Fig. 7). The cracks are Zn and O-rich (Fig. 10) and could be composed of zinc oxide or carbonate. It could be a case of zinc pest, a corrosion phenomenon known to cause disintegration in poor quality alloys (Selwyn 2004, Zhang 2011).

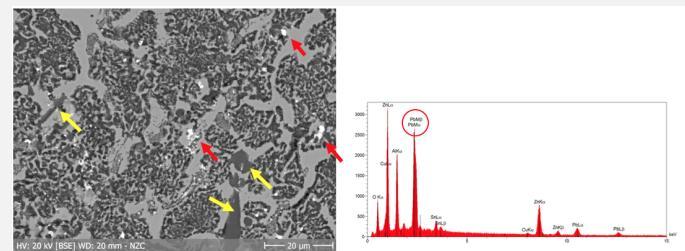
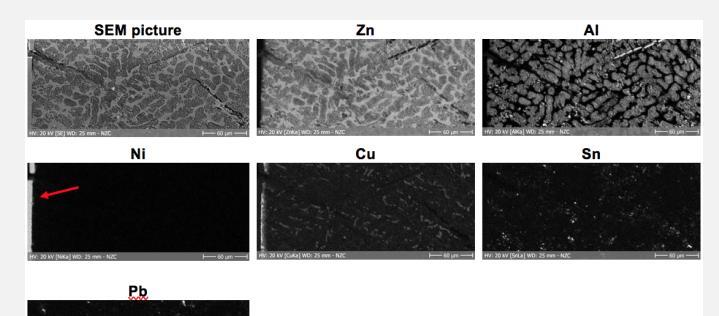
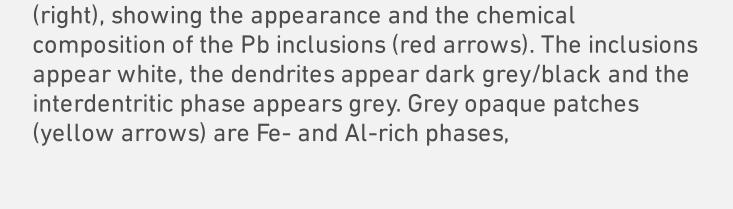
Fig. 8: SEM-image in BSE-mode (left) and EDS-spectrum

Fig. 9: SEM image and elemental chemical distribution of the selected area from Fig. 7 (rotated 270° and inversed). Method of analysis: SEM-EDS. Lab. of Electronic Microscopy and Microanalysis, Néode, HEI Arc,

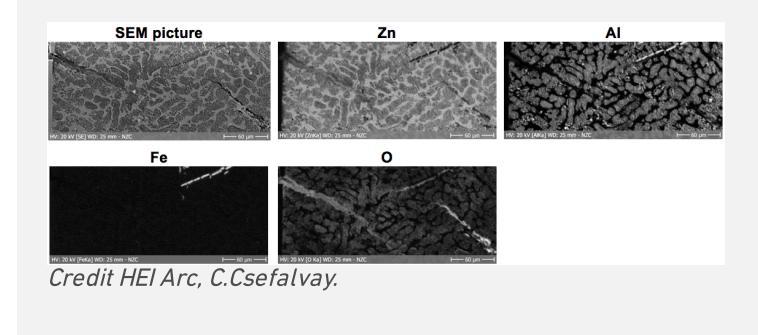
Fig. 10: SEM image and elemental chemical distribution of the selected area from Fig. 7 (rotated 270° and inversed). Method of analysis: SEM-EDS. Lab. of Electronic Microscopy and Microanalysis, Néode, HEI Arc,

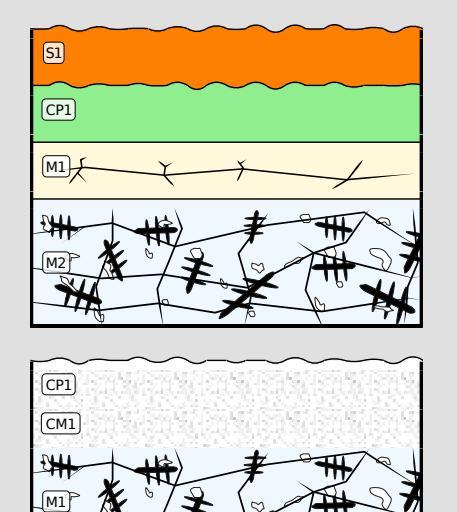
Fig. 11: Stratigraphic representation of the sample taken from the domed cap nut in cross-section (dark field) using the MiCorr application. The characteristics of the strata are only accessible by clicking on the drawing that redirects you to the search tool by stratigraphy representation. Stratigraphy representative of an area with intact metal plating (M1). S1 represents Fe-polluted soil while CP1 is a green translucent corrosion product, Credit UiO-IAKH, M.Hovind.

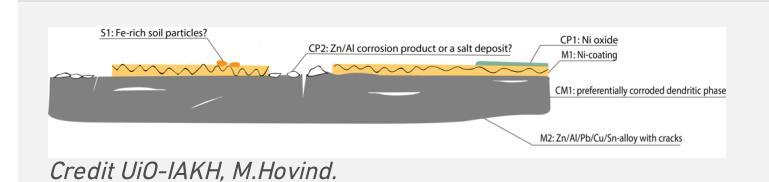
Fig. 13: Improved stratigraphic representation of the domed cap nut with results from SEM-EDS analysis and visual microscopic observation. The colour of the metal was changed to grey as this was the colour of the metal when viewed in cross-section. CP = corrosion product, S = soil, M = metal, CM = corroded metal,

The domed cap nut is made of nickel plated Zn/Al/Pb/Cu/Sn alloy. It has a dendritic microstructure, indicative of production by casting (probably a die cast). The deterioration of the core metal could be due to absence of cohesion between the different phases which enabled the penetration of oxygen during the manufacture of the alloy and the formation of internal corrosion products, eventually leading to the expansion of its internal structure (zinc pest), the local breakage of the nickel plating, and the accentuation of the core metal.
