# ROOF GUTTER ELEMENT – ZN ALLOY – MODERN TIMES – FRANCE

Artefact name	Roof gutter element
Authors	Christian. Degriigny (HE-Arc CR, Neuchâtel, Neuchâtel, Switzerland) & Mathea. Hovind (University of Oslo, Department of archaeology, conservation and history (IAKH-UiO), Oslo, Oslo, Norway)
Url	/artefacts/1258/

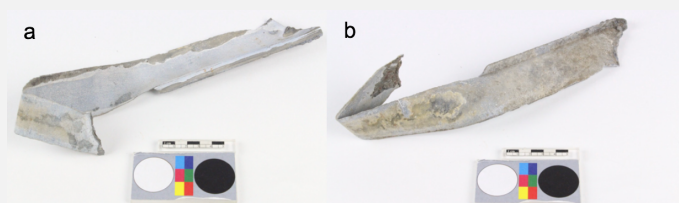
Fig. 1: Roof gutter element having different appearances on each of its surfaces: "a" on the left and "b" on the right,

Description of the artefact	A roof gutter element with remains of lead solder (Fig. 1). Its surfaces are covered by a white, strongly adherent oxide layer. Surface "b" is slightly darker in colour than surface "a" due to the presence of soil particles. Dimensions: L = 265mm; W = 47mm; T = 1mm; WT = 93g.
Type of artefact	Architectural element
Origin	Château de Germolles (14th century), Mellecey, Bourgogne, France
Recovering date	Unknown
Chronology category	Modern Times
chronology tpq	1900 A.D. ▼
chronology taq	2000 A.D. ▼
Chronology comment	19th-20th century
Burial conditions / environment	Outdoor atmosphere
Artefact location	HE-Arc CR, Neuchâtel, Neuchâtel
Owner	Château de Germolles, Mellecey, Bourgogne
Inv. number	None

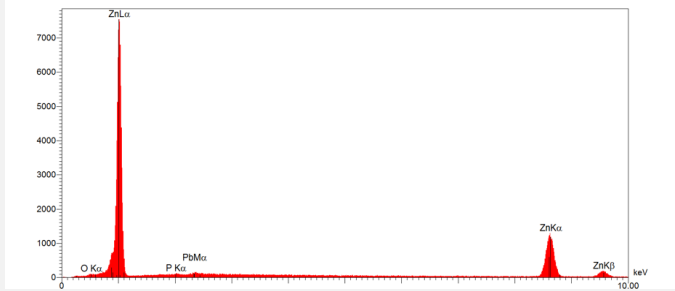
The roof gutter element is composed of Zn with P and Pb at lower concentrations (Fig. 5). The latter is probably originating from the solder that was applied to adjoin several metal sheets for the roof gutter.

Fig. 5: Chemical composition of the metal. Method of analysis: SEM-EDS. Lab. of Electronic Microscopy and Microanalysis, Néode, HEI Arc,

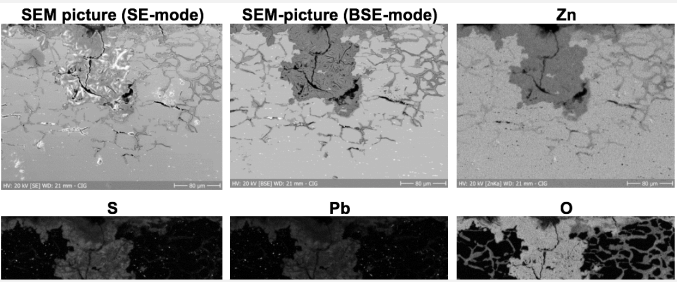
Fig. 13: SEM image and elemental chemical distribution of a selected area of Fig. 10 (rotated almost 180° and reversed). Method of analysis: SEM-EDS. Lab. of Electronic Microscopy and Microanalysis, Néode, HEI Arc,

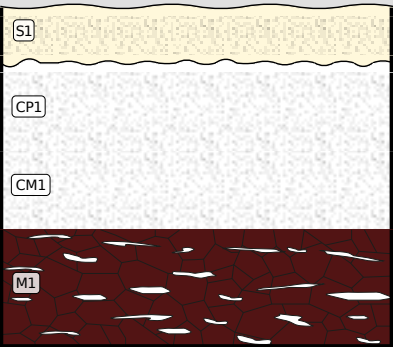
Fig. 14: Stratigraphic representation of the sample taken from the roof gutter (surface "b") in cross-section (dark field) using the MiCorr application. The characteristics of the strata are only accessible by clicking on the drawing that redirects you to the search tool by stratigraphy representation. This representation can be compared to Figs. 10 and 11, Credit UiO-IAKH, M.Hovind.
