FRAGMENT OF AN AEGIS OF NEÏTH 1886.305.0096 – LEADED BRONZE

Artefact name	Fragment of an Aegis of Neïth 1886.305.0096
Authors	Line. Pedersen (HE-Arc, Neuchâtel, Neuchâtel, Switzerland) & Christian. Degriigny (HE-Arc CR, Neuchâtel, Neuchâtel, Switzerland) & Valentin. Boissonnas (HE-Arc CR, Neuchâtel, Neuchâtel, Switzerland)
Url	/artefacts/1372/

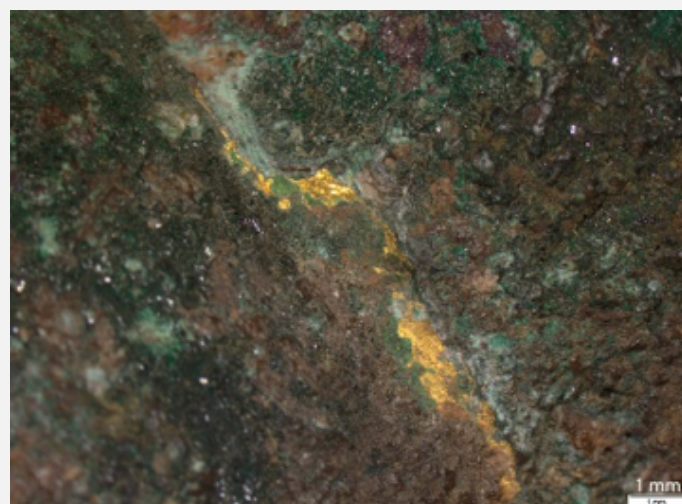
Fig. 3: Remains of foil-gilding on the corroded surface,

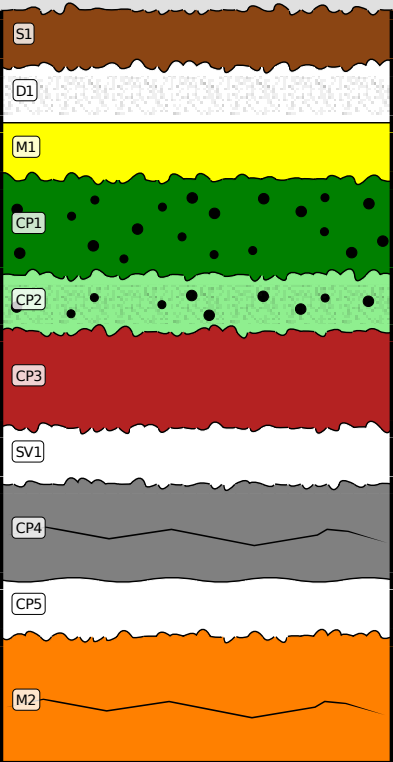
Fig.9: Schematic representation combining stratigraphies 1 and 2 under binocular microscope and using the MiCorr application. The characteristics of the strata are only accessible by clicking on the drawing that redirects you to the search tool by stratigraphy representation, Credit He-Arc CR, L.Pedersen.

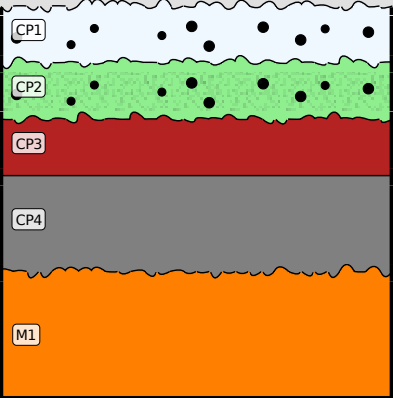
Fig.10: Schematic representation of stratigraphy 3 under binocular microscope and using the MiCorr application. CP1 is CP6 in Fig. 8. The characteristics of the strata are only accessible by clicking on the drawing that redirects you to the search tool by stratigraphy representation, Credit He-Arc CR, L. Pedersen.

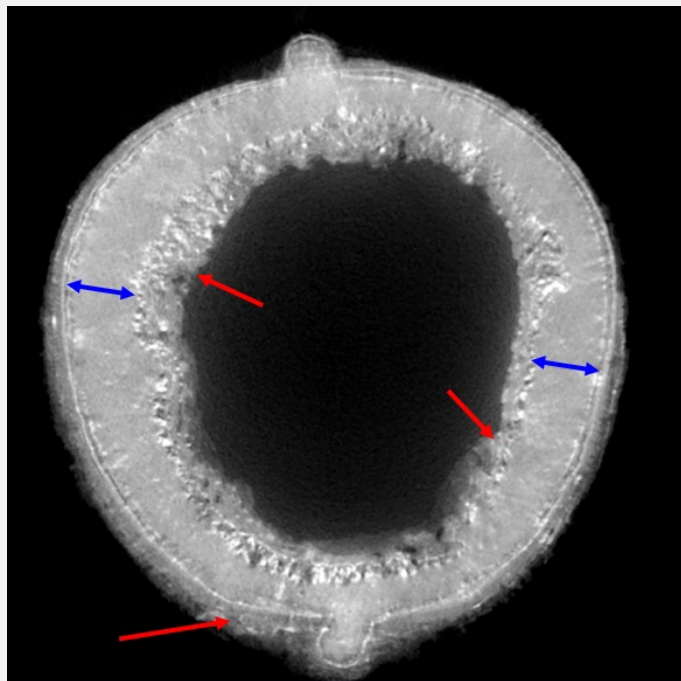
The metal seems to be a leaded bronze with remains of gold leaf on the surface (Table 1).
As indicated by the X-ray tomography, the metal of the aegis seems to be well preserved (Figs. 11-12).

Fig. 11: X-ray tomography by cross section of the crown showing a dense and non-porous metal core (blue arrows). The corrosion products however are porous (red arrows). The external limit is visible as a fine line preserved under corrosion layers,

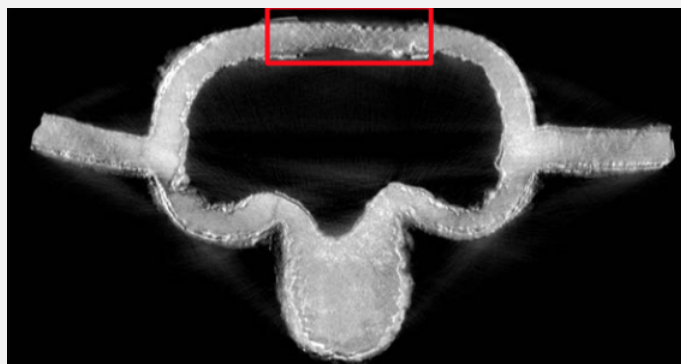
Fig. 12: X-ray tomography by cross section of the lower part showing that there are losses of the original surface (red square),

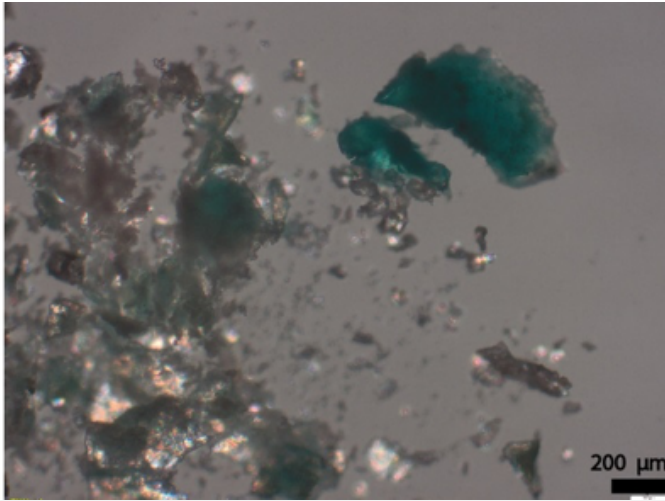
Fig. 19: Observation of the red corrosion product above the black original surface containing corresponding markers such as engravings,

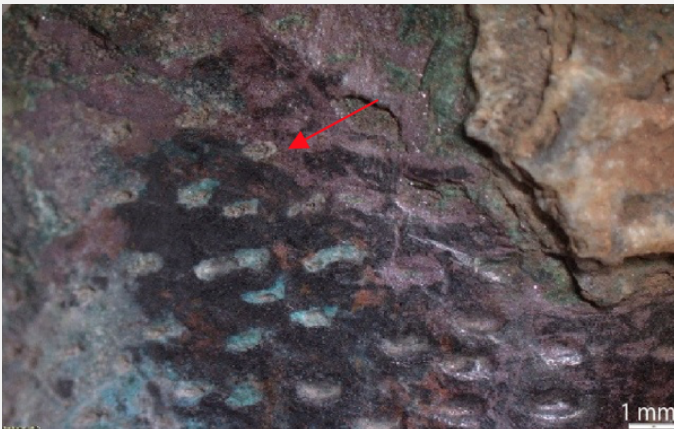
Fig. 20: Dark red corrosion product identified as cuprite Cu_2O as major component and tenorite CuO as minor component. Microscopic examination under polarized light,

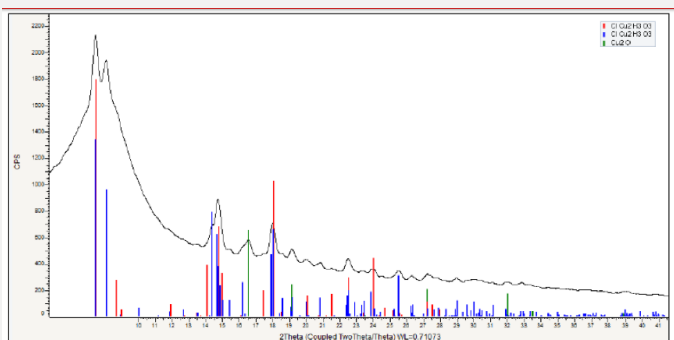
Fig. 21: XRD spectrum of the sample of the dark green corrosion product showing the presence of atacamite and paratacamite ($\text{Cu}_2\text{Cl}(\text{OH})_3$) as major compound and cuprite (Cu_2O) as minor compound,
