TANG FRAGMENT OF A KNIFE HR-6246 – TIN BRONZE – LATE BRONZE AGE – SWITZERLAND

Artefact name	Tang fragment of a knife HR-6246
Authors	Marianne. Senn (EMPA, Dübendorf, Zurich, Switzerland) & Christian. Degrigny (HE-Arc CR, Neuchâtel, Neuchâtel, Switzerland)
Url	/artefacts/224/

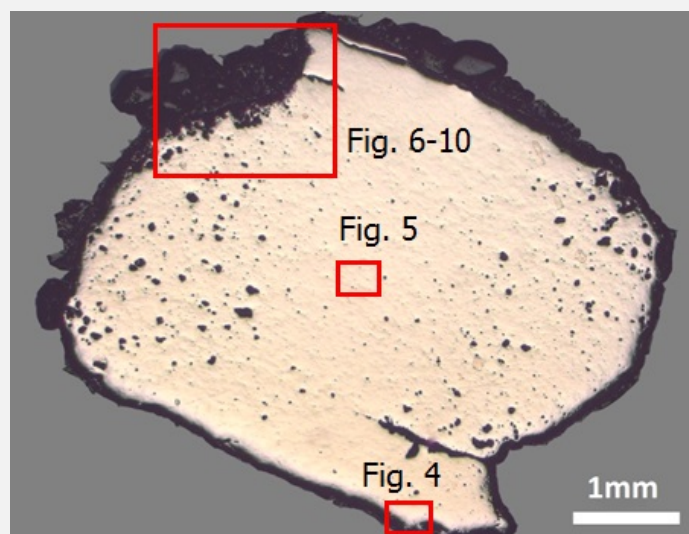
Fig. 3: Micrograph of the cross-section showing the locations of Figures 4 to 10,

The remaining metal is a tin bronze (Table 1) with high porosity and large cracks both on the left and right edges of the sample (Fig. 3). The metal contains small, elongated copper sulphide (Table 2) and Pb inclusions that are oriented parallel to the cracks. Near the metal surface, slip lines are outlined by the development of intergranular corrosion (Fig. 4). The etched metal shows small, elongated grains with slip lines (Fig. 5). Annealing is visible in areas near the surface. The average hardness of the metal is HV1 145, but significant variations are observed, depending on where the measurements are taken.

The corrosion crust has a thickness between 0.1mm and 0.7mm (Fig. 3). In bright field (Fig. 6), one can observe that the metal has been replaced by light-grey corrosion products. Adjacent to the metal is a thick, heterogeneous, dark-grey layer with a band of light-grey corrosion products. In polarised light (Fig. 7), all corrosion products which were previously light-grey appear brown-orange, the dark-grey layer turquoise. The elemental chemical distribution of the SEM image (Figs. 8 and 9) reveals that the inner corrosion products are Sn-rich whereas the adjacent band is Cu and S-rich (Fig. 10). The outer layer contains large inclusions (quartz and others, Si, Al and Na, see Figs. 9-10) and is most probably composed of malachite/ $\text{Cu}_2(\text{CO}_3)(\text{OH})_2$ (only Cu and O are detected – Fig. 10). S is distributed throughout this layer. XRD analyses indicated the presence of posnjakite/ $\text{Cu}_4\text{SO}_4(\text{OH})_6\text{H}_2\text{O}$, chalcocite/ Cu_2S and djurleite/ $\text{Cu}_{1.93}\text{S}$ (Schweizer 1994).

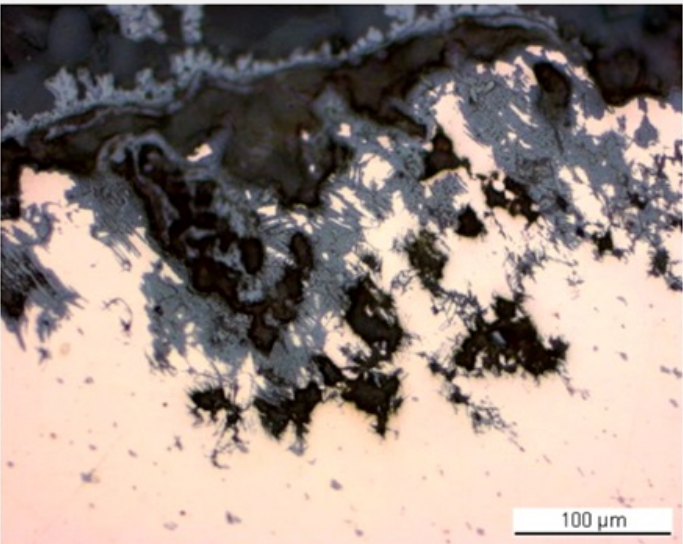
Fig. 4: Micrograph of the metal sample from Fig. 3 (inverted and reversed picture, detail), unetched, bright field. Corrosion products are in dark-grey whereas the metal is in pink. Slip lines are outlined by the development of intergranular corrosion,

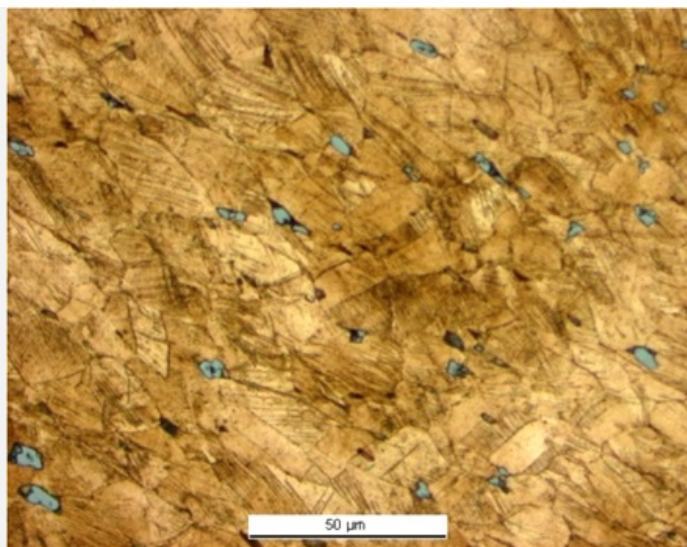
Fig. 5: Micrograph of the metal sample from Fig. 3 (detail), etched, bright field. We observe elongated grains with slip lines as well as grey copper sulphide inclusions,

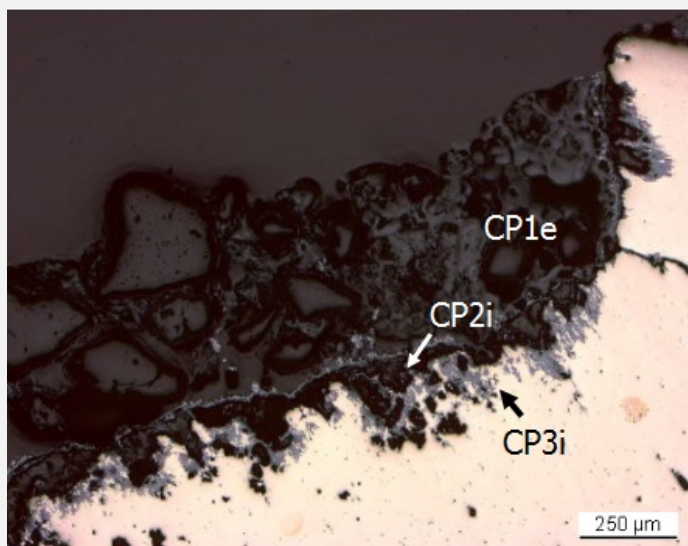
Fig. 6: Micrograph of the metal sample from Fig. 3 (detail), unetched, bright field. The inner light-grey corrosion products extend into the metal surface (in pink) and appear as a line within the dark-grey corrosion layer,

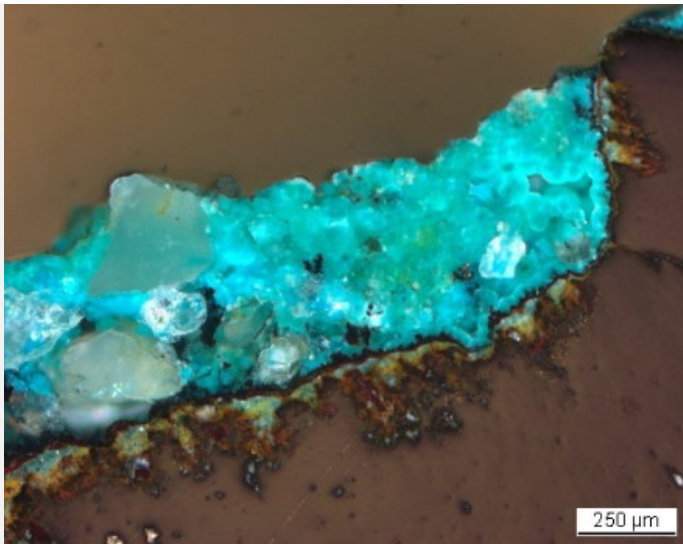
Fig. 7: Micrograph similar to Fig. 6, polarized light. One can see that large mineral features are incorporated only in the corrosion layers above the brown-orange corrosion band,

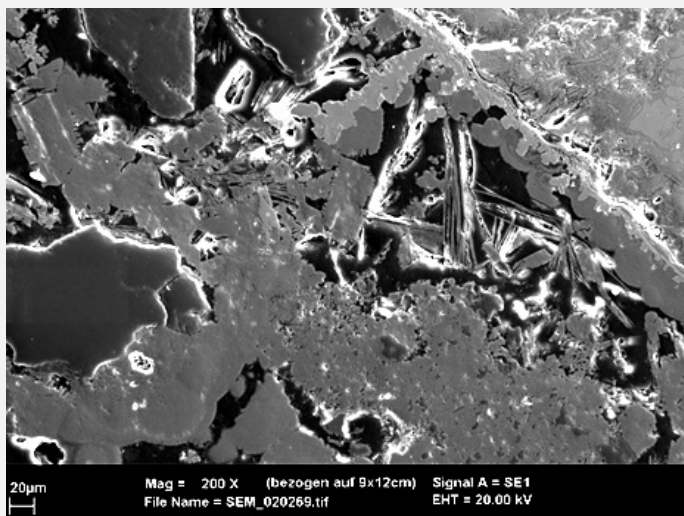
Fig. 8: SEM image (detail of Fig. 6), SE-mode. From bottom to top right: the thick, porous outer corrosion layer, the light-grey band and the remaining metal,

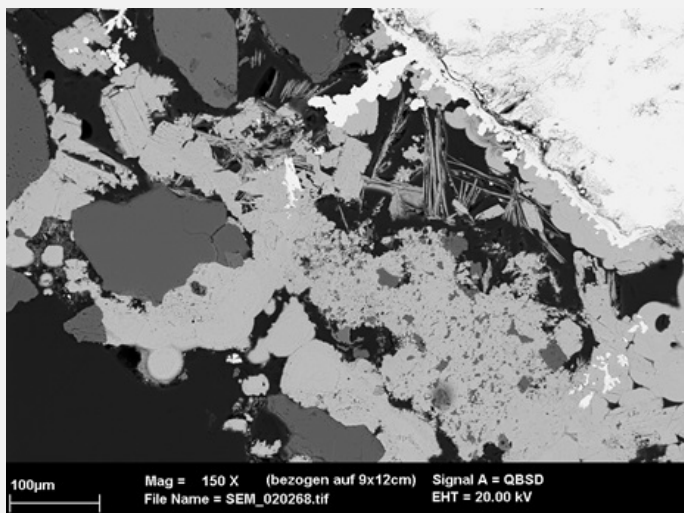
Fig. 9: SEM image, similar to Fig. 8, BSD-mode.

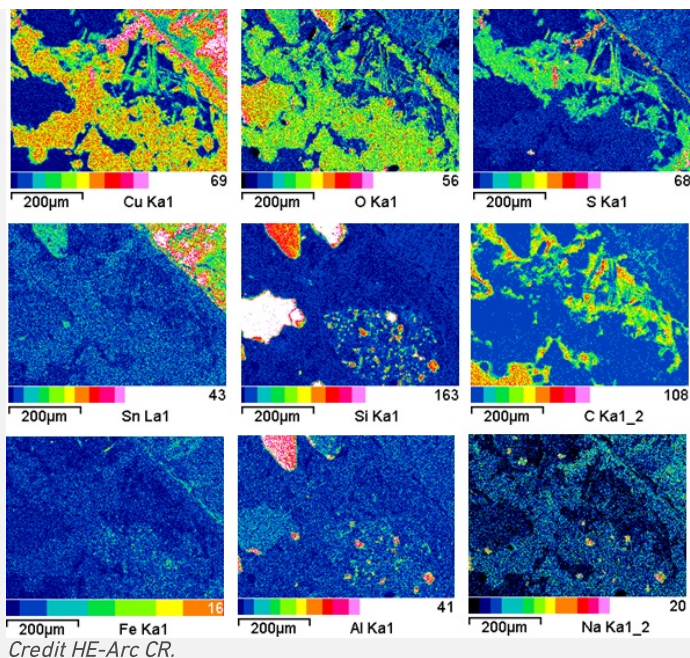
Fig. 10: EDX elemental chemical distribution of the SEM image of Fig. 8. Method of examination: SEM/EDX, Laboratory of Analytical Chemistry, Empa,

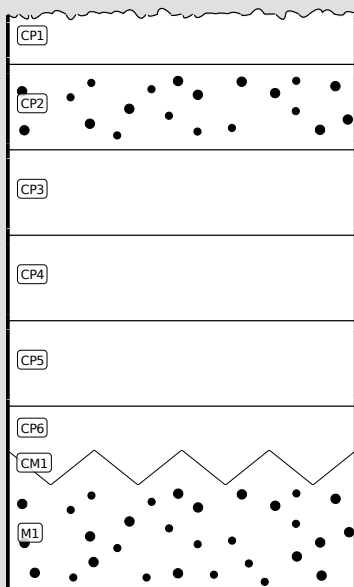
Corrosion form Uniform - transgranular

Corrosion type Type I (Robbiola)

Fig. 4: Stratigraphic representation of the object in cross-section using the MiCorr application. This representation can be compared to Fig. 8.
