SACRIFICIAL ANODE VHS-8339 - ZN ALLOY - MODERN TIMES

Sacrificial anode VHS-8339

Marianne. Senn (EMPA, Dübendorf, Zurich, Switzerland) & Christian. Degrigny (HE-Arc CR, Neuchâtel, Neuchâtel, Switzerland)

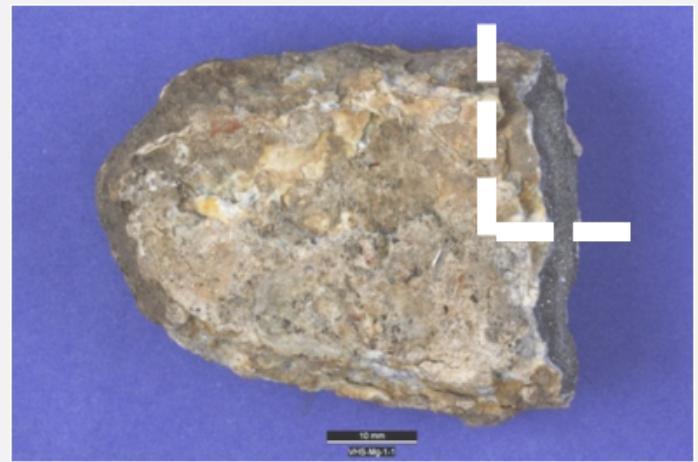
Fig. 2: Location of sampling area,

The sample (Fig. 3) shows a cross-section from the sacrificial anode (Fig. 2). The thickness of the corrosion crust is variable. Dimensions: L = 17mm; W = 14mm.

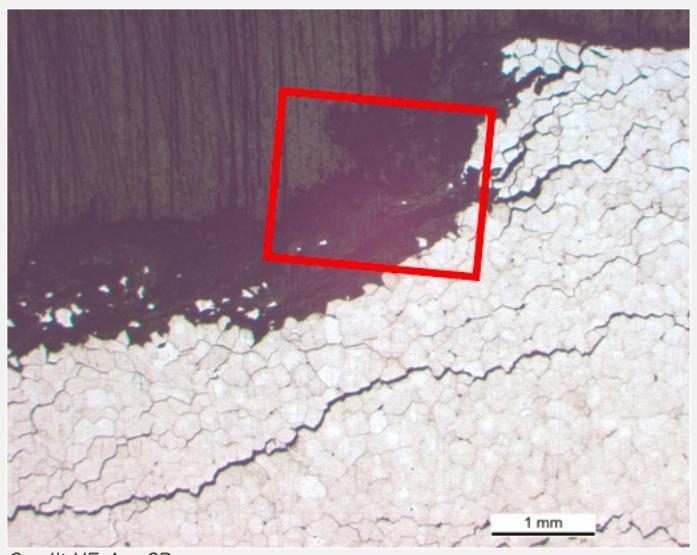
Fig. 5: Micrograph of the metal sample from Fig. 3 (reversed picture, detail), unetched, bright field. Extensive intergranular corrosion is visible.The rectangle marks Fig. 7,

Extended intergranular corrosion has developed in the metal structure (Figs. 5, 6). The metal is covered by a corrosion crust that is hardly visible in bright field and which contains remnant metal (Fig. 5). On most of the sample the corrosion crust is uniform. In areas we see cracks (Fig. 7) appearing as brown lines separating the corrosion crust (Fig. 8). In bright field the corrosion crust appears grey containing dark-grey zones (Fig. 7). Under polarized light, the corrosion crust appears white with darker parts including remnant metal (Fig. 8). It contains Zn and O as well as S along some cracks (Table 2 and Fig. 9).

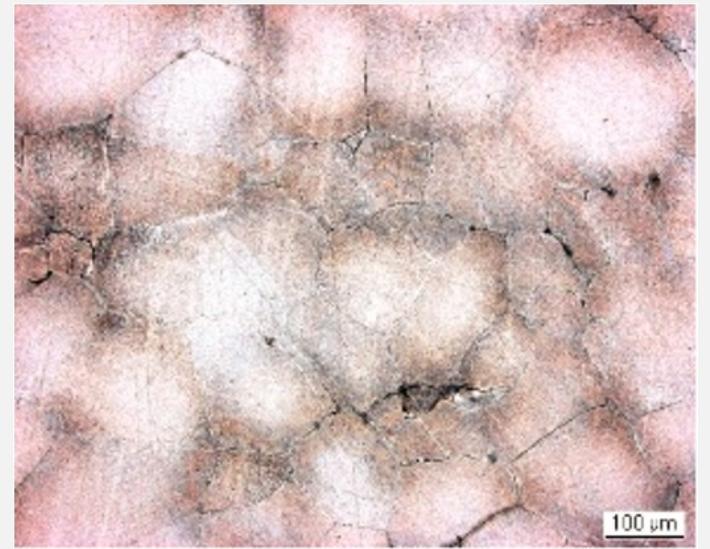
Fig. 6: Micrograph of the metal sample from Fig. 3 (detail), etched,

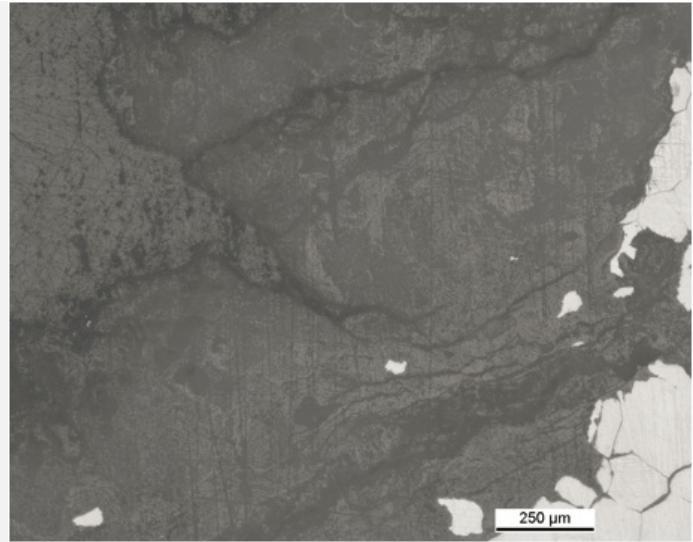
Fig. 7: Micrograph showing the metal - corrosion products interface from Fig. 5 (detail), unetched, bright field,

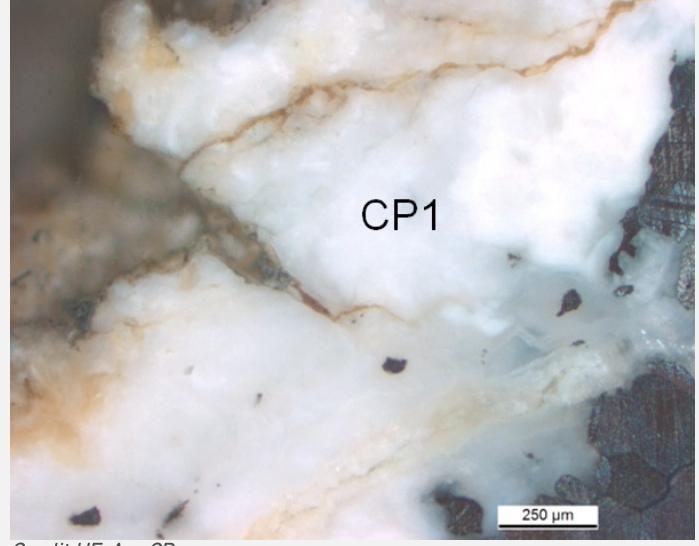
Fig. 8: Micrograph (same as Fig. 7) corresponding to the stratigraphy of Fig. 4, unetched, polarised light. We observe in dark-grey the metal, in white the corrosion crust separated by brown cracks including remnant metal,

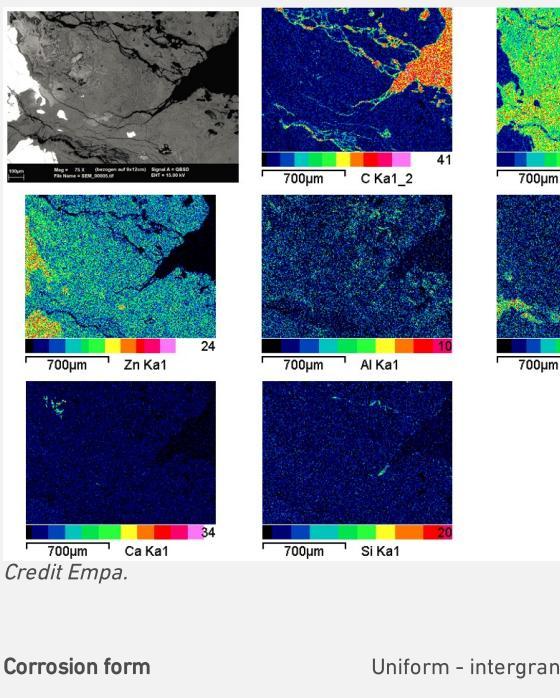
Fig. 9: SEM image, BSE-mode, and elemental chemical distribution of most of the area of Fig. 7 (reversed picture). Method of examination: SEM/EDS, Laboratory of Analytical Chemistry, Empa,
