# SITULA EMT09-554.665 - TIN BRONZE - IRON AGE - SWITZERLAND

Situla EMT09-554.665

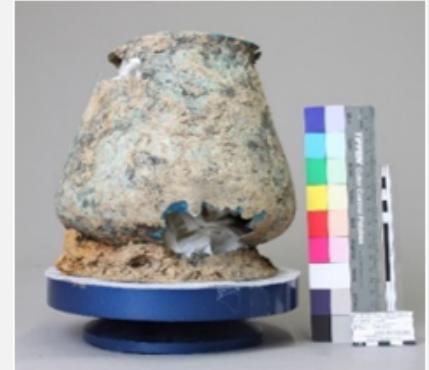
Fig. 1: Tin bronze Celtic situla (Archeodunum (Gollion), 2009) inverted as found in situ,

The size and quality of the object makes it likely that is was reserved for important occasions or for ritual use. Secondary use could be a votive offering. Burial condition: inside a 3 meters deep hole in upside-down position.

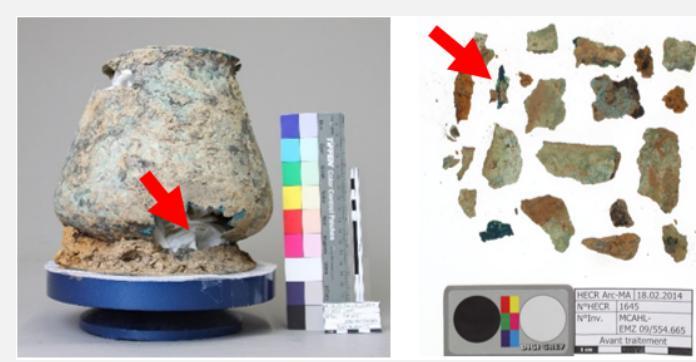
Fig. 2: Location of sampling area and sample selected from detached fragments,

Description of sample	The sample was cut from a detached fragment of the upper part of the main body of the situla in Fig. 2. The cross-section is representative of the entire thickness (0.5 mm) of the object's body where on the outside there is a thicker accumulation of corrosion including curly malachite clusters (Fig. 3). A metallic core is still present inside the corrosion products layers (Fig. 4).
Alloy	Tin Bronze
Technology	Cold worked (hammering on a counter-mould), annealed but no final annealing
Lab number of sample	None
Sample location	HE-Arc CR, Neuchâtel, Neuchâtel
Responsible institution	Musée cantonal d'archéologie et d'histoire, Lausanne, Vaud
Date and aim of sampling	2014, metallography and chemical analyses (FTIR, SEM-EDS)
Complementary information	
Nothing to report.

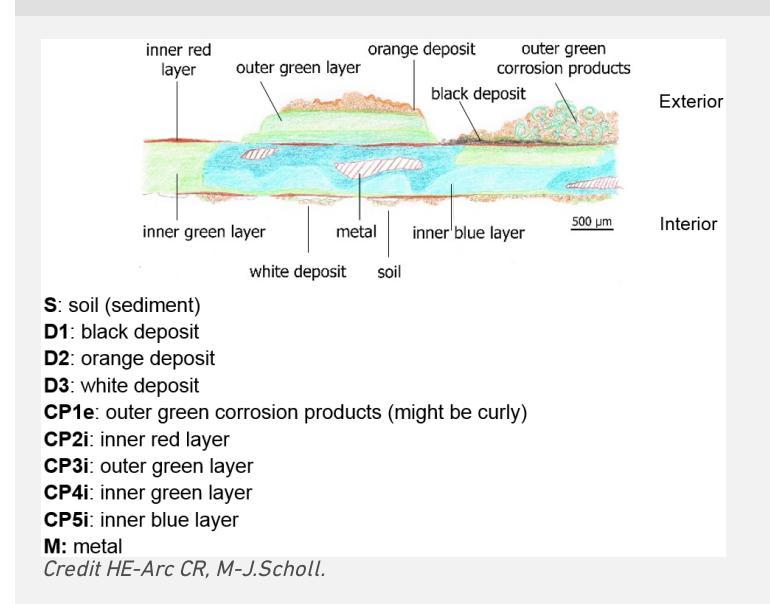
The schematic representation below gives an overview of the corrosion layers encountered on the situla from a first visual macroscopic observation (additional e and i within the coding correspond to strata in contact with the environment (e) and internal strata (i)).

Fig. 3: Stratigraphic representation of the situla in cross-section by macroscopic observation,

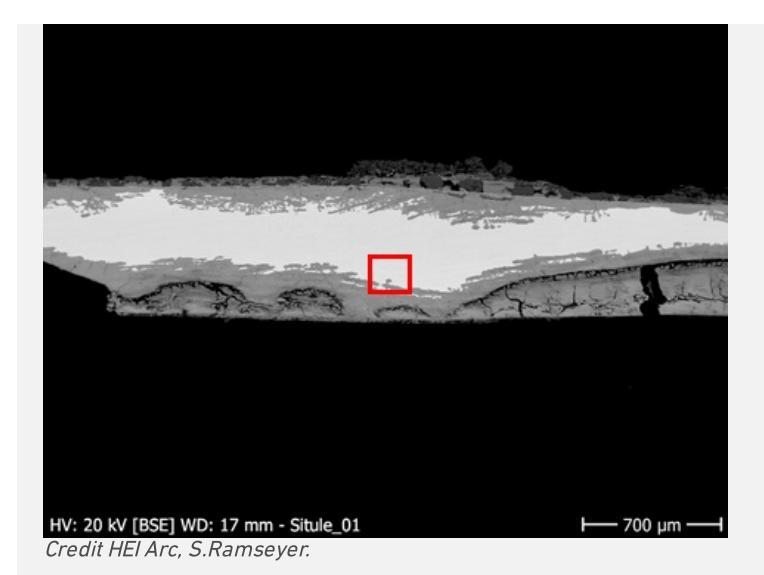
The remaining metal is a dense tin bronze (Fig. 7, Table 1), showing no inclusion. In bright field, the etched alloy shows a structure principally consisting of polygonal alpha phase grains (Fig. 8). Some of the grains include twin lines (Fig. 9). The presence of strain lines (slip lines) indicates a final cold work without annealing (Fig. 9).

Fig. 7: SEM image, BSE-mode, of the metal sample from Fig. 4. Area of Fig. 8 is marked by a rectangle,

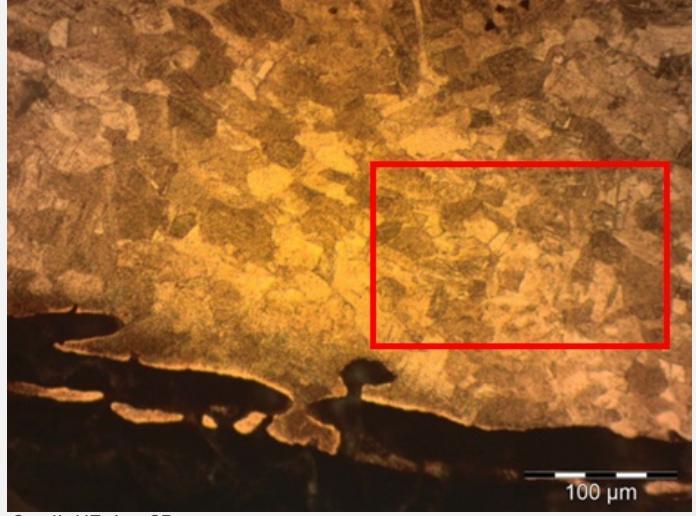
Fig. 8: Micrograph of the etched metal structure from Fig. 7 (detail), etched, bright field, 50x. The alpha phase of the alloy shows polygonal grains. Area of Fig. 9 is marked by a rectangle,

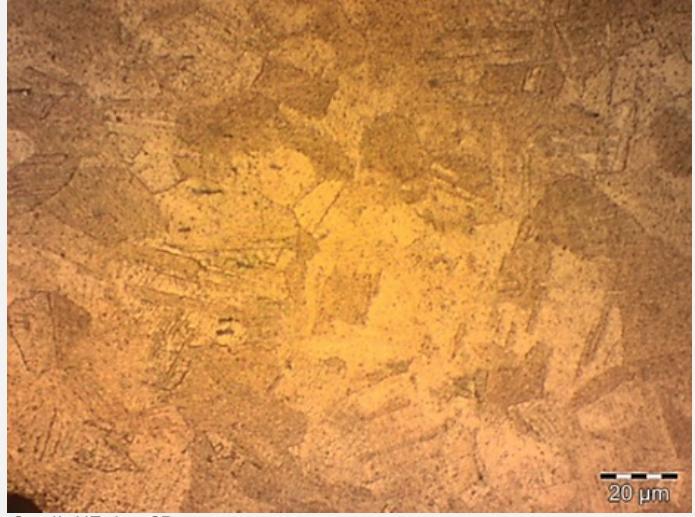
Fig. 9: Micrograph of the selected area of Fig. 8, etched, b	oright field,
500x. The grains show both twin and strain lines,

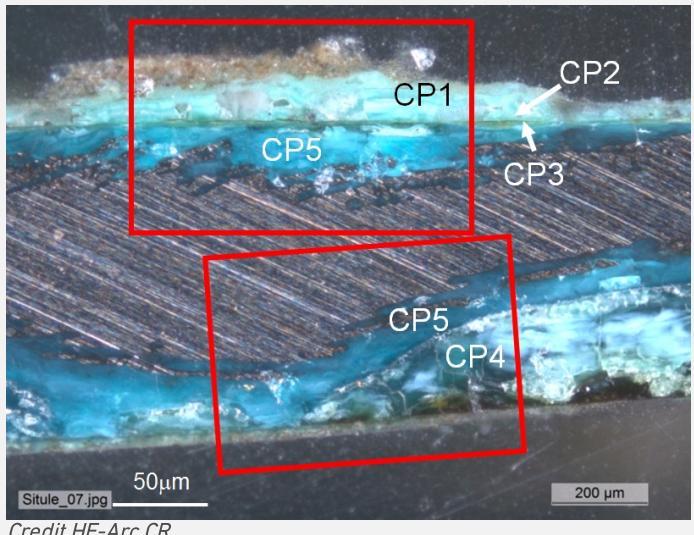
Fig. 10: Micrograph of the metal sample from Fig. 4, unetched, dark

The corrosion crust is heterogeneous and has in places completely replaced the metal. The metal - corrosion products interface is irregular due to transgranular corrosion (Figs 7-8). In most cases, the corrosion crust can be divided in three main layers: an inner compact blue layer directly on the metal core (CP5, Figs. 6, 10 and 11 and CP3, Fig. 5). In areas of extensive corrosion this blue layer coexists with a friable green layer (CP4, Figs. 6, 10 and 11 and CP2, Fig. 5). Depending on the area either a very fine dark green (CP3, Fig. 6 and Fig. 10) or red corrosion layer (CP2, Fig. 6 and Fig. 10) marks the limit of the original surface. It is followed by an external fourth layer, consisting of friable and sometimes curly pale green corrosion products intermingled with soil products (CP1, Fig. 6 and Fig. 10 and 13). In heavily worked and fragile parts of the object a cleavage between the inner layers of blue and green corrosion is present, rendering the green corrosion vulnerable to loss (Fig. 11).

field, 50x. Areas of Fig. 11 (bottom, corresponding to the stratigraphy of Fig. 5) and Figs. 12 and 13 (top, corresponding to the stratigraphy of Fig. 6) are marked by a rectangle. Codes are those of Fig. 6,

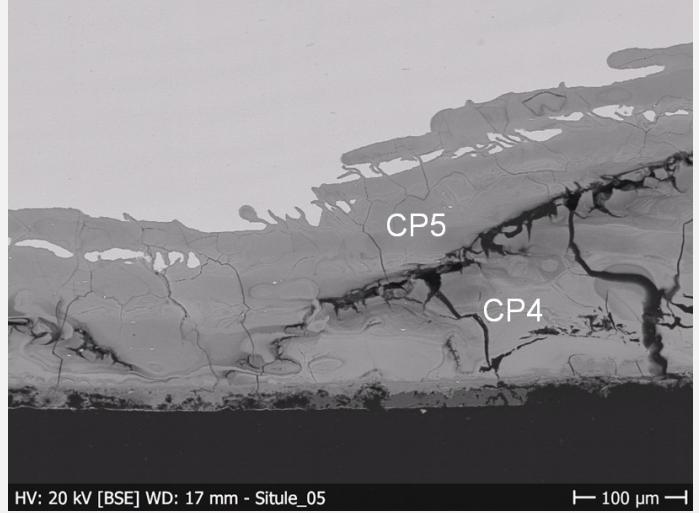
Fig. 11: SEM image, BSE-mode of the metal sample from Fig. 10 (detail) showing cleavage between the inner blue (CP5) and green (CP4) layers of Fig. 6,

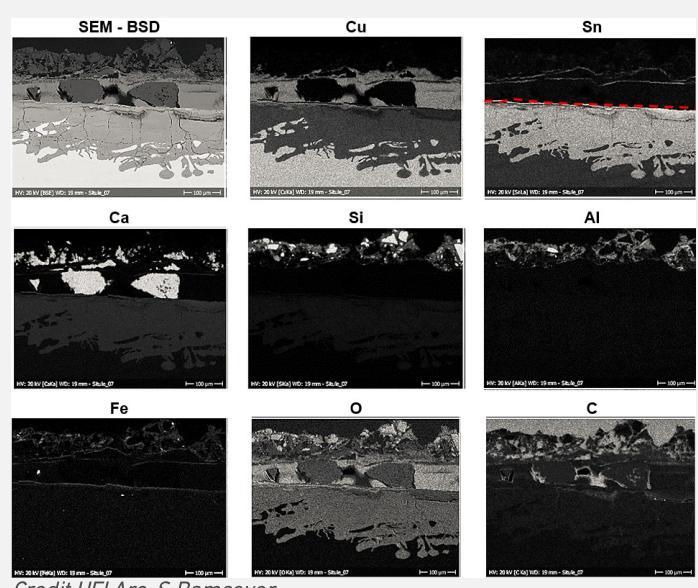
The inner layers (CP3-CP5) are Sn and O-rich and depleted in Cu (Table 2). The outer layers (CP1 and CP2) are Cu and O-rich, contain no Sn, and are contaminated with Ca, Si, Al and Fe coming from the soil (Fig. 12). The colour of the corrosion crust varies according to the content of Sn (the more Sn, the darker green or blue the corrosion). FTIR on the inner blue (CP5 and Fig. 14) and outer green (CP1 and Fig. 15) layers were difficult to interpret. Only malachite could be identified in both cases. XRD spectra could not be interpreted because of the deficiency of peaks.

The limit of the original surface is well defined (interface of CP1 and CP2) but due to the fragility of the inner corrosion layers it was difficult to uncover.

Fig. 12: SEM image, SE-mode, and elemental chemical distribution of the selected area of Fig. 10. In red: the limit of the original surface highlighted by the enriched tin layer. Method of examination: SEM-EDS, Lab of Electronic Microscopy and Microanalysis, IMA (Néode), HEI Arc,

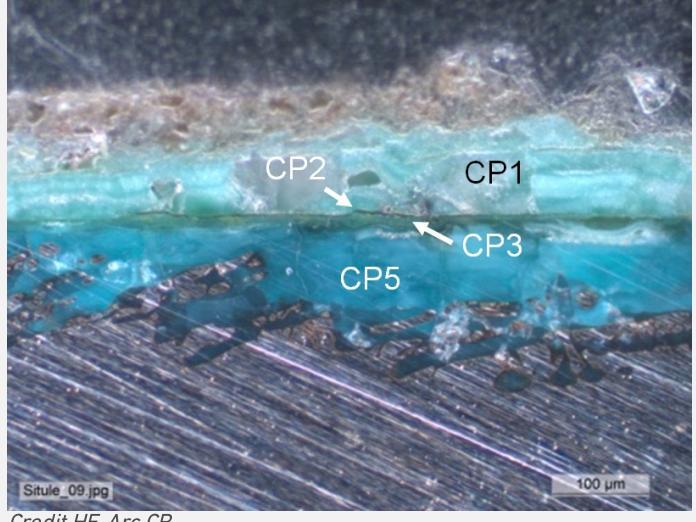
Fig. 13: Micrograph of the metal/corrosion interface (detail of Fig. 10) unetched, dark field, 100x.The outer layer (CP1 of Fig, 6) incorporates soil material and the thin dark layer (CP2 of Fig, 6) highlights the limit of the original surface,

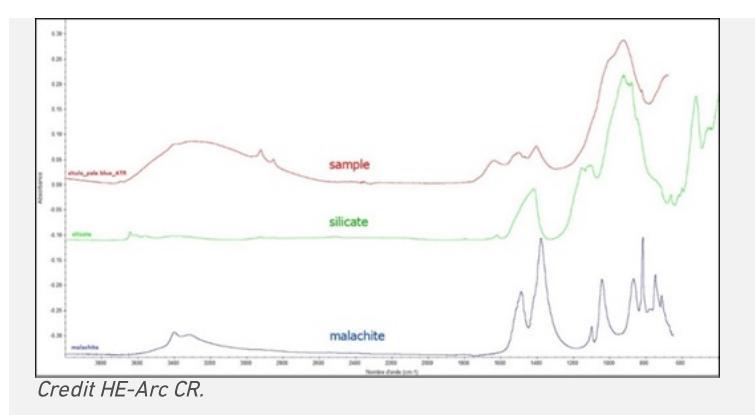
Fig. 14: FTIR spectrum (ATR mode) of the inner blue layer compared to the silicate and malachite standard spectrum. Method of analysis: FTIR spectroscopy, HE- Arc CR,

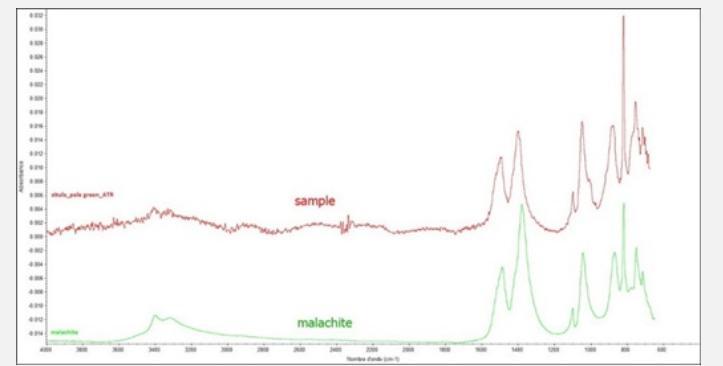
Fig. 15: FTIR spectrum (ATR mode) of the outer green layer compared to the malachite standard spectrum. Method of analysis: FTIR spectroscopy, HE-Arc CR.,

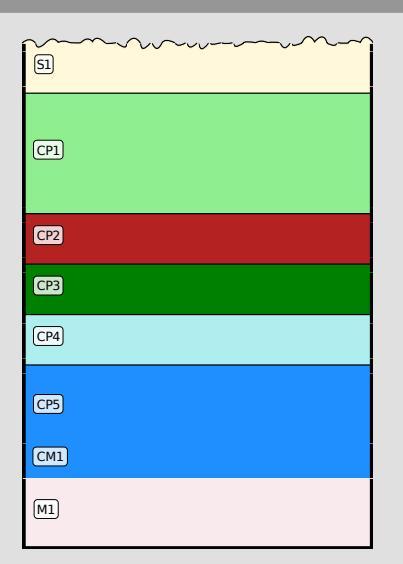
There are 2 stratigraphies (Fig. 5 corresponding to the interior face of the situla and Fig. 6 to its exterior face). The strata are similar in composition but their coding is different: CP1 to CP3 in Fig. 5 correspond to CP3 to CP5 in Fig. 6. Since the stratigraphy of Fig. 6 is more complete, the composition of each of its strata is given below.

Fig. 6: Stratigraphic representation of the object in cross-section using the MiCorr application. This representation shows the interior face and can be compared to Fig. 10 (top square), Credit HE-Arc CR, M-J.Scholl.

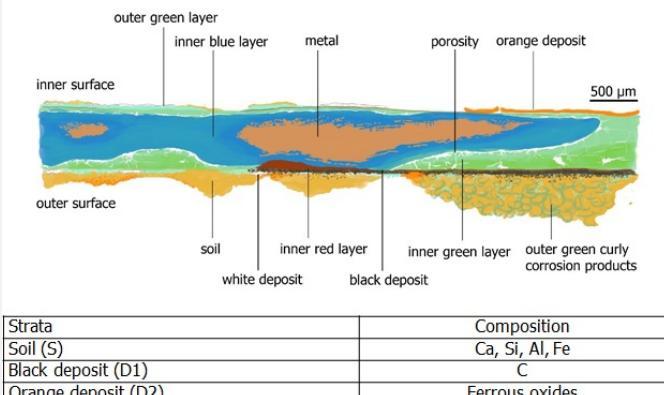
Orange deposit (D2)	Ferrous oxides
White deposit (D3)	Ca
Outer green curly corrosion product (CP1e)	Copper carbonates (curly malachite)
Inner red (CP2i)	Copper oxide (cuprite ?)
Outer green layer (CP3i)	Copper carbonates (malachite)
Inner green layer (CP4i)	Copper carbonates (?) + Sn
Inner blue layer (CP5i)	Copper carbonates (?) + Sn
Remnant metal phase (M)	Bronze (90%Cu, 10% Sn)

The metal structure of this low-tin bronze shows extensive cold work and multiple annealing cycles with a final cold work. The total absence of inclusions highlights a highly developed knowledge in bronze metallurgy. The metal is much corroded. Transgranular corrosion is visible. The majority of the internal corrosion products are composed of copper carbonates that have replaced much of the metal. Curly malachite has developed in clusters on the outside of the surface. This pattern is characteristic of a long-term burial period. The presence of inner enriched Sn layers shows a decuprification phenomenon (dissolution of Cu). Because of the friable nature of the inner green layer that supports the limit of the original surface, as well as its cleavage with the blue layer underneath, the original surface has become very fragile. The corrosion is thought to be of type 1 according to Robbiola et al. 1998.

Fig. 16: Improved stratigraphic representation of the situla from visual observations and analyses,
