# VOTIVE FIGURE OF A BAT IVB4168 - GILDED BRASS - MODERN TIMES

Votive figure of a bat IVb4168

Christian. Degrigny (HE-Arc CR, Neuchâtel, Neuchâtel, Switzerland) & Naima. Gutknecht (HE-Arc CR, Neuchâtel, Neuchâtel, Switzerland) & Valentin. Boissonnas (HE-Arc CR, Neuchâtel, Neuchâtel, Switzerland)

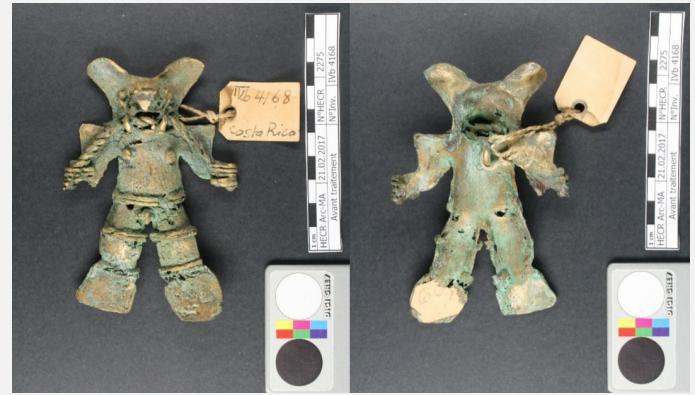
- **Description of the artefact** The object represents a bat-like figure holding and chewing a rope (Fig. 1). The copper alloy was most likely cast using the lost wax process. There are remains of a surface gilding. The object has a red-brown adherent layer where the gold has flaked off with a heterogenous green and white loosely bound layer on top. Dimensions: Length = 110 mm; Width = 73mm; Height = 25mm; WT = 60g. Type of artefact Votive figure Origin Costa Rica Unknown, acquisition in 1970 **Recovering date** Chronology category Modern Times chronology tpq chronology taq **Chronology comment** 20th century (fake)
  - MiCorr | Votive figure of a bat IVb4168 Gilded brass Modern Times This work is licensed under <u>CC BY-NC-ND 4.0</u> 😳 🚯 😑

Fig. 1: Votive figure of a bat, front (left) and back (right) view,

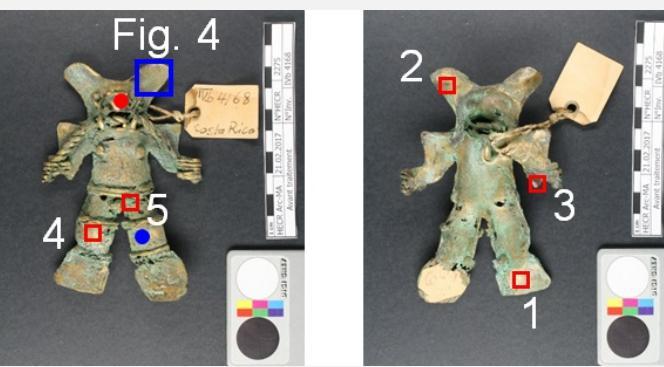
Fig. 2: Bat figure, front (left) and back (right) view with location of XRF analyses (red squares), FTIR analysis with sampling (blue point) and SEM-EDS analysis (red point),

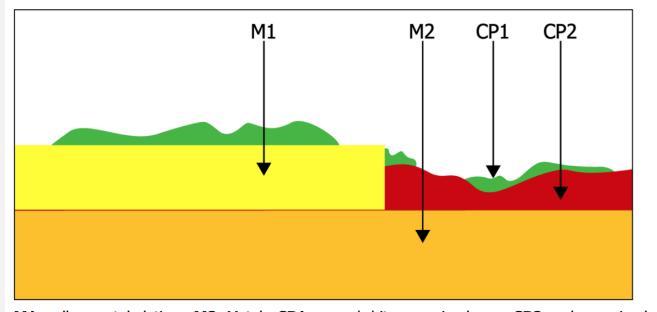
M1: yellow metal plating M2: Metal CP1: green/white corrosion layer CP2: red corrosion layer Credit HE-Arc CR, N.Gutknecht.

Fig. 3: Stratigraphic representation of the bat in cross-section by macroscopic observation,

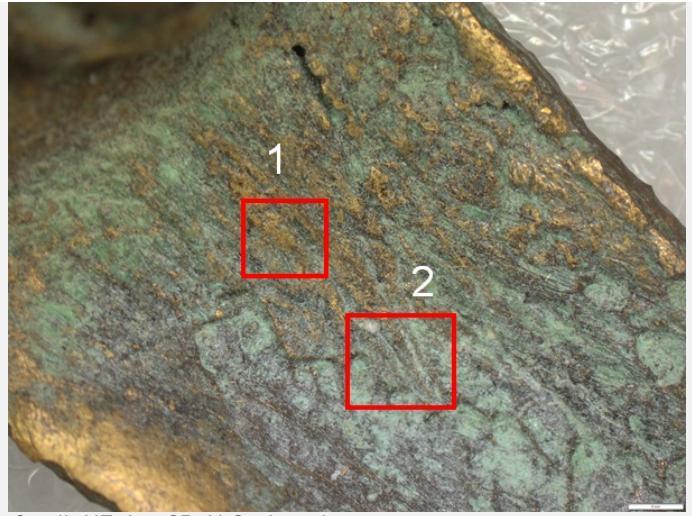
Fig. 4: Location of the areas 1 and 2 used to build the MiCorr stratigraphies of Figs. 5 and 6,

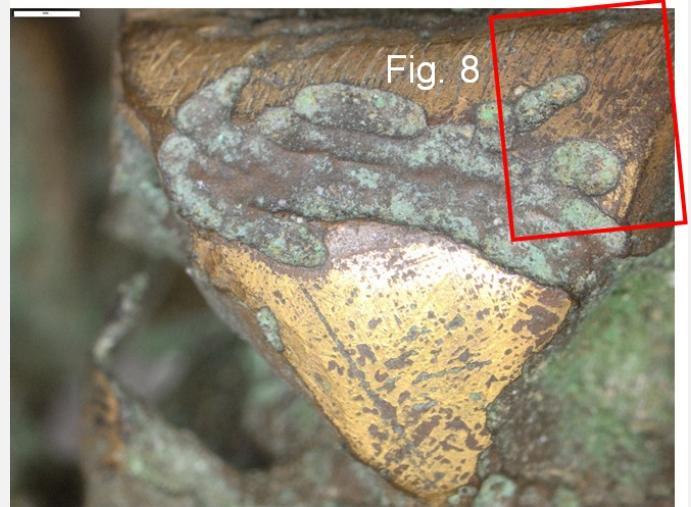
The metal seems to have been heavily attacked (acid dissolution). There are several perforations on the lower part of the object, and where the gold layer is absent the surface is unevenly pitted by corrosion (Figs. 1, 2 and 7). The submetallic core is not visible from the surface.

There are two corrosion products (Figs. 7 and 8). The red one (CP2) has a submetallic brightness and is opaque, nonmagnetic, compact, hard and adherent. It is very thin (less than a few microns thick) and only appears where the gold layer has been lost. The EDX spectrum (Fig. 9) shows that it is a Cu- and O rich product, probably cuprite (Cu2O). The light green to white corrosion product (CP1) has a waxy consistency and is thin, translucent, non-magnetic, powdery and very soft. It is very loosely bound. It is distributed on the whole object (front and back) as disparate clumps. It is mainly located on the cavities and irregularities of the surface. FTIR analyses (ATR mode) of both green and white areas of CP1 have similar spectra and were identified as copper nitrate (Fig. 10).

of Fig. 8,

Fig. 7: Binocular image of the nose of the bat showing detail

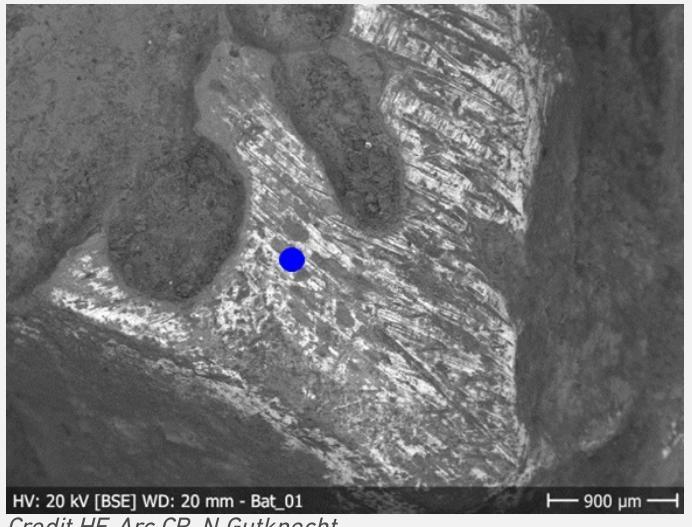
Figs. 8: SEM images of the metal on the nose of the bat. The blue point represents the area for the EDS point analysis (Fig. 9),

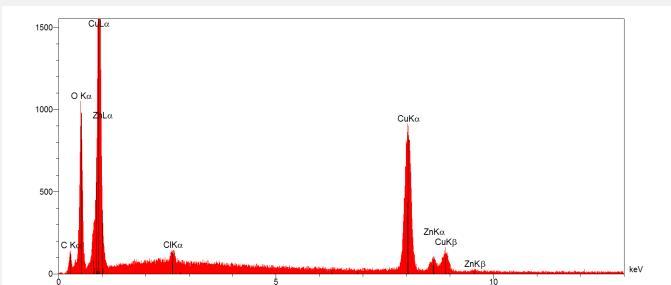
Fig. 9: EDS analysis of the red corrosion product. Method of analysis: SEM-EDS, Lab of Electronic Microscopy and Microanalysis, Néode, HEI Arc,

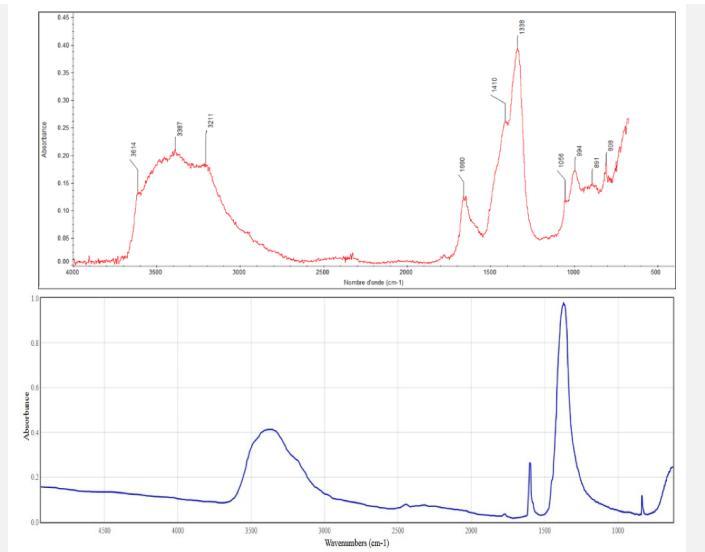
Fig. 10: FTIR spectrum (ATR mode) of the white corrosion product product (top), and of synthesized copper nitrate (Cu(NO3)2 \* 3H2O) (bottom),

FTIR analysis of the green/white corrosion product suggests that it is a copper nitrate, a highly water soluble corrosion product that cannot be found in an archaeological context. However, it has been recorded on artificially patinated copper alloys (Scott 2000; Craddock 2009).

The dissolution of the metal and the subsequent formation of the patina is most likely the result of a forced attack with concentrated nitric acid. The holes and pits in the metal are unnatural for a natural corrosion process which would produce a stratified, adherent and thick corrosion crust (Craddock 2009). The copper nitrates could have formed over time from residual acidic solution that was left on the surface.The lack of an archaeological context, the
