AIRCRAFT FRONT FASTENING PLATE VHS-497 (2) – AL CU SN ZN SI ALLOY – MODERN TIMES

Aircraft front fastening plate VHS-497 (2)

Marianne. Senn (EMPA, Dübendorf, Zurich, Switzerland) & Christian. Degrigny (HE-Arc CR, Neuchâtel, Neuchâtel, Switzerland)

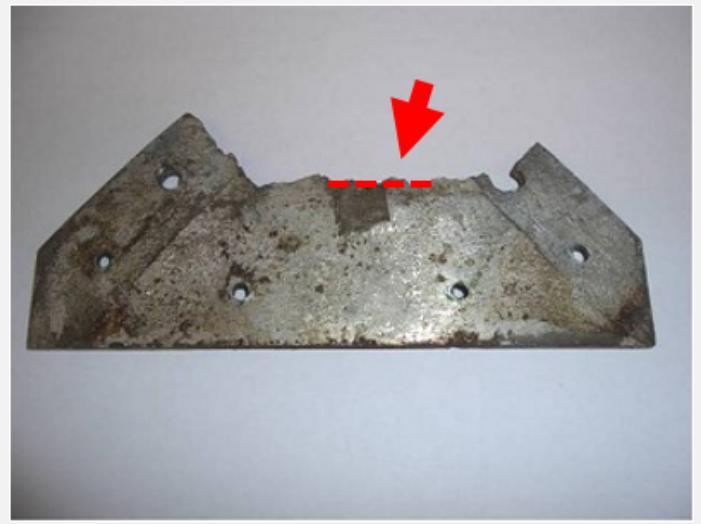
Fig. 1: Fastening plate from the front of the Dufaux IV (left) and top view of the aeroplane showing its location (red dot, right) (www.hepta.aero),

Description of the artefact	Metal fastening plate for the wooden construction of the front of the aeroplane, broken by use (Fig. 1) covered with a thin corrosion layer.					
Type of artefact	Aeroplane part					
Origin	Dufaux IV aeroplane					
Recovering date	Biplane built by Henri and Armand Dufaux in 1909/10					
Chronology category	Modern Times					
chronology tpq	1909 A.D. 🗸					
chronology taq	1910 A.D. 🗸					
Chronology comment						
Burial conditions / environment	Outdoor to indoor atmosphere					
Artefact location	Swiss Museum of Transport, Luzern, Lucerne					
Owner	Swiss Museum of Transport, Luzern, Lucerne					
Inv. number	VHS-497 (2)					
Recorded conservation data	Not known

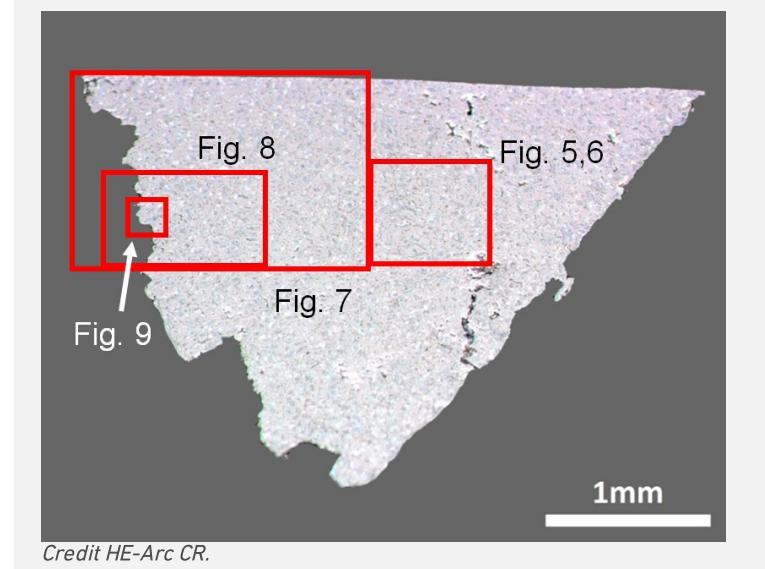
Fig. 3: Micrograph of the cross-section of the sample taken from the front fastening plate showing the location of Figs. 5 to 9, $\,$

Description of sample	The top part has been cut during sampling (Fig. 2). The more regular right side is the plate surface and the irregular side is the broken edge (Fig. 3). Dimensions: L = 4mm ; W = 4mm.
Alloy	Al Cu Sn Zn Si Alloy
Technology	As-cast
Lab number of sample	DUF-4
Sample location	Empa (Marianne Senn)
Responsible institution	Swiss Museum of Transport, Luzern, Lucerne
Date and aim of sampling	September 2007, metallography and alloy composition

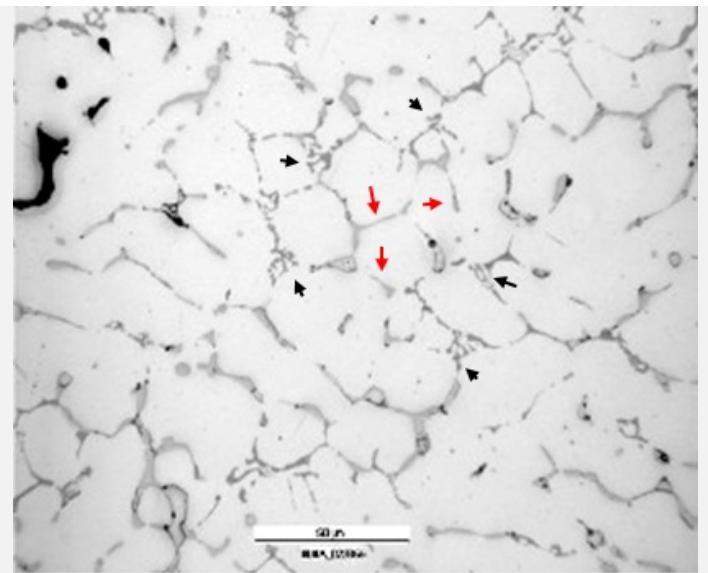
The metal is an aluminium alloy containing Cu, Sn, Zn and Si (Table 1). The unetched metal shows an as-cast structure consisting of the aluminium matrix with Sn (not soluble in Al) inclusions (Figs. 5 and 6), intermetallic compounds such as Al₂Cu (Fig. 5, red arrows) and clusters of Al,Fe,Cu & Si phases (Fig. 5, black arrows). There are porosities in the metal (Figs. 3 and 5). The average hardness of the metal is HV1 80.

Fig. 5: Micrograph of the metal sample from Fig. 3 (detail), unetched, bright field. The cast structure is revealed by light grey intermetallic compounds (Al2Cu, red arrows), dark-grey Al,Fe,Si & Cu phase clusters (black arrows) and Sn inclusions (nodules). On the top left some pores can be seen,

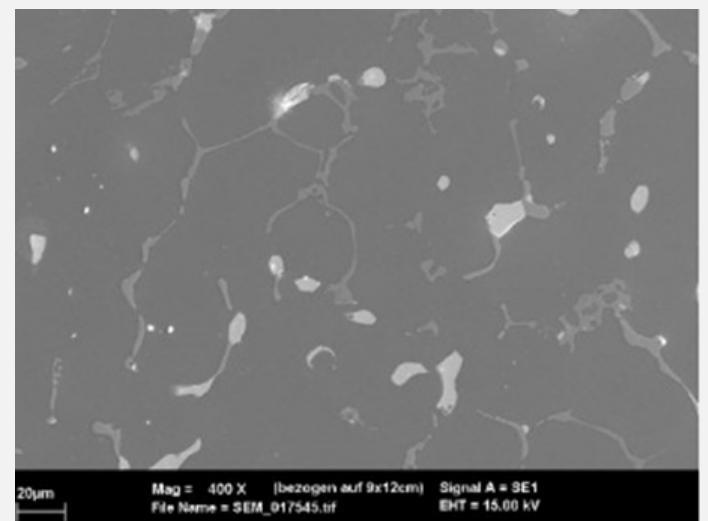
Fig. 6: SEM image of the metal sample from Fig. 3 (detail), SE-mode, unetched. We observe in dark-grey the metal matrix, in medium-grey the intermetallic compound Al2Cu as well as Al,Fe,Si & Cu phase clusters and in light-grey the Sn inclusions,

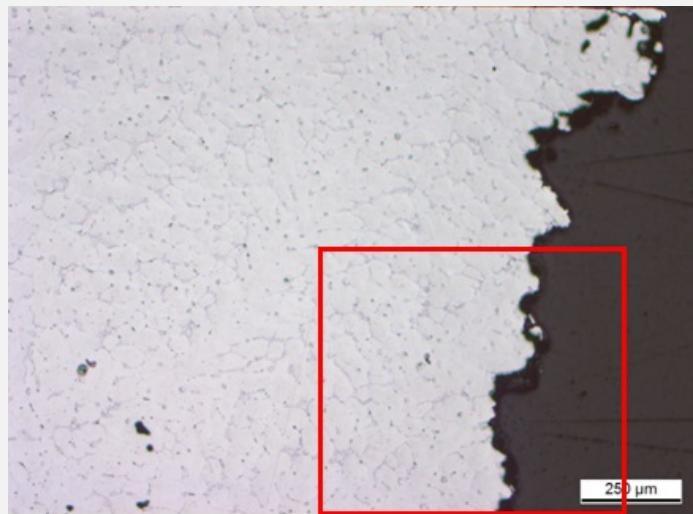
No corrosion layer can be seen on the metal surface (Figs. 3 and 7). Under polarized light small white and brown particles are visible on the broken edge (D1, Fig. 8). Their analysis reveals the presence of silica particles surrounded by dirt (Table 2 and Fig. 9). The metal surface is covered by a thin oxygen bearing skin (CP1, Fig. 9).

Fig. 7: Micrograph showing the metal - "corrosion products" interface from Fig. 3 (reversed picture, detail), unetched, bright field. We observe in white the metal matrix, in dark-grey Al,Fe, Si & Cu phase and light-grey Al2Cu intermetallic compounds. The micrograph of Fig. 8 is marked by a rectangle,

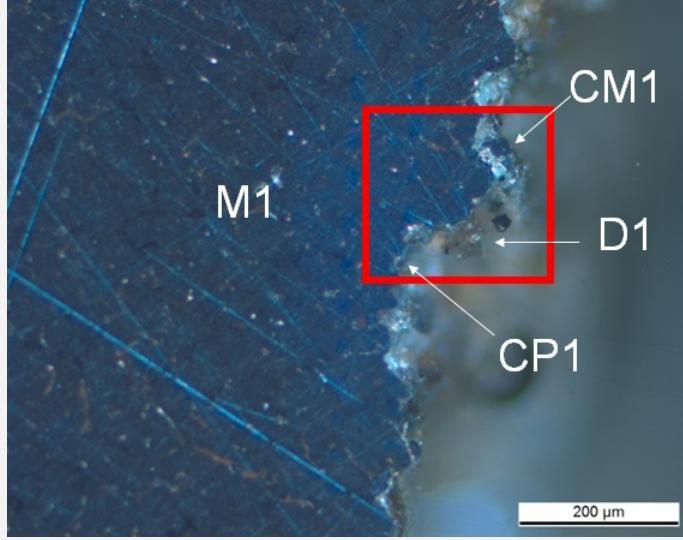
Fig. 8: Micrograph from Fig. 7 (detail) and corresponding to the stratigraphy of Fig. 4, unetched, polarised light. We observe in grey the metal matrix and blue-brown the adherent material. The area selected for elemental chemical distribution (Fig. 9) is marked by a rectangle,

Although not common at the beginning of the 20th, this Al-Cu-Sn-Zn-Si cast alloy was used on the Dufaux IV plane. No corrosion layer has been found on the metal surface except adherent silica-rich particles and the thin oxidised skin typical of Al alloys. The presence of these materials can be explained by the regular maintenance of the metal, probably using silicon carbide abrasive paper.

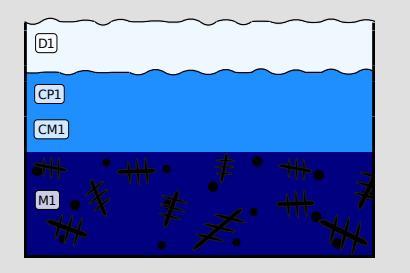
Fig. 4: Stratigraphic representation of the sample taken from the front fastening plate in cross-section (dark field) using the MiCorr application. The characteristics of the strata are only accessible by clicking on the drawing that redirects you to the search tool by stratigraphy representation. This representation can be compared to Fig. 8, Credit HE-Arc CR.
