RAIN GUTTER FRAGMENT – GREY CAST IRON – MODERN TIMES – FRANCE

Rain gutter fragment

Christian. Degrigny (HE-Arc CR, Neuchâtel, Neuchâtel, Switzerland) & Mathea. Hovind (University of Oslo, Department of archaeology, conservation and history (IAKH-UiO), Oslo, Oslo, Norway)

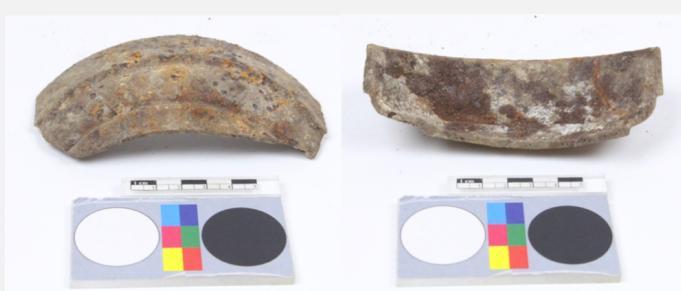
Fig. 1: Rain gutter fragment, exterior and interior faces (to the left and right, respectively),

✤ Description and visual observati	on					
Description of the artefact	Rain gutter fragment (Fig. 1), possibly part of the extension of a roof drain pipe. Both the exterior and interior surfaces are covered by heterogeneous corrosion crusts. The underlying metal seems however to be well preserved, including features such as a difference in thickness etc. Dimensions: L = 55mm; W (interior) = 120mm; Tmax. = 6mm; WT = 176g.					
Type of artefact	Architectural element					
Origin	Château de Germolles (14th century), Mellecey, Bourgogne, France					
Recovering date	Date unknown					
Chronology category	Modern Times					
chronology tpq	1801 A.D. 🗸					
chronology taq	2000 A.D. 🗸					
Chronology comment	19th - 20th century					
Burial conditions / environment	Outdoor atmosphere					
Artefact location	Haute Ecole Arc Conservation-Restauration					
Owner	Château de Germolles, Mell	ecey, Bourgogne

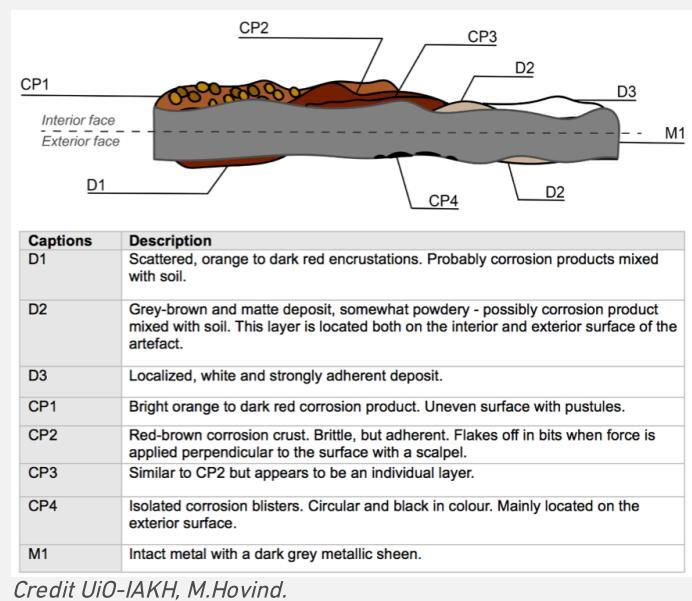
Fig. 3: Preliminary stratigraphy corresponding to the overall surface of the artefact. The interior surface is shown above the stippled line and the exterior surface below. D = Deposit, CP = Corrosion products, M = Metal,

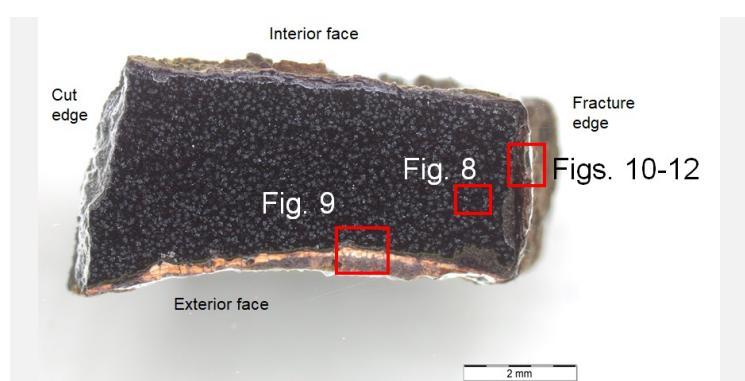
Fig. 4: Micrograph of the sample taken from the rain gutter fragment showing its orientation relative to the artefact and the

locations of Figs. 8-12,

Description of sample	The sample consists of a rectangular section (Fig. 4) which was cut out from the fractured edge the gutter fragment. It is representative of three surfaces: the exterior and interior surface, as w as the fracture edge. Dimensions: L = 7mm; Wmax. = 5mm; Tmax. = 4mm (approx.).			
Alloy	Grey cast iron			
Technology	Cast			
Lab number of sample	CIG2018 (Cast Iron Gutter, sampled in 2018)			
Sample location	Haute Ecole Arc Conservation-Restauration			
Responsible institution	Haute Ecole Arc Conservation-Restauration			
Date and aim of sampling	March 2018, study of corrosion stratigraphy and chemical analyses

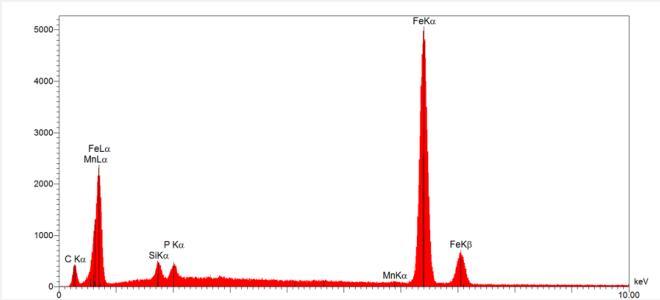
The metal is a P-rich grey cast iron with Si and Mn (Fig. 7). Its microstructure is characterized by evenly distributed graphite flakes in a matrix composed of dendrites and an interdendritic eutectic phase (Fig. 8). What appears to be irregular graphite flakes / porosity is in fact deformed graphite flakes; graphite is soft and prone to destruction by smearing and/or preferential removal during polishing (Scott 1991).

Fig. 7: EDS-spectrum showing the chemical composition of the metal. Method of analysis: SEM-EDS. Lab. of Electronic Microscopy and Microanalysis, Néode, HEI Arc,

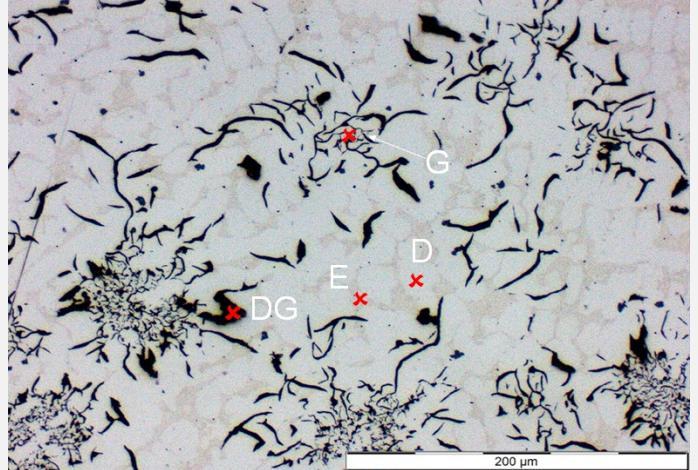
The dendrites appear light grey under polarized light, while the eutectic phase appear light brown (Fig. 8). The eutectic phase is rich in Fe and P and contains small amounts of C and Si, whereas the dendritic phase contains much less P (Table 1).

Fig. 8: Micrograph of the metal sample from Fig. 4 (detail). Unetched, bright field. Graphite flakes (G) in black, the dendrites (D) in light grey and the eutectoid phase (E) in light brown. Deformed graphite (DG) flakes are visible as irregular black inclusions,

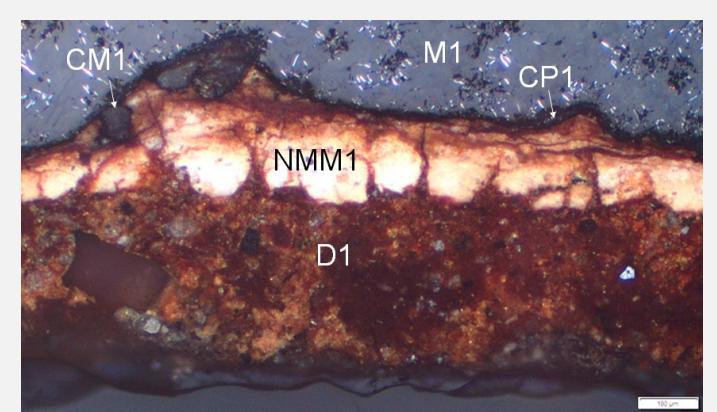
The exterior face (Figs. 2, 4 and 9) consists of a white / light yellow cracked layer (NMM1 in Fig. 5) superimposed by a layer of deposit mixed with orange-red corrosion products (D1 in Fig. 5). Punctual analysis by SEM-EDS (Table 2) revealed that the white / light yellow layer is rich in Ba, O, S, Fe, C and Zn. It has a chemical composition similar to Lithopone (BaSO4,ZnS), a preparatory paint layer. Fe is probably a contamination from the superimposed porous deposit / corrosion product D1 (Table 2). The latter (D1) is Fe- and O-rich and contains Si, Al and some Ca, in addition to a range of elements (K, P, Na, Cl, S and Ti) present in minor amounts (Table 2). A thin layer of corrosion products (CP1) is located just beneath the paint layer, appearing dark grey under polarized light (Fig. 9). This layer is followed by a corroded metal phase (CM1). Their exact composition was not analyzed but is likely to correspond to the corroded metal phase of the fracture edge, described below.

Fig. 9: Micrograph of the metal sample from Fig. 4 (detail), unetched, polarized light, 5x. The stratigraphy of the exterior surface, from top to bottom: the metal (M1) in grey, a layer of corroded metal (CM1) followed by a thin layer of CP1, and a white cracked layer (NMM1) superimposed by a porous dark-red deposit (D1),

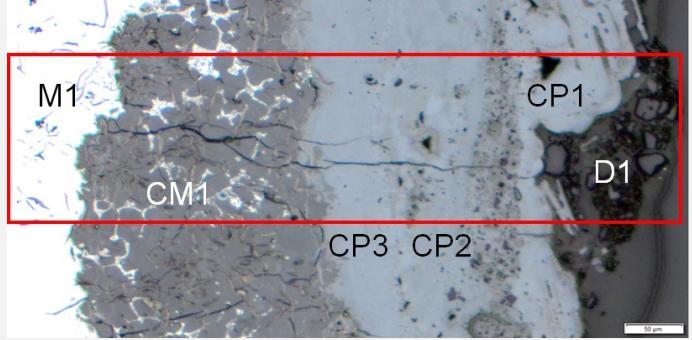
The interior face (Figs. 2 and 4) shows similar characteristics but does not include a white layer similar to NMM1. The fracture edge however (Figs. 2, 4 and 10), shows a more complex stratigraphy consisting of a dense product layer which can be further divided into two individual strata (CP3 and CP2), superimposed by a porous corrosion crust appearing orange under polarized light (CP1) (Fig. 11). The corroded metal (CM1) is located just beneath CP3 and contains remnants of the P-rich eutectic phase (Figs. 10-12). The M/CP ratio (metal to corrosion products) is rather high, implying extensive internal corrosion. Furthermore, a simple crack is traversing the corrosion layers – indicating a fragilization of the structure. As for the composition of the corrosion products CP1, CP2 and CP3, they all contain Fe and O (Fig. 12). A marbling effect within CP2 and CP3 indicates a variation in the concentration of Fe and O (particularly visible in bright field – Fig. 10). The white deposit (D1 in Fig. 6) might originate from exposure to calcareous water (Table 2). The presence of exogenous elements such as Si, Ca, Al, Na and O (Table 2) was confirmed by elemental mapping (Fig. 12).

Fig. 10: Micrograph of the metal sample from Fig. 4 (detail), unetched, bright field. From left to right: intact metal (M1) in white, followed by preferentially corroded metal (CM1) and dense product layers (CP3 and CP2) in various shades of grey. CP1 is slightly porous and covered by grain-like particles (D1). The area selected for elemental chemical distribution (Fig. 12) is marked by a red rectangle. A simple crack is traversing the corrosion layers,

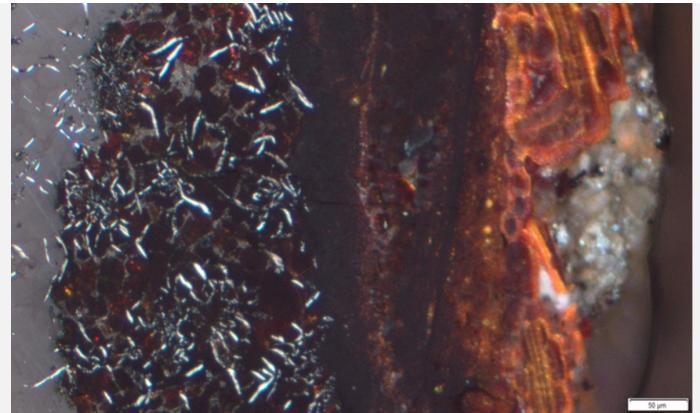
Fig. 11: Micrograph similar to Fig. 10 but under polarized light. The external deposit (D1) appears grey-white, CP1 in bright orange, while CP2 and CP3 appear dark red to brown. The corroded metal (CM1) contains remnants of graphite flakes (in white) and the P-rich eutectic (in grey),

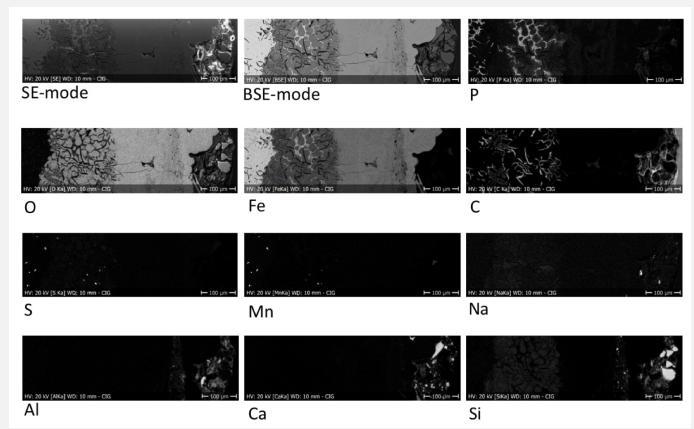
Fig. 12: SEM image and elemental chemical distribution of the selected area from Fig. 10. Method of analysis: SEM-EDS. Lab. of Electronic Microscopy and Microanalysis, Néode, HEI Arc,

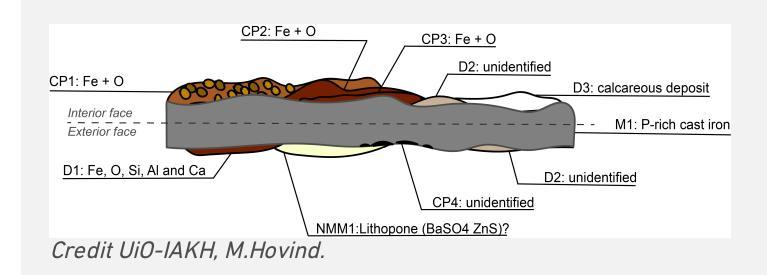
Fig. 13: Improved stratigraphic representation of the rain gutter fragment with results of SEM-EDS analysis and visual microscopic observation,

The rain gutter fragment is a grey cast iron with a microstructure consisting of graphite flakes and a P-rich eutectic phase. The exterior surface contains a preparatory paint layer, located beneath a layer of corrosion products mixed with soil. It seems likely that the cast iron gutter has been covered with a protective paint layer (e.g. Lithopone) to slow down the rate of atmospheric corrosion. The presence of Lithopone reinforces the suggested dating of the artefact (20th century) as this pigment was developed and used from the 1880s and onwards (Lithopone 2007). However, it seems that the protective layer has none or only very limited effect as (pitting) corrosion is present also in these areas.

The corrosion layers consist mainly of Fe and O, indicating atmospheric corrosion with presence of only a very small amount of contaminants/pollution. The scattered white deposit is possibly originating from exposure to calcareous water as it is localized mainly on the interior face of the fragment, where rain water would hit the metal before entering the ground.
