# CHISEL POINT DEV 995 1069 PR – EUTECTOID TO HYPEREUTECTOID STEEL – EARLY MEDIEVAL TIMES – SWITZERLAND

Chisel point DEV 995 1069 PR

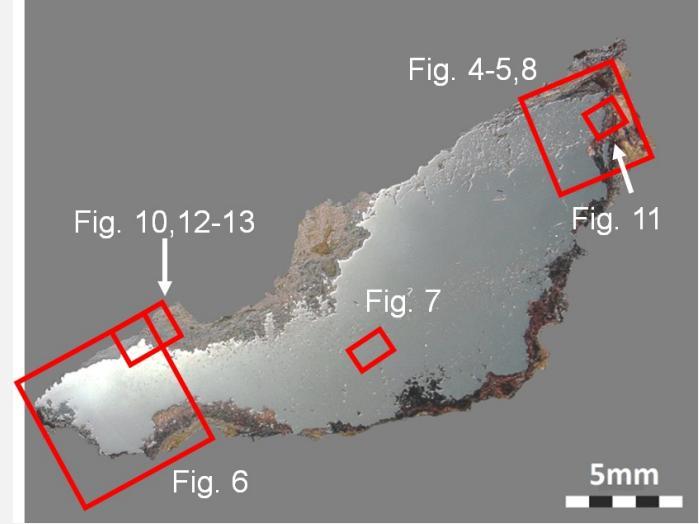
Fig. 3: Micrograph of the cross-section of the chisel point showing the location of Figs. 4 to 8 and 10 to 13,

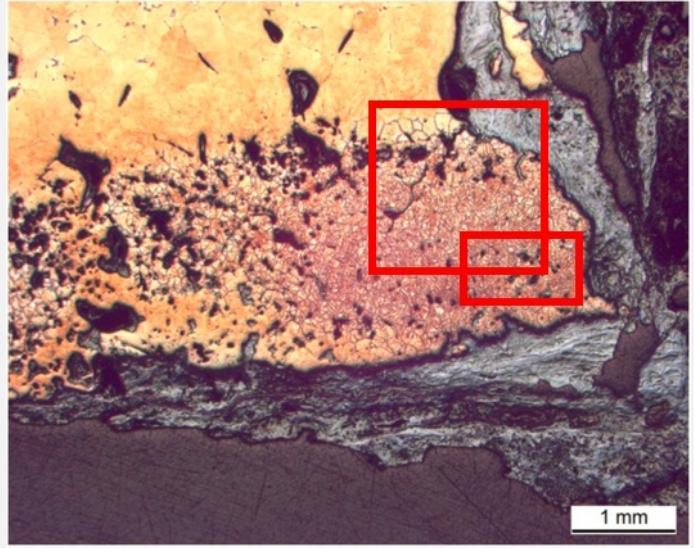
The remaining metal is a eutectoid to hypereutectoid steel (C 0.8-1 mass%) with cracks and porosity (Figs. 4 and 5). Its composition is given in Table 1 (except Fe). Of the trace elements, only Ni reaches a medium concentration (Ni 0.07 mass%). The composition and the high Ni/Co ratio are atypical for iron worked in smithies of the settlement at Develier-Courtételle JU, CH. The few slag inclusions and their chemical composition confirm this (Table 2). The slag is rich in CaO whereas the pisolithic or bean ore worked in the Central Jura smelting district is rich in Al<sub>2</sub>O<sub>3</sub>. The slag inclusions cannot be smithing slag because the artefact is formed from one piece of metal. The slag probably incorporated while refining the bloom or during the bloom smelting process. The ore from which this metal was smelted cannot yet be identified. Intergranular corrosion has developed, penetrating into the metal structure (Fig. 5). The etched metal shows a dominant martensitic structure, typical of quench hardened steel (Figs. 4, 6, 7 and 8). The characteristic forms of the martensite are non-organised needles (Fig. 7). In restricted areas bainite nodules occur (Figs. 6 and 7). In the centre of the point, hypereutectoid steel is composed of cementite in the grain boundaries and in needle like shapes within the grains (Fig. 9). Hypereutectoid regions also occur in the centre of the shaft and on its left surface (Fig. 4). Here the hypereutectoid steel is composed of martensite and cementite in the grain boundaries and in needle form within the grains (Figs. 5 and 8). Nevertheless, most of the chisel is dominated by eutectoid steel. The average hardness of the quench hardened eutectoid steel is about HV1 690. In the bainite nodules the average hardness drops to about HV1 350, the martensite has an average hardness of HV1 750.

Fig. 4: Micrograph of the metal sample from Fig. 3 (inverted picture, detail), etched, bright field. The metal contains porosity and cracks (in black). The micrographs of Figs. 5 and 8 are marked by the top and bottom rectangles respectively,

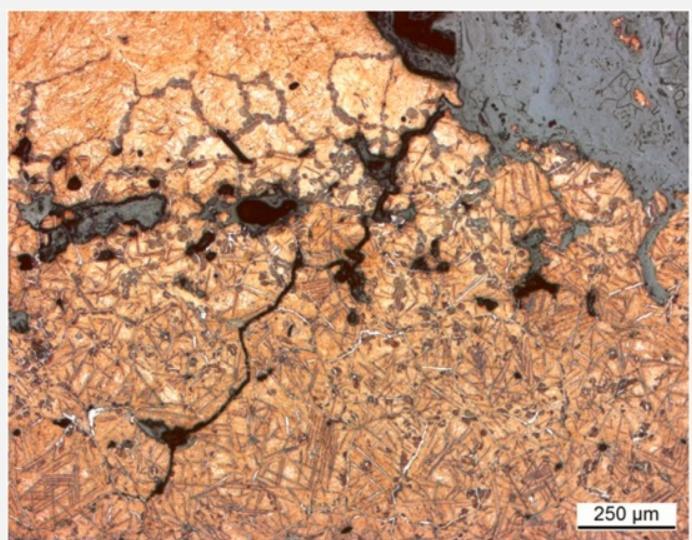
Fig. 5: Micrograph of the metal sample, detail from Fig. 4, etched, bright field. We observe martensite (in orange), cementite (in grey), porosity and intergranular cracks (in black) and corrosion,

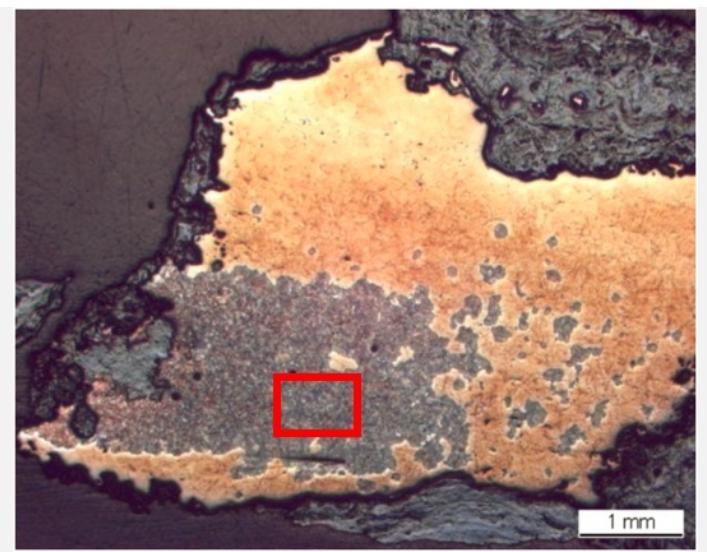
Fig. 6: Micrograph of the metal sample from Fig. 3 (inverted picture, detail), etched, bright field. We observe the metal with martensite (orange) and bainite nodules (blue). The micrograph of Fig. 9 is marked by a rectangle,

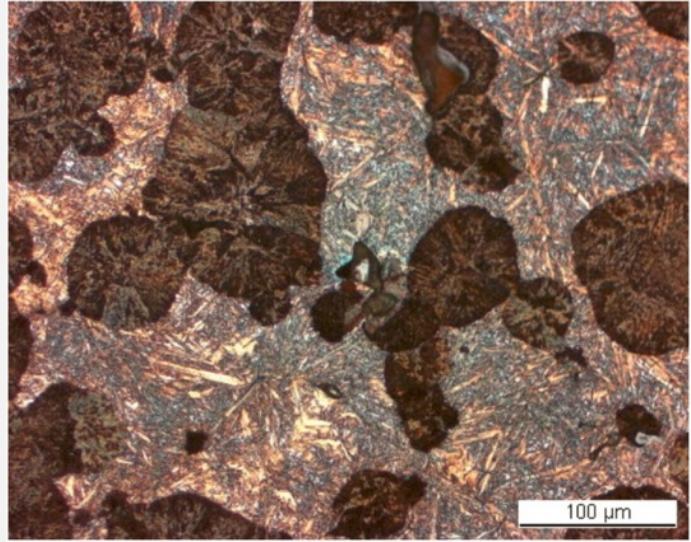
Fig. 7: Micrograph of the metal sample from Fig. 3 (detail), etched, bright field. We observe dark bainite nodules combined with martensite needles,

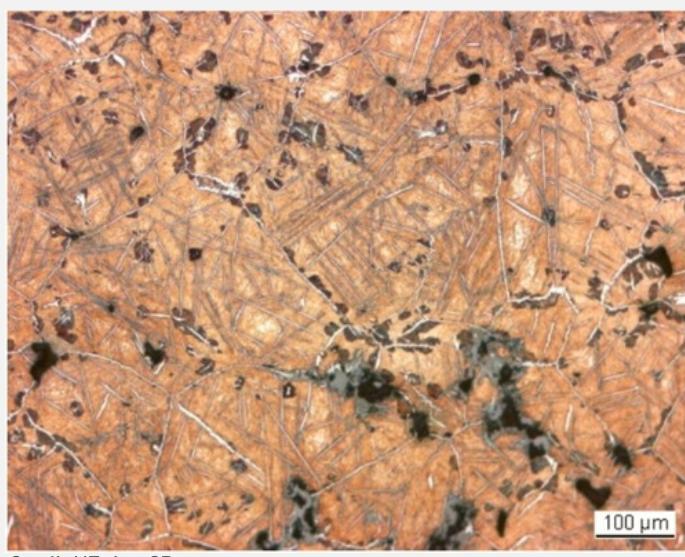
Fig. 8: Micrograph of the metal sample, detail from Fig. 4, etched, bright field. Hypereutectoid steel with a structure of cementite in white in the grain boundaries and in needle form combined with martensite (pink). Some bainite occurs around the grain boundaries,

The tool is made of hard, eutectoid to hypereutectoid steel and was, as a last manufacturing step, entirely quenched. In this state it is too hard and brittle to be used. It is likely that the quenched hypereutectoid structure provoked the breakage of the tool when it was first used. The absence of a tempering process at the end is unclear. The chemical composition of the metal and the slag inclusions indicate that the artefact was imported to the hamlet of Develier-Courtételle JU. The corrosion has, in areas, replaced the metal structure retaining a ghost structure; the outer layer has been mostly removed during surface cleaning. Extensive pitting corrosion has occurred, typical for steel with an elevated C content. The presence of S in the inner layer can be explained by putrefaction processes in the soil. Chlorides are still present at the metal-corrosion interface as no desalination process was attempted. Iron carbonates are present in the centre of a corrosion pit. The corrosion is of terrestrial type.

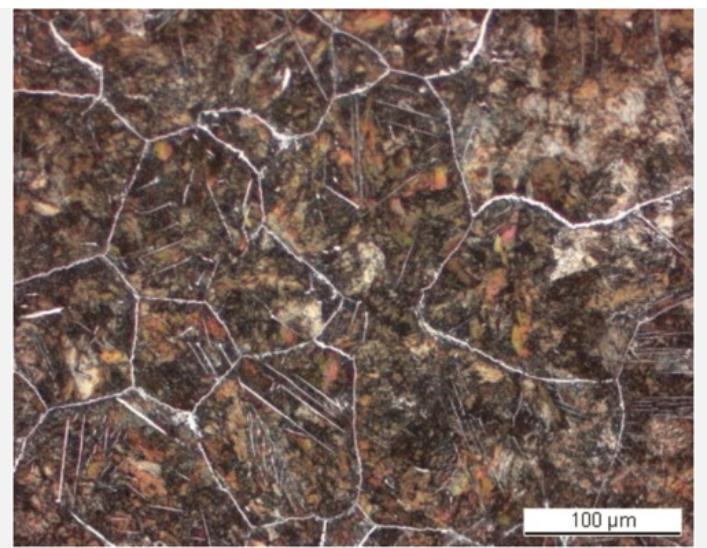
Fig. 9: Micrograph of the metal sample, detail from Fig. 6, etched, bright field. Hypereutectoid steel with a structure of cementite in white in the grain boundaries and in needle form combined with bainite (dark),

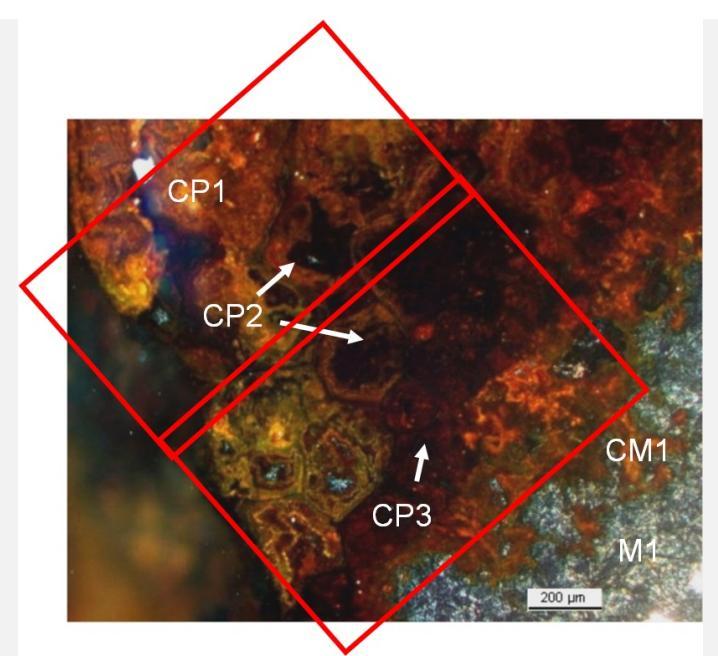
The metal is heavily corroded and the thickness of the corrosion crust is irregular, but averages about 0.5mm. The corrosion products enclose different ghost structures: the corrosion crust has preserved the shape of polygonal grains (Figs. 10 and 12) and cementite needles (Fig. 11). Under polarised light, the corrosion products at the metal – corrosion crust interface are dark-red and form an inner S-rich layer (CP3, Figs. 10 and 12). Cl occurs locally (CP3) and C is present in layers CP2 and CP3 (Fig. 12). The outer layer of the corrosion products (CP1) is orange and contains more 0 than the inner layer CP3 (Figs. 10 and 13).

Fig. 10: Micrograph showing the metal – corrosion crust interface from Fig. 3 (rotated by 270°, detail) and corresponding to the stratigraphy of Fig. 14, unetched, polarised light. Polygonal grains are visible as ghost structure in the corrosion crust. The selected areas for elemental chemical distribution (Figs. 12 and 13) are marked by two rectangles (bottom: Fig. 12 and top: Fig. 13),

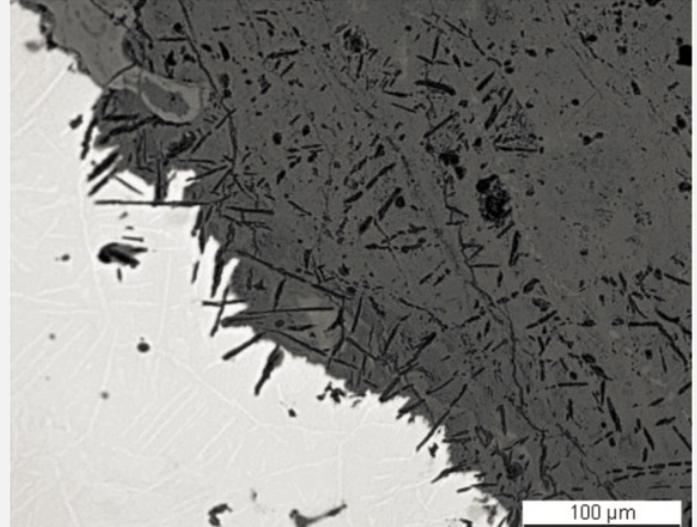
Fig. 11: Micrograph showing the metal – corrosion crust interface from Fig. 3 (detail), unetched, bright field. The cementite is visible as white needles in the metal and its ghost structure as black needles in the corrosion crust,

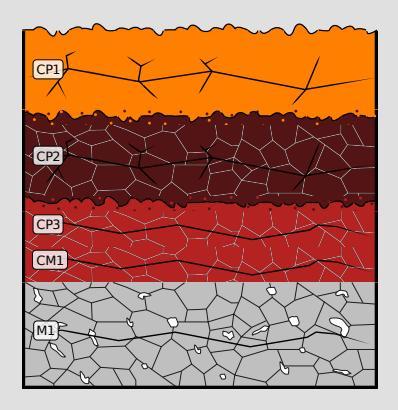
Fig. 14: Stratigraphic representation of the chisel point in crosssection (dark field) using the MiCorr application. The characteristics of the strata are only accessible by clicking on the drawing that redirects you to the search tool by stratigraphy representation. This representation can be compared to Fig. 10, Credit HE-Arc CR.
